**NAME:** Slate retaining wall & culvert, Martin's & Bastian's Quarries, 81 Quarry Road, WILLUNGA SOUTH

**PLACE NO.:** Local, HID 5442

**DESCRIPTION:**

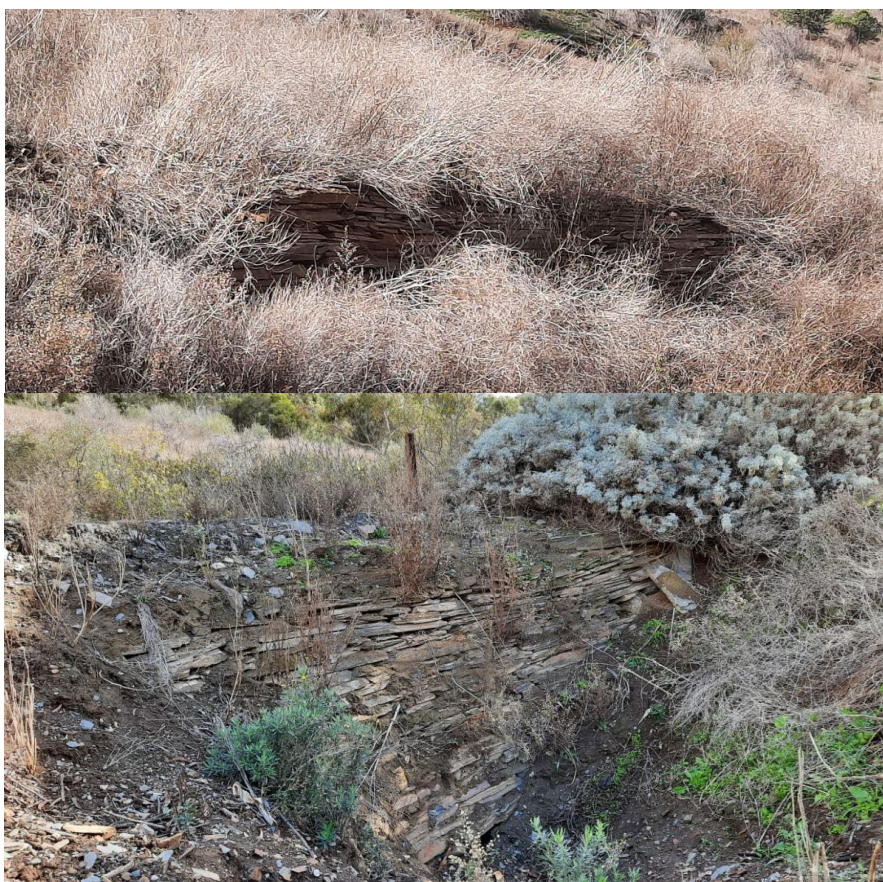
Slate retaining wall and culvert to Martin's & Bastian's Quarry, 81 Quarry Road, Willunga South (GGA, 2022).

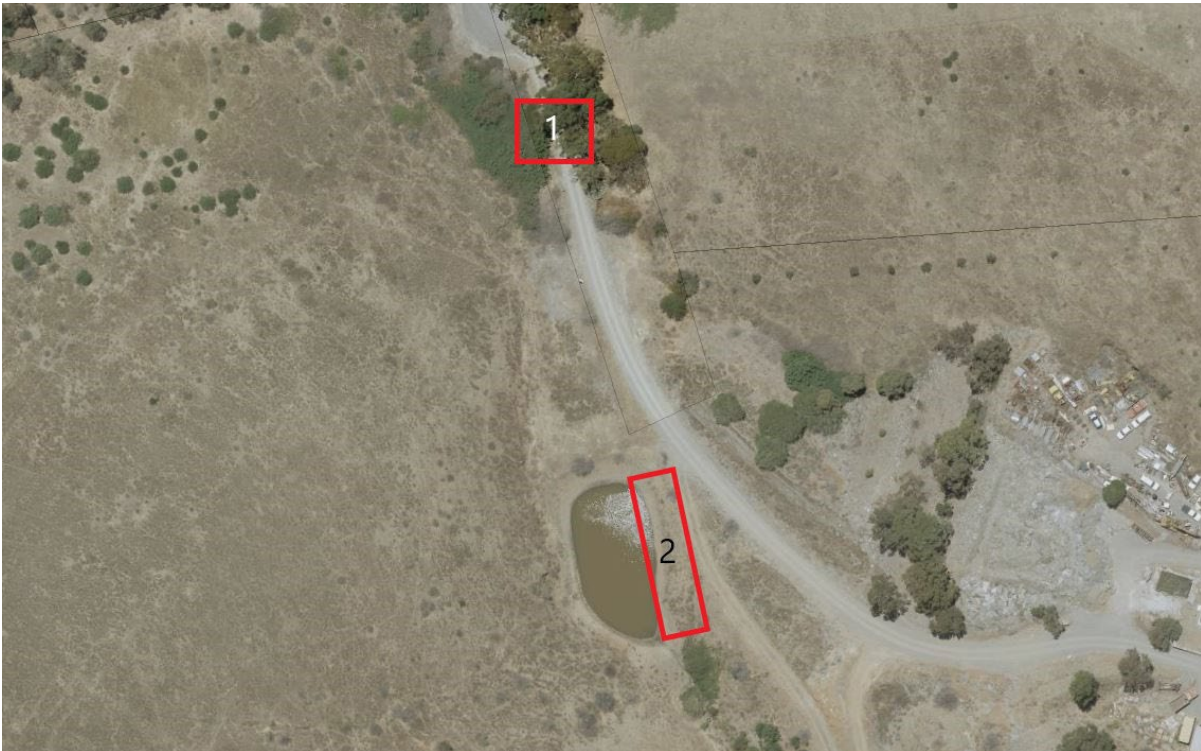
Site of retaining wall and culvert at Martin & Bastian Quarries, 81 Quarry Road, Willunga South; (1) site of culvert at quarry entrance; (2) site of retaining wall to the eastern embankment of the quarry pool (SAPPA, 2022).

It is understood that a large portion of the slate retaining wall may be currently buried beneath foliage and soil. It is recommended that minor excavation works be undertaken to determine the exact size and extent of the retaining wall to ensure an understanding of its heritage significance.

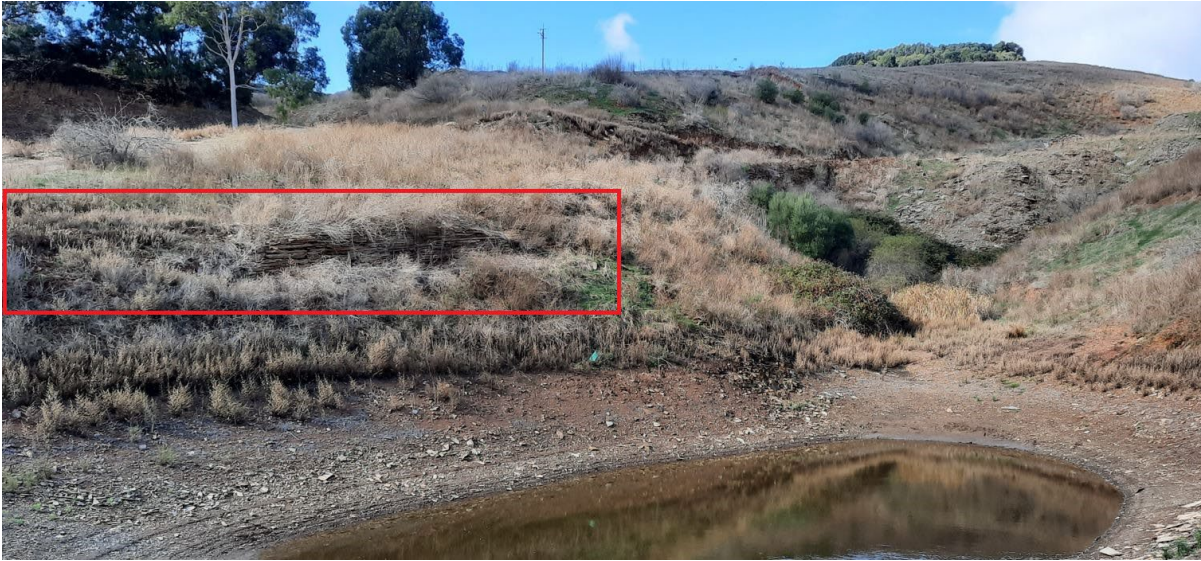
The exact construction date of the slate retaining wall, located to the eastern embankment of the site's pool, and the substantial slate culvert, located to the entrance gate of the site, are unknown but are presumed to date to an early period for their 'book-leaf' construction method and infrastructural usage, ie. c.1840s. While no further information regarding their history has been identified, the slate retaining wall and culvert now comprise the only surviving examples of early masonry construction remaining on the site, most likely dating to the site's early history.

Site of quarry pool; retaining wall located to eastern embankment (shown within red box), looking east (GGA, 2022).

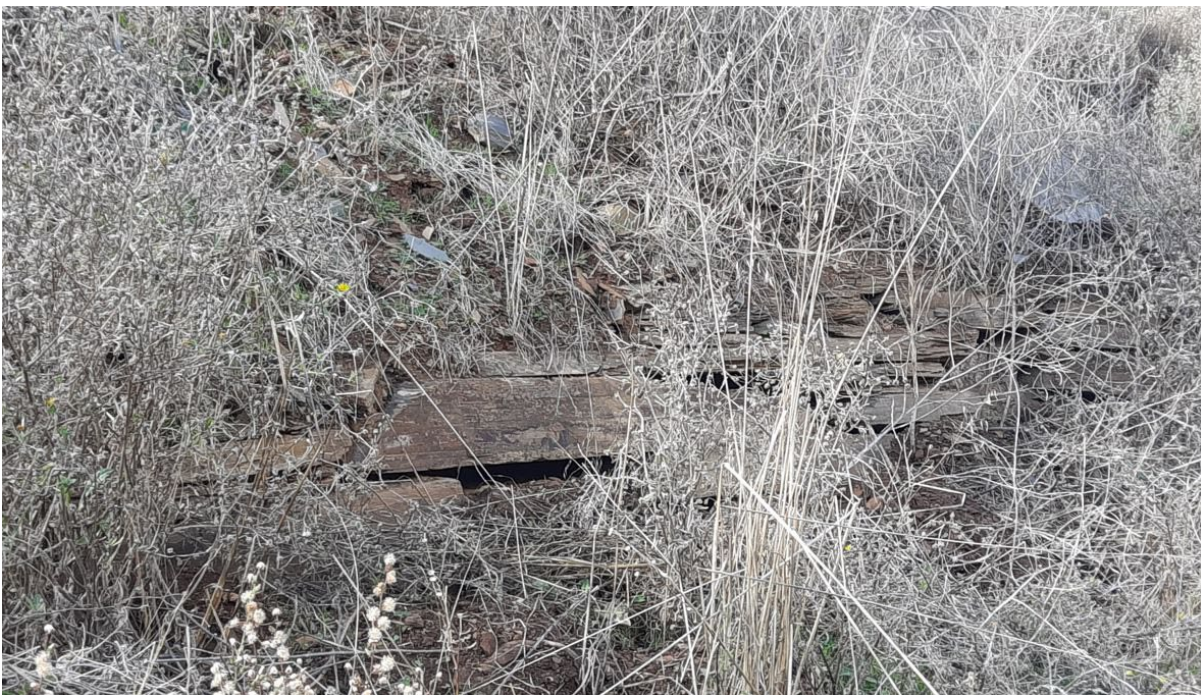
Additional partially-buried slate fabric to slate retaining wall, looking east (GGA, 2022).

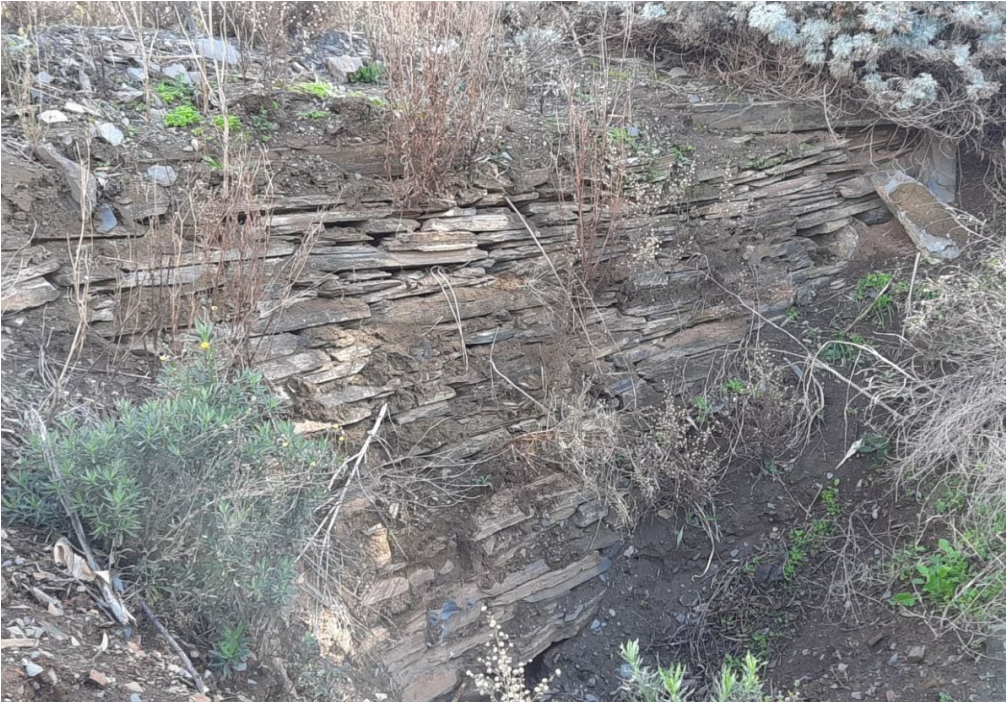
Slate fabric to right-hand side of culvert, located immediately south of the quarry entrance from Quarry Road, looking west (GGA, 2022).

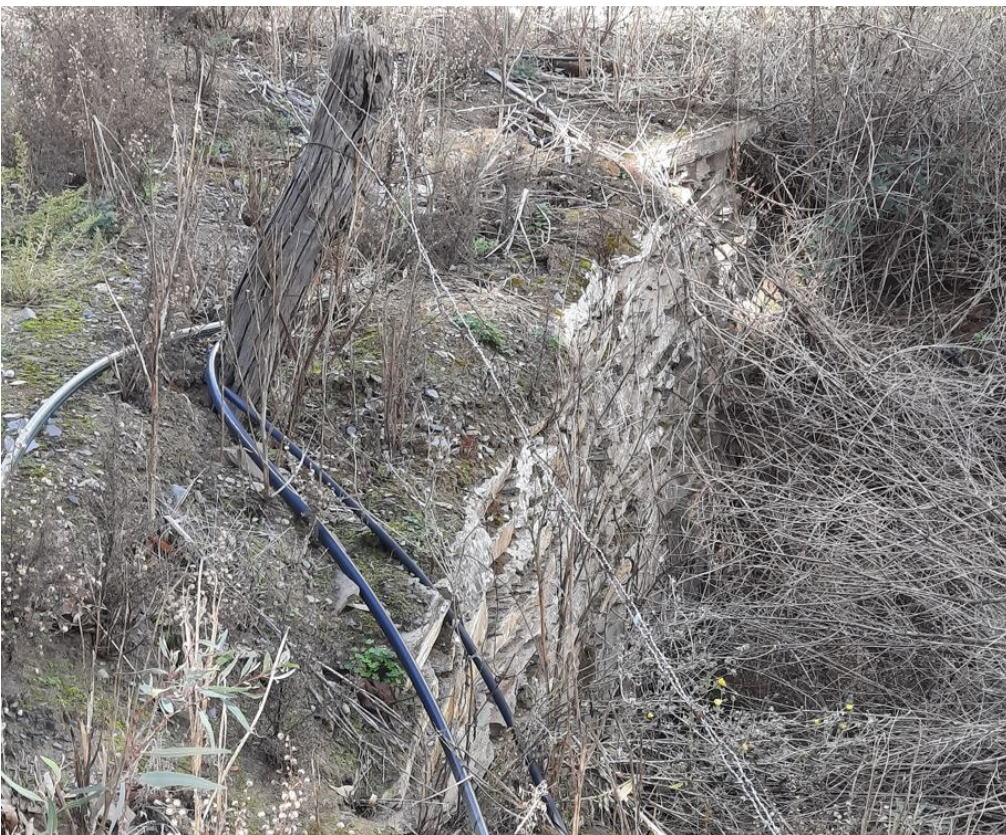
Slate fabric to left-hand side of culvert, located immediately south of the quarry entrance from Quarry Road, looking south-west (GGA, 2022).
