**NAME: 'Port Willunga Jetty Pylons', PORT WILLUNGA**

**CURRENT USE:** Jetty ruins  
**FORMER USE:** Jetty  
**DATE(S) OF CONSTRUCTION:** C. 1868 with later alterations

**RECOMMENDATION:** Local Heritage Place

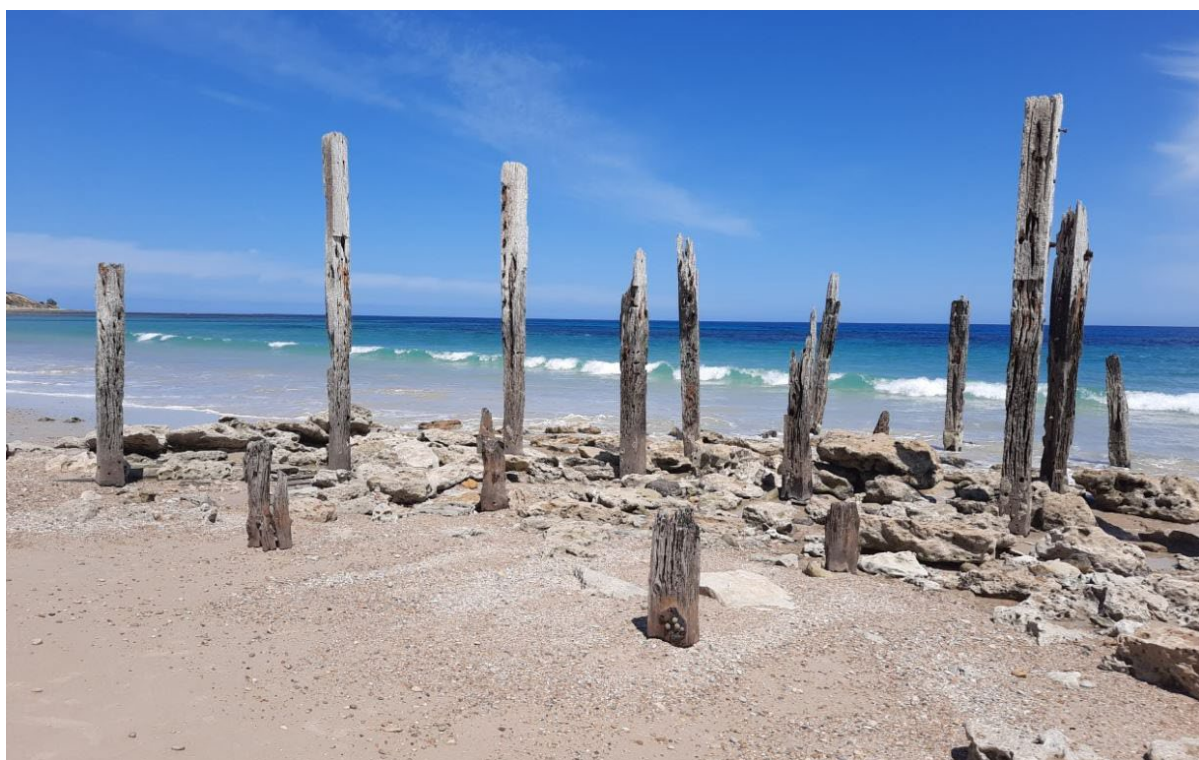
Old Port Willunga Jetty pylons, Port Willunga (GGA, 2022)

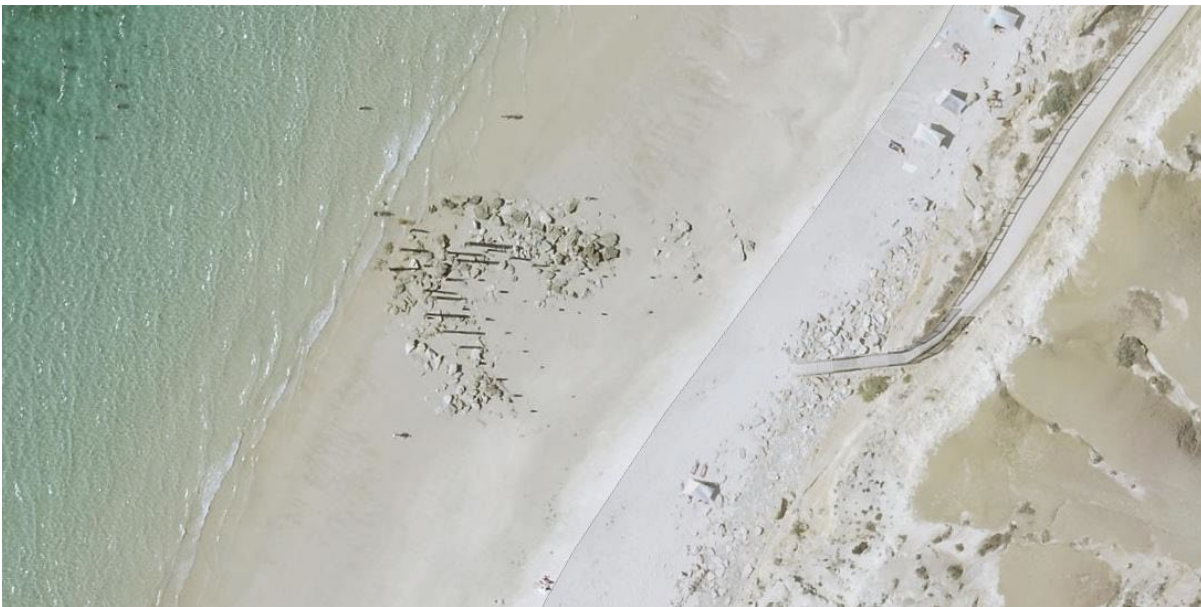
Enhancement of SAPPa satellite mapping of Port Willunga Jetty pylons, showing individual surviving pylons, associated stone foundations etc. (Planning SA SAPPa)

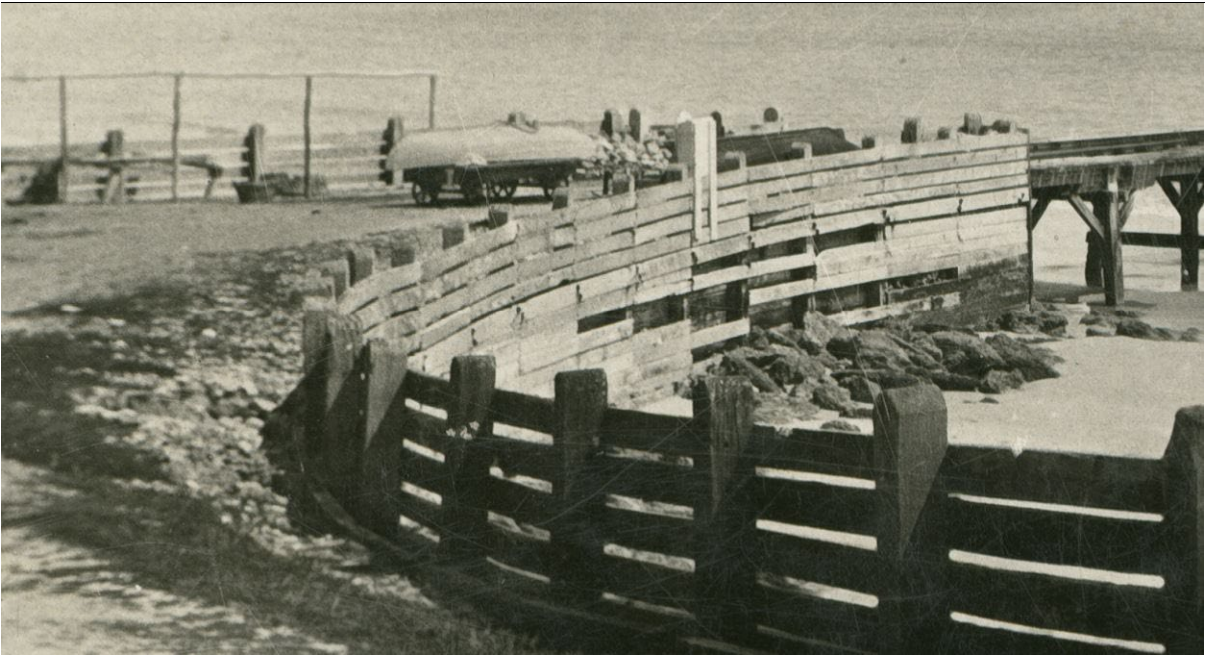
Pre-1915 photograph of north-side of Port Willunga jetty embankment, with timber retaining wall infrastructure and footing, now the remaining fabric of the Port Willunga jetty pylons (SLSA, B 7451).

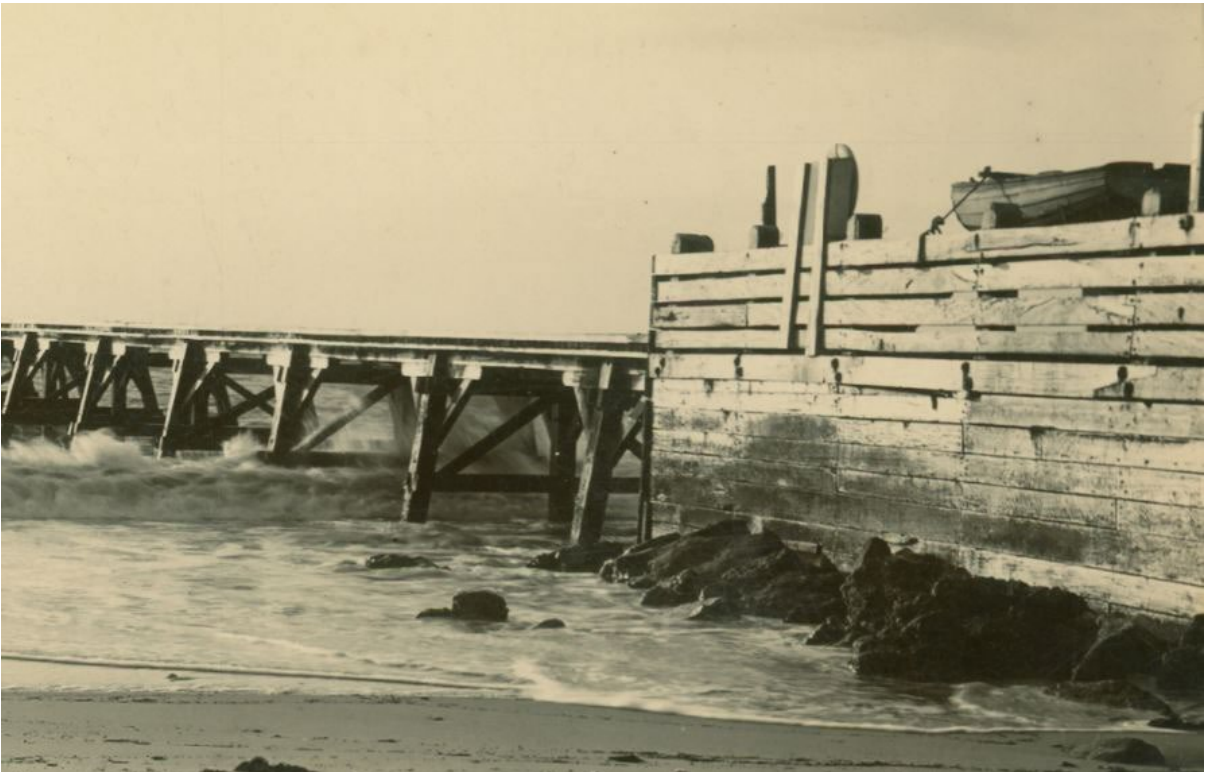
C.1905 photograph of south-side Port Willunga jetty embankment, with timber retaining wall infrastructure and footing, now the remaining fabric of the Port Willunga jetty pylons (SLSA, B 22137).

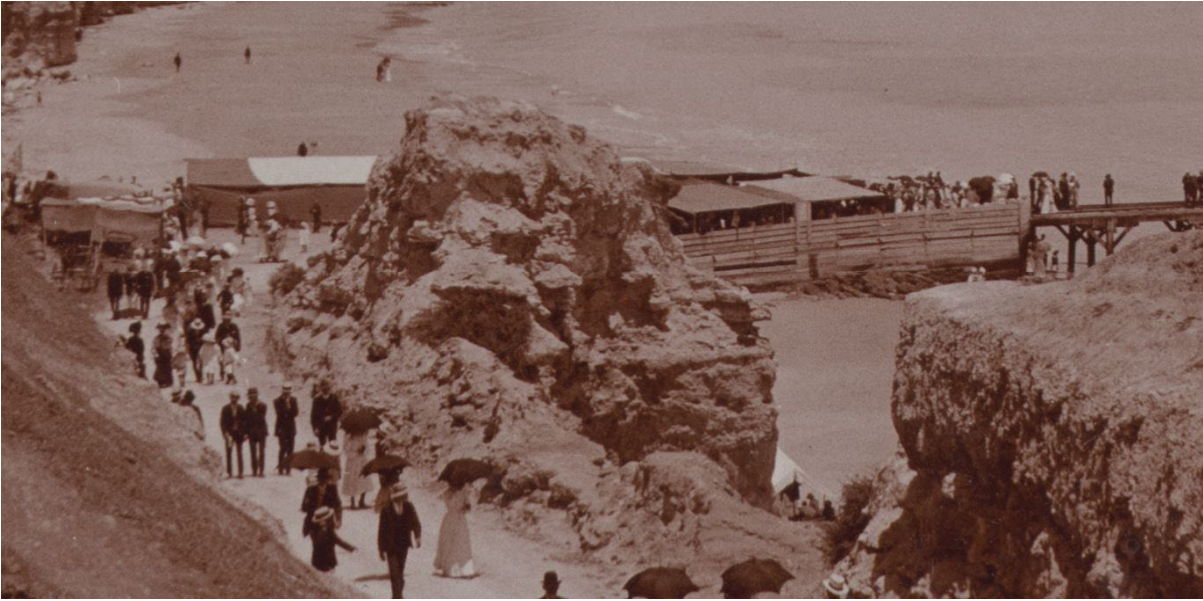
Pre-1915 photograph of Port Willunga jetty ramp and embankment with timber retaining wall infrastructure and footings, now the remaining fabric of the Port Willunga jetty pylons. Note numerous recreational tents erected on embankment, demonstrating how this site was used by holidaymakers during this period (SLSA, B 25663).

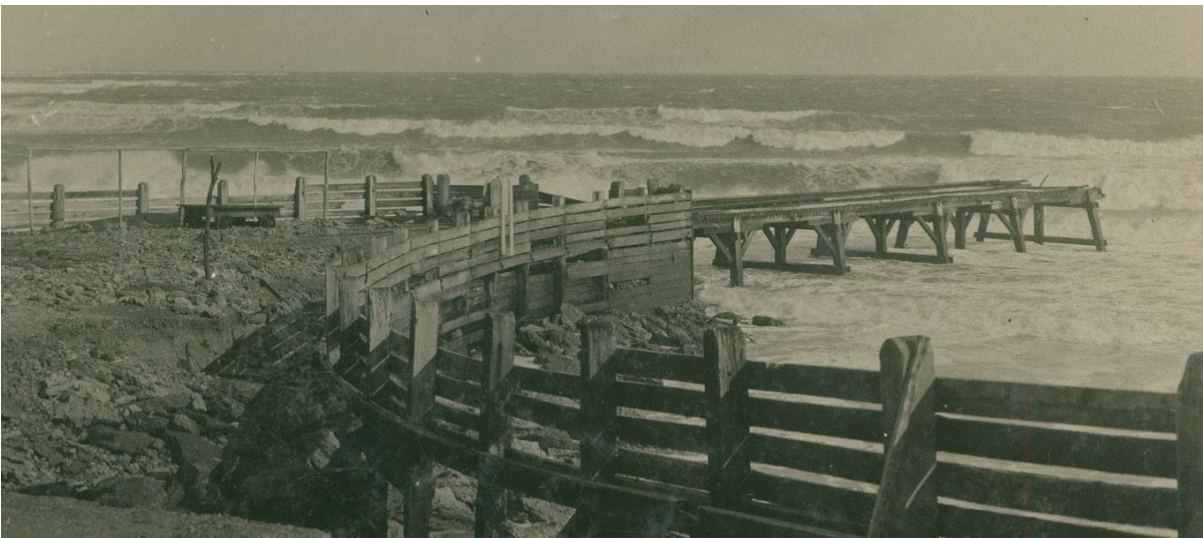
Remains of Port Willunga Jetty and associated embankment after storms in 1915 (SLSA, B 11918).

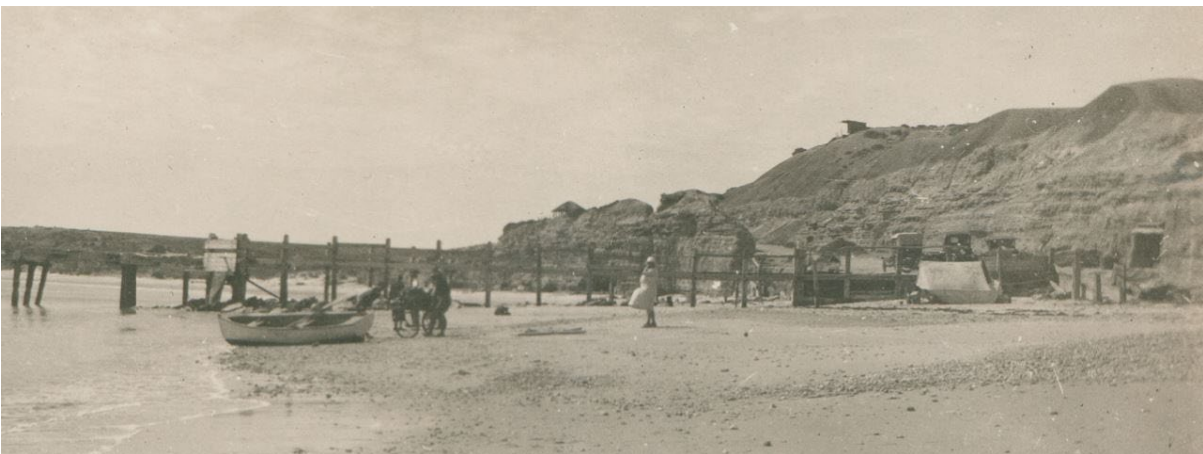
Port Willunga jetty site in the c.1920s (SLSA description erroneously attributes a date of c.1910), showing reconfigured 'boardwalk' construction to the jetty remnants after the destructive 1915 storms (SLSA, B 16429)

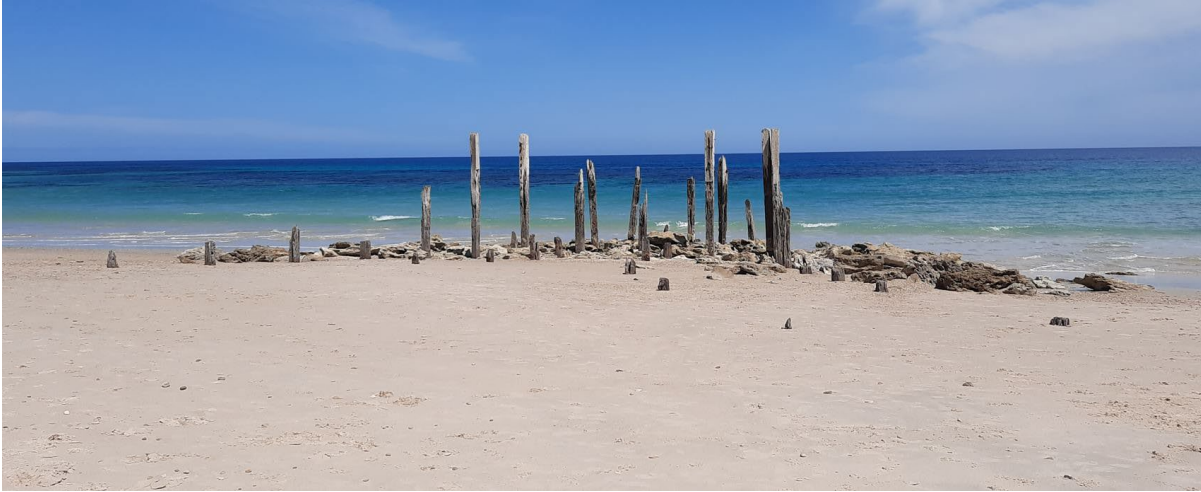
Timber remnants and stone foundations of the Port Willunga Jetty embankment and subsequent 'boardwalk', looking west (GGA, 2022)

As noted in the 1997 Survey, all surviving elements of the c.1868 embankment and post-1915 'boardwalk' should be retained as long as is practical and possible.

It is recommended that an inspection schedule of should be established to determine current condition and longevity of surviving remnants.

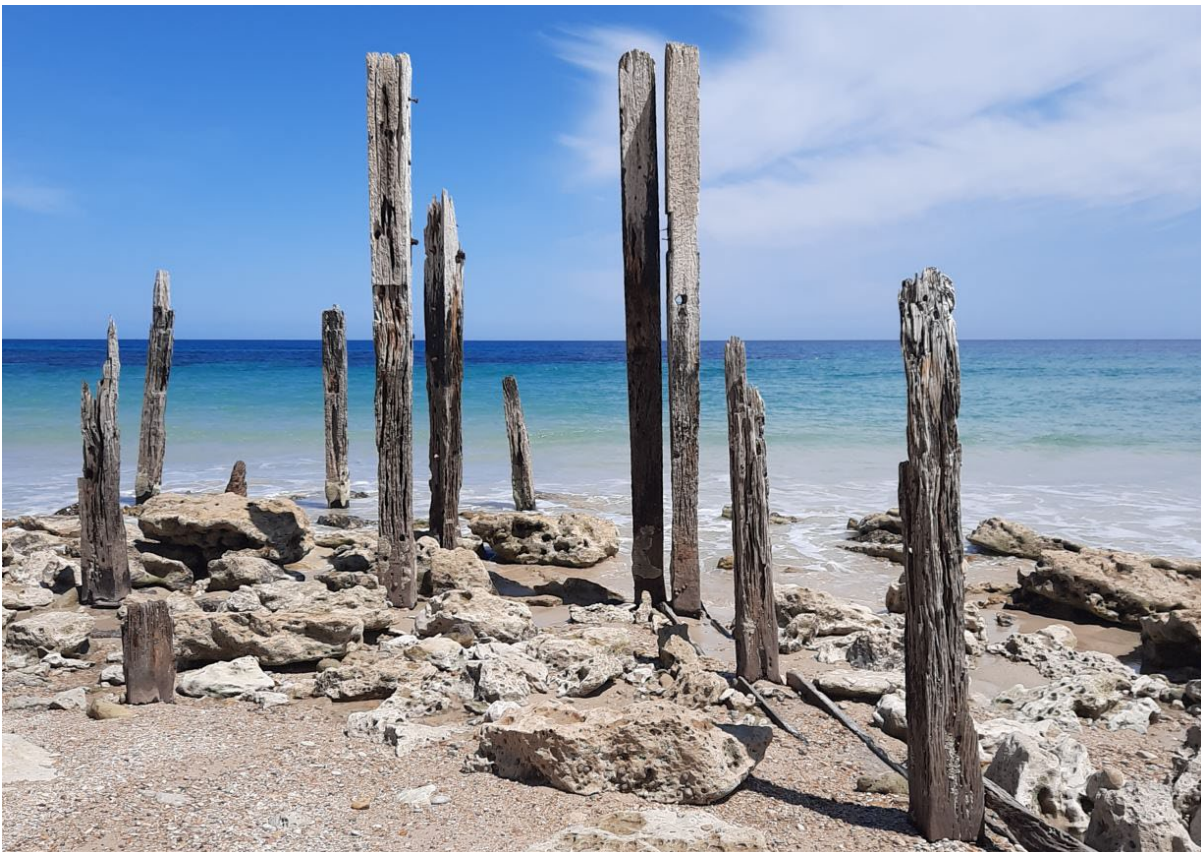
Timber remnants and stone foundations of the Port Willunga Jetty embankment and subsequent 'boardwalk', looking west. Later vertical timbers are understood to relate to the post-1915 'boardwalk', with deteriorated timbers relating to the c.1868 timber retaining walls of the former jetty embankment (GGA, 2022)

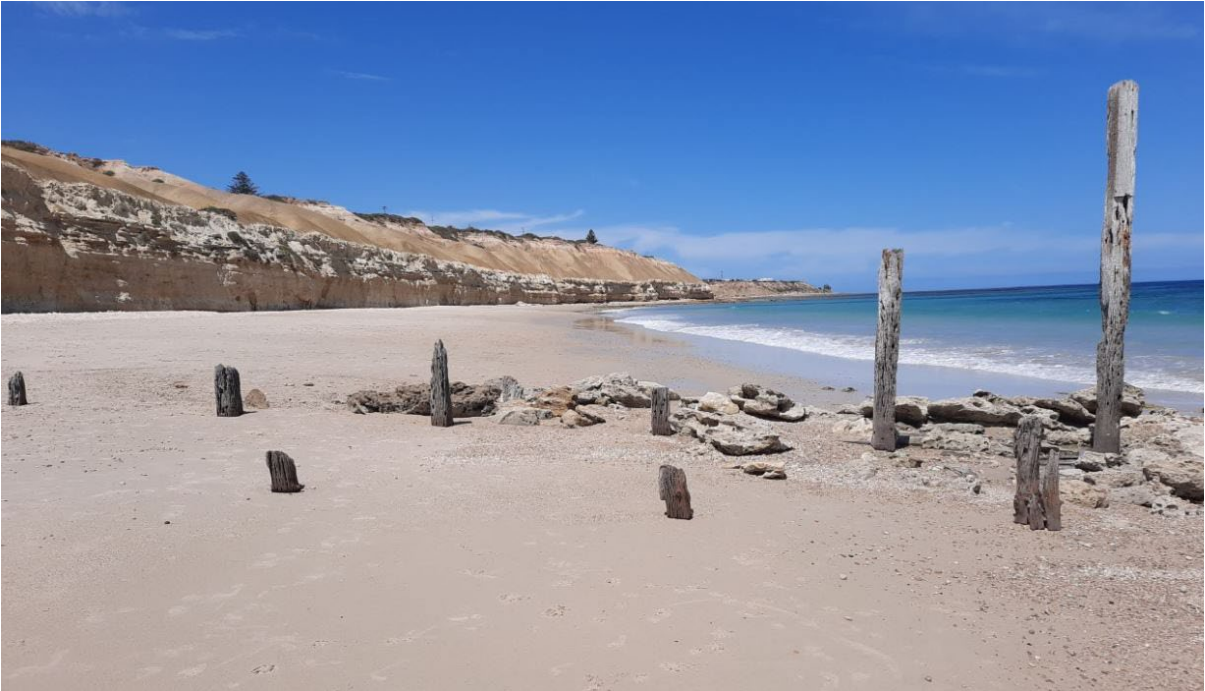
Timber remnants of the c.1868 timber retaining walls of the former jetty embankment, looking south (GGA, 2022)

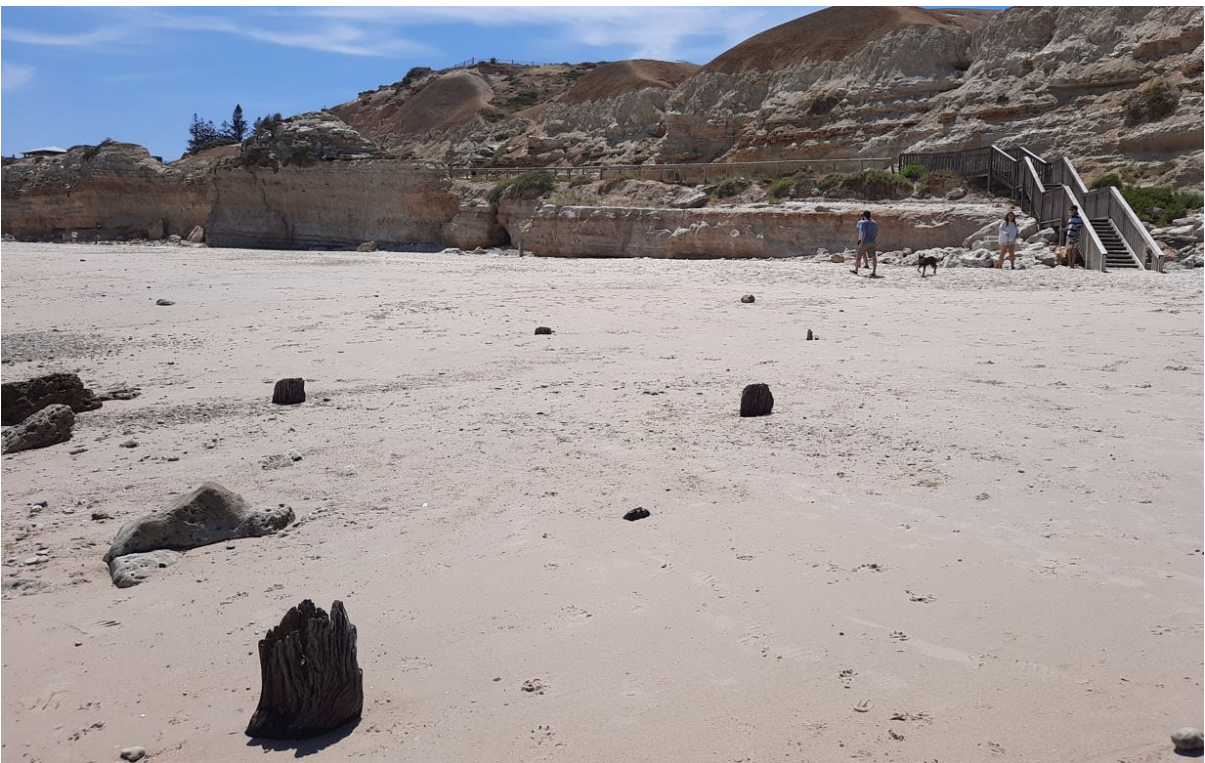
Timber remnants of the c.1868 timber retaining walls of the former jetty embankment extending east to the c.1868 ramp, looking east (GGA, 2022)
