**NAME:** Farmhouse and Outbuildings, Lot 28 Main South Road, HACKHAM

**PLACE NO.:** Local, HID 5298

**DESCRIPTION:**

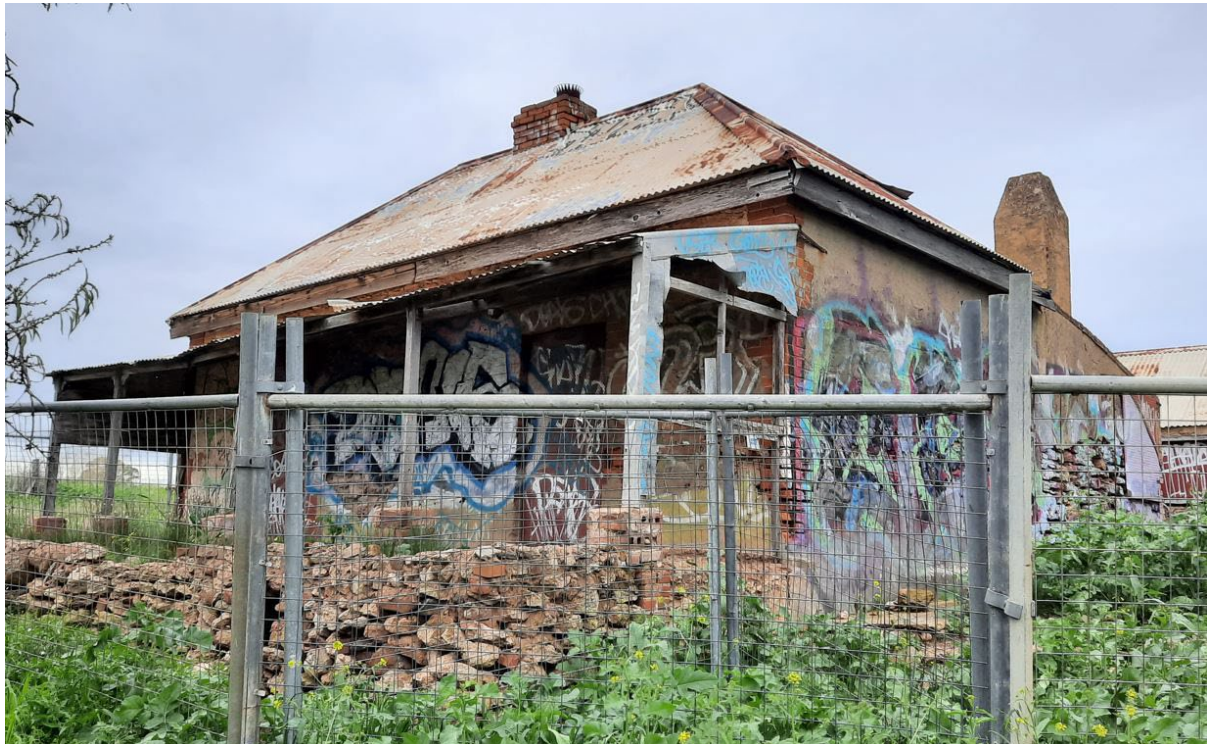
Lot 28 Main South Road, Hackham (GGA, 2021)

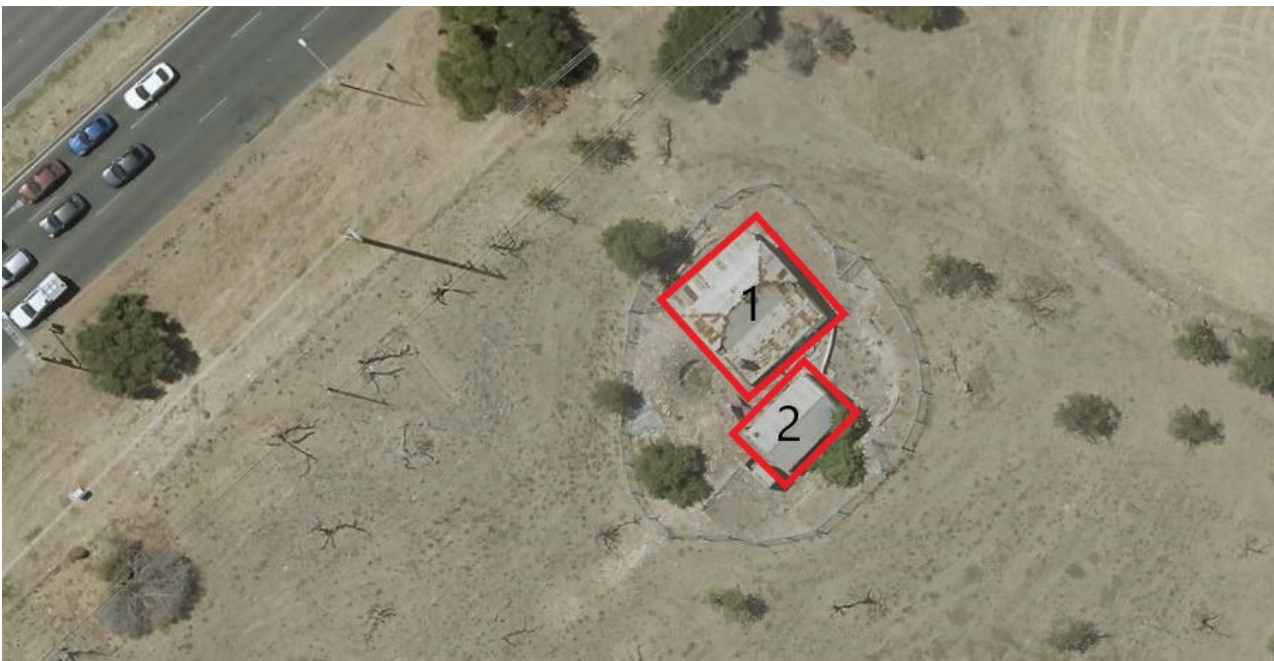
Site of Lot 28 Main South Road, Hackham; (1) residence; (2) early outbuilding (Planning SA SAPP)

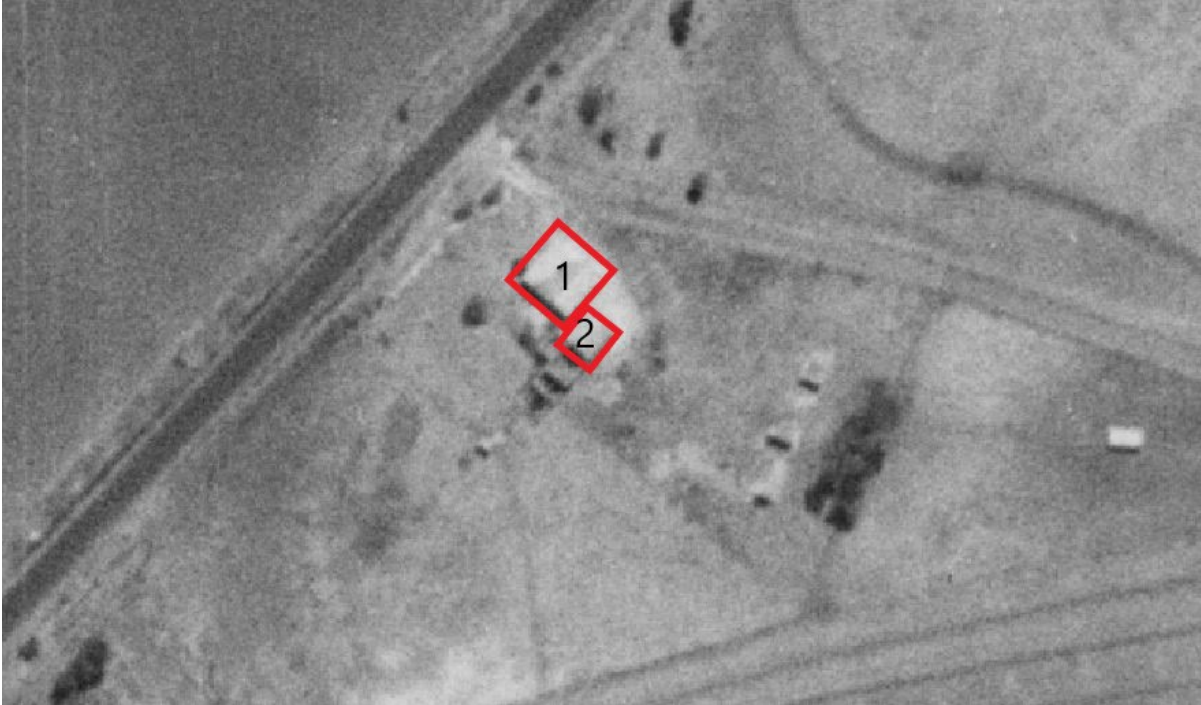
1936 aerial photograph of farm complex at Lot 28 Main South, Hackham; (1) farmhouse; (2) early outbuilding (ICSM Historical Aerial Photography, Film Number MAP1941, Run 1, Frame 6319, dated 3rd April, 1936. <https://imagery.aerialphotography.fsdf.org.au/>, accessed 3/11/2021).

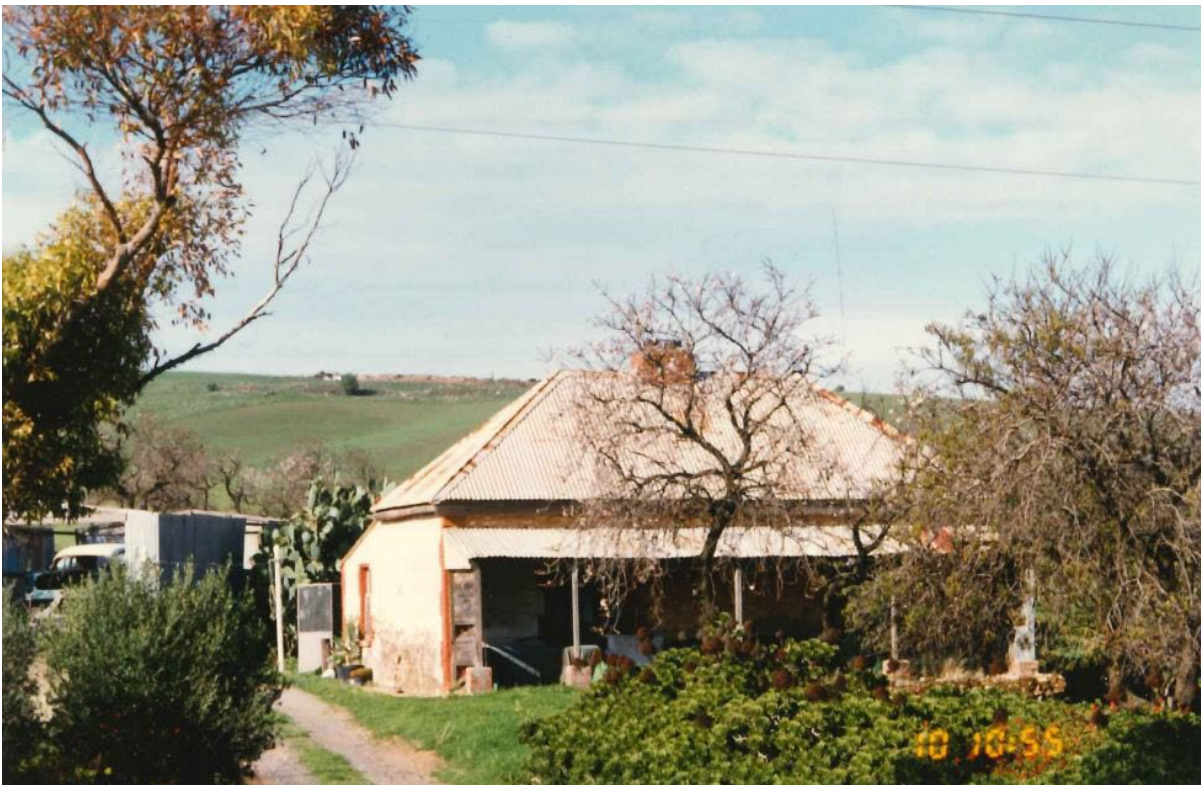
North west elevation of former farmhouse in 1997 (1997 Noarlunga Local Heritage Review)

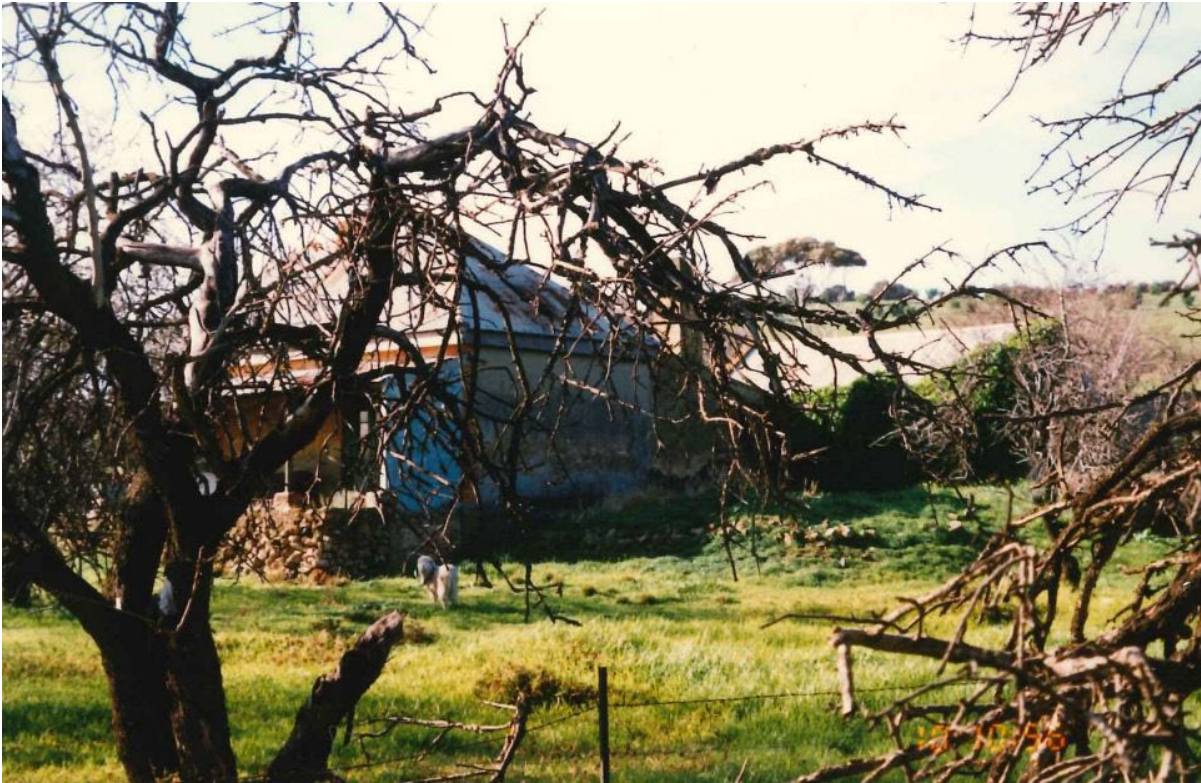
North west elevation of former farmhouse in 1997 (1997 Noarlunga Local Heritage Review)

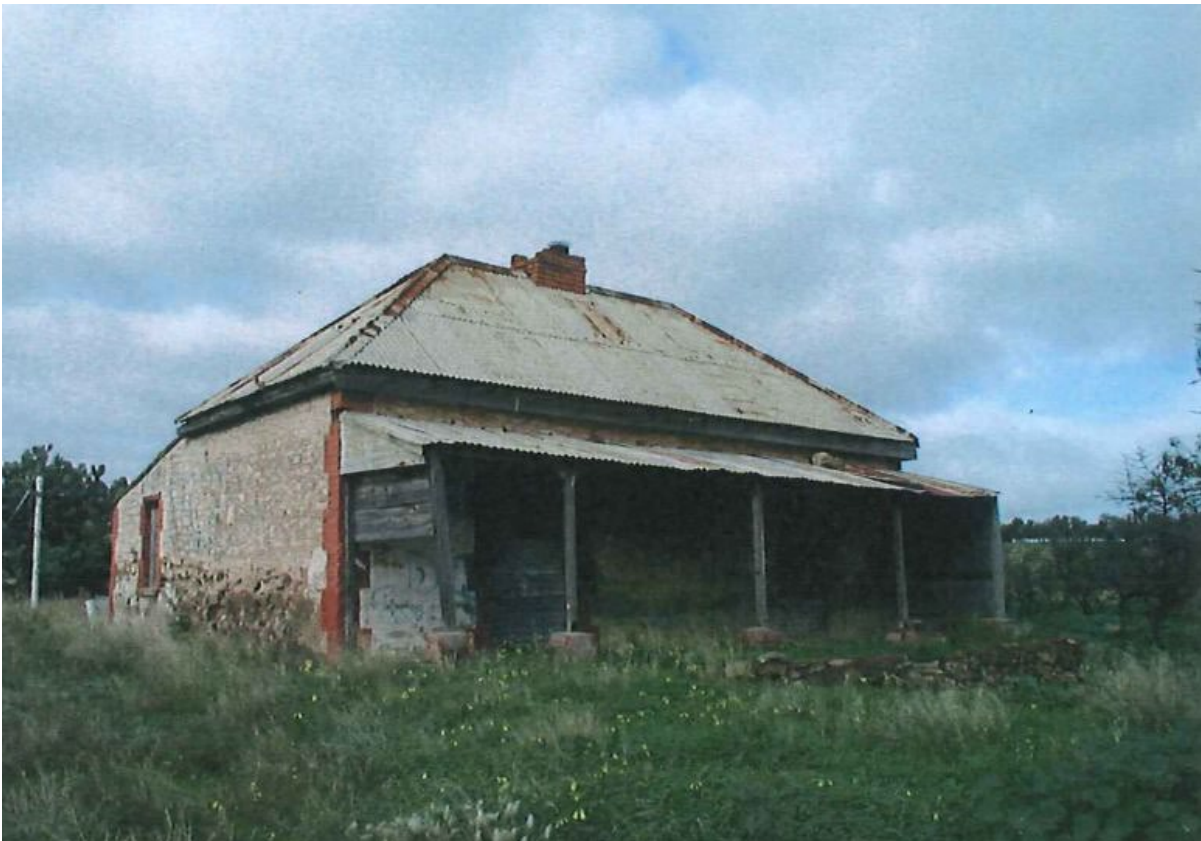
North west elevation of former farmhouse in 2003, then in dilapidated condition (2003 Noarlunga Local Heritage Register)

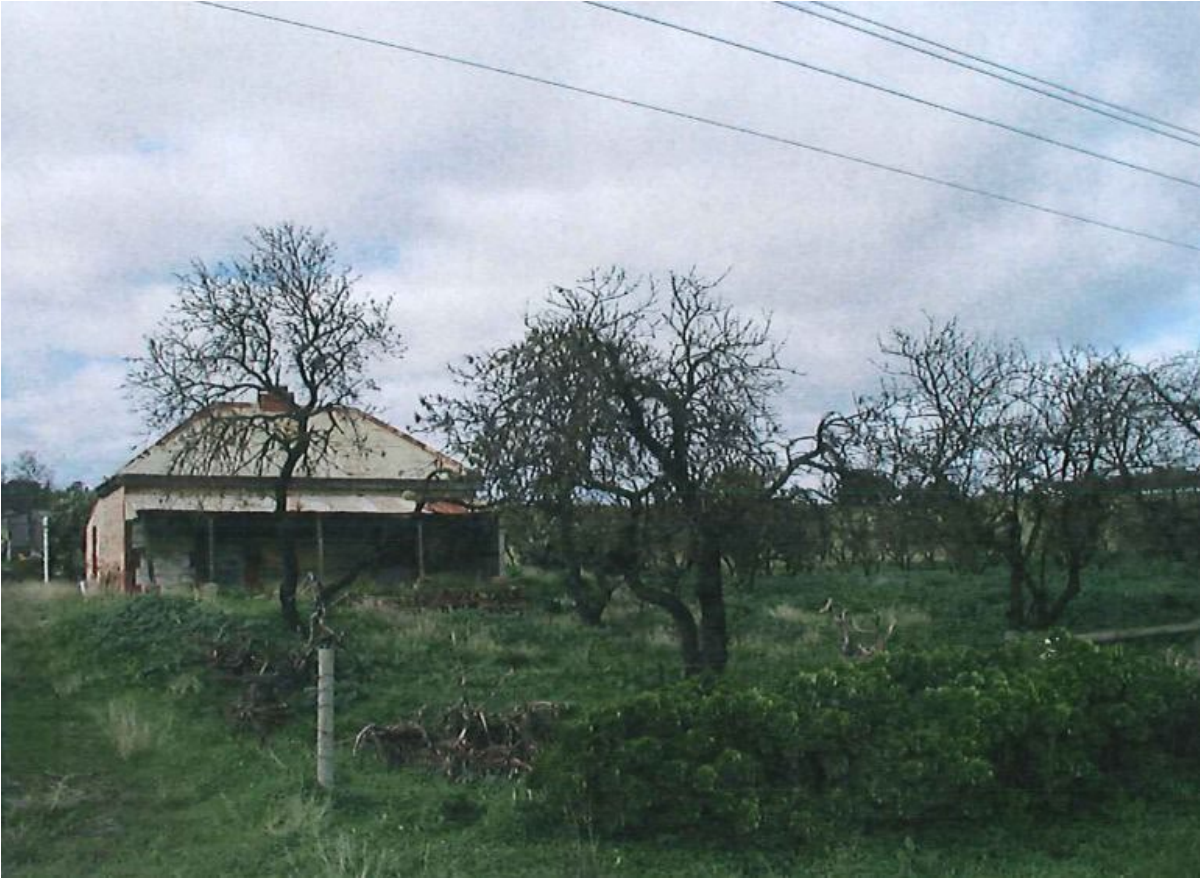
North west elevation of former farmhouse in 2003, then in dilapidated condition (2003 Noarlunga Local Heritage Register)

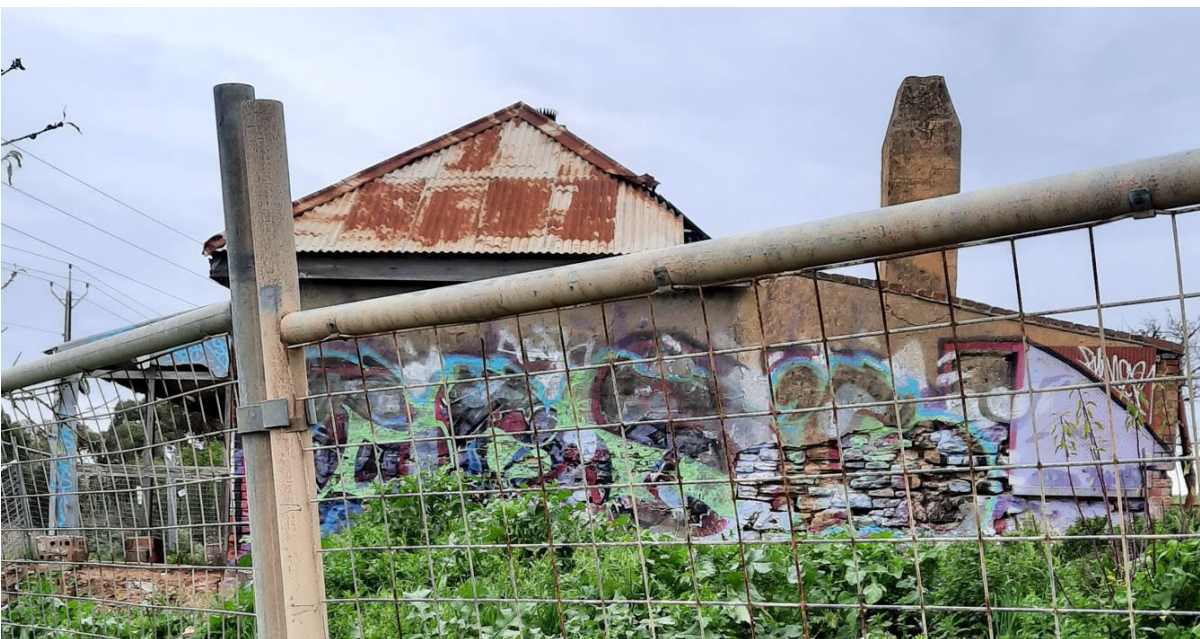
C.1870s former farmhouse, constructed of masonry with brick quoins and surrounds with brick chimney with early door and window openings. Early lean-to additions to the south-east with rendered masonry chimney. Original timber-framed roof form with early corrugated iron with early timber-framed corrugated iron-clad verandah to north-west elevation. Farmhouse currently in dilapidated condition, roof timbers appear to have been recently burnt.

West elevation of former farmhouse, currently in dilapidated condition (GGA, 2021).

The form and materials of masonry elements to the C.1870s former farmhouse, including all masonry walls, chimneys, early window and door openings and lean-to additions. The roof form is of significance, as is the use of corrugated steel cladding. However, current dilapidated materials are not included in the listing. The form and use of the timber-framed, corrugated iron-clad verandah to north-west elevation is of significance and is included in the listing though current dilapidated materials are not included in the listing.

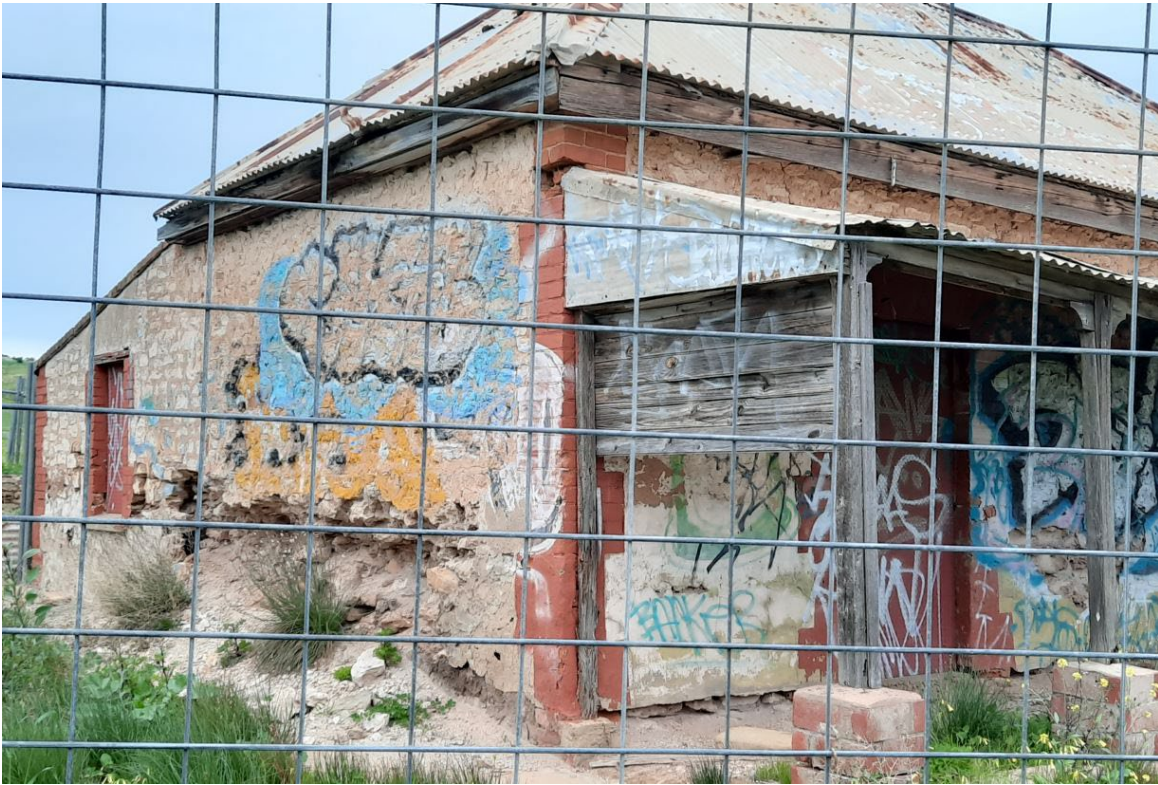
East elevation of former farmhouse, currently in dilapidated condition (GGA, 2021).

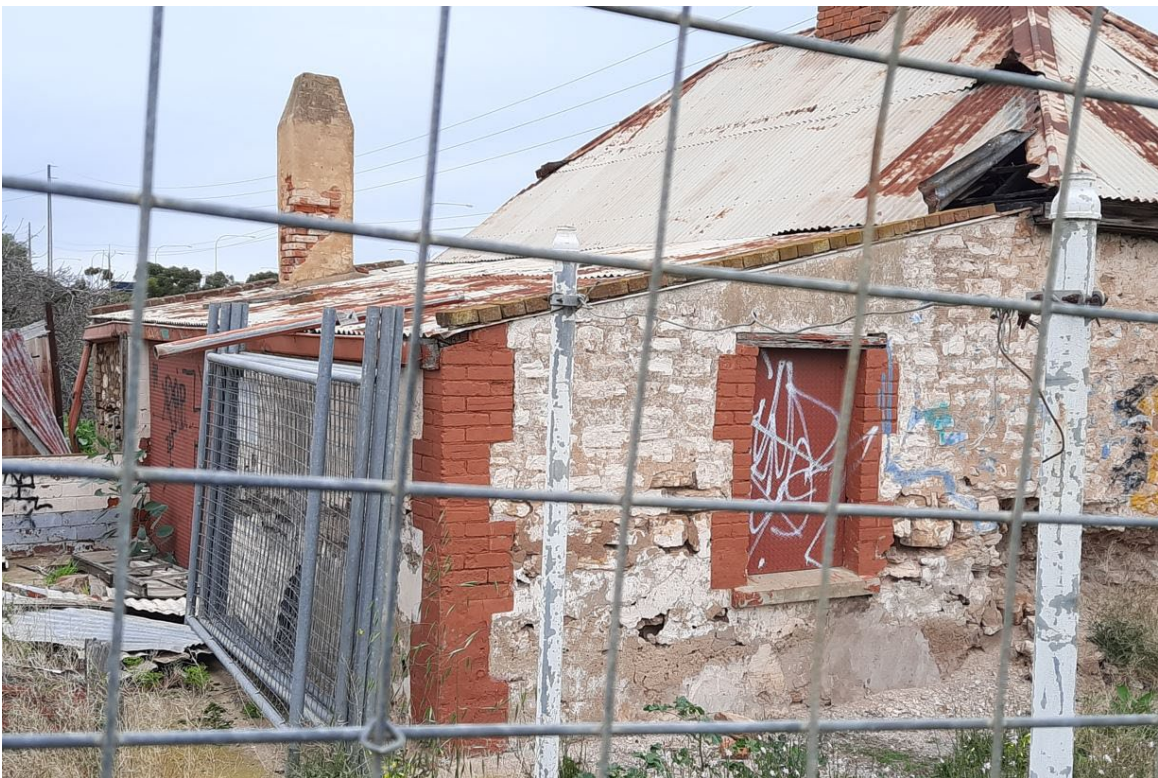
Southern lean-to additions to former farmhouse with various areas of external rendering, currently in dilapidated condition (GGA, 2021).

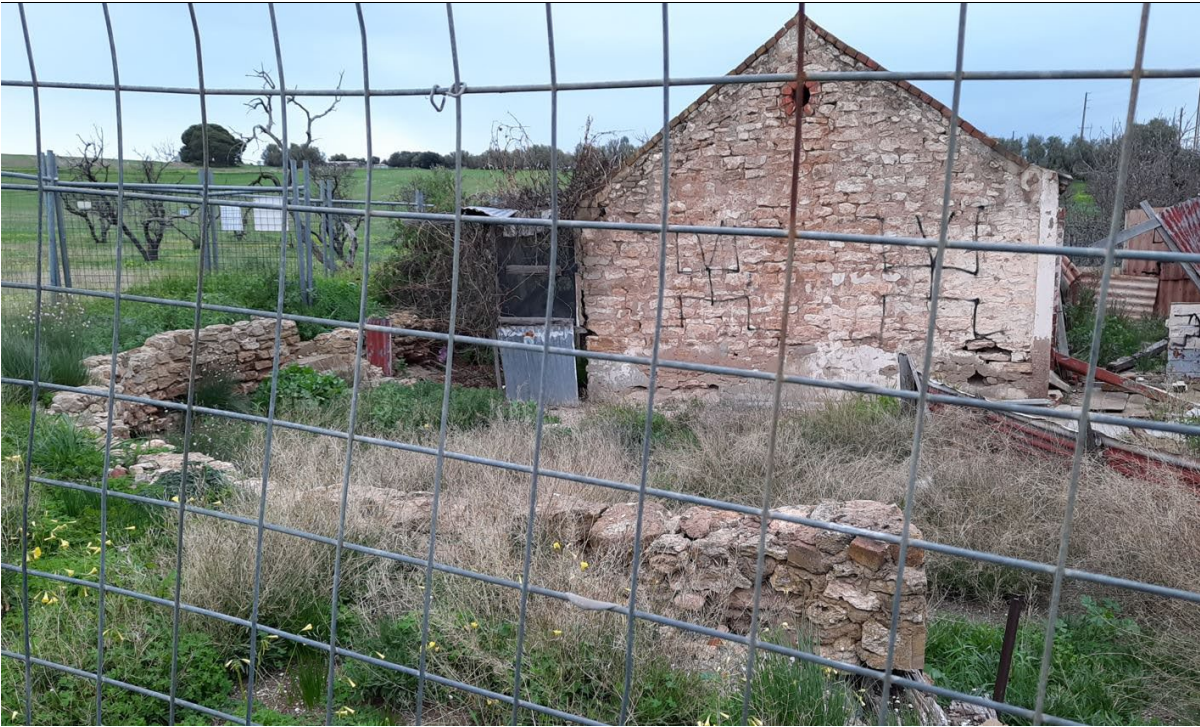
C.1870 farming outbuilding to immediate south of farmhouse, constructed of masonry with brick quoins and surrounds with various areas of external concrete rendering. Brick-lined 'oculus' ventilator window to north-west elevation. Timber lintel to external window to south-west elevation.

Early freestone masonry fencing to north-west elevation and to courtyard immediately east of farmhouse and outbuilding.

East elevation of early outbuilding with courtyard retaining wall and boundary fencing (GGA, 2021).

The form and materials of masonry elements to the c.1870s farming outbuilding, including all walls and door and window openings. The form and use of early timber elements including timber lintels is of significance and is included in the listing though current materials are not included in the listing.

The form and materials of all surviving masonry boundary fencing is also included in the listing.

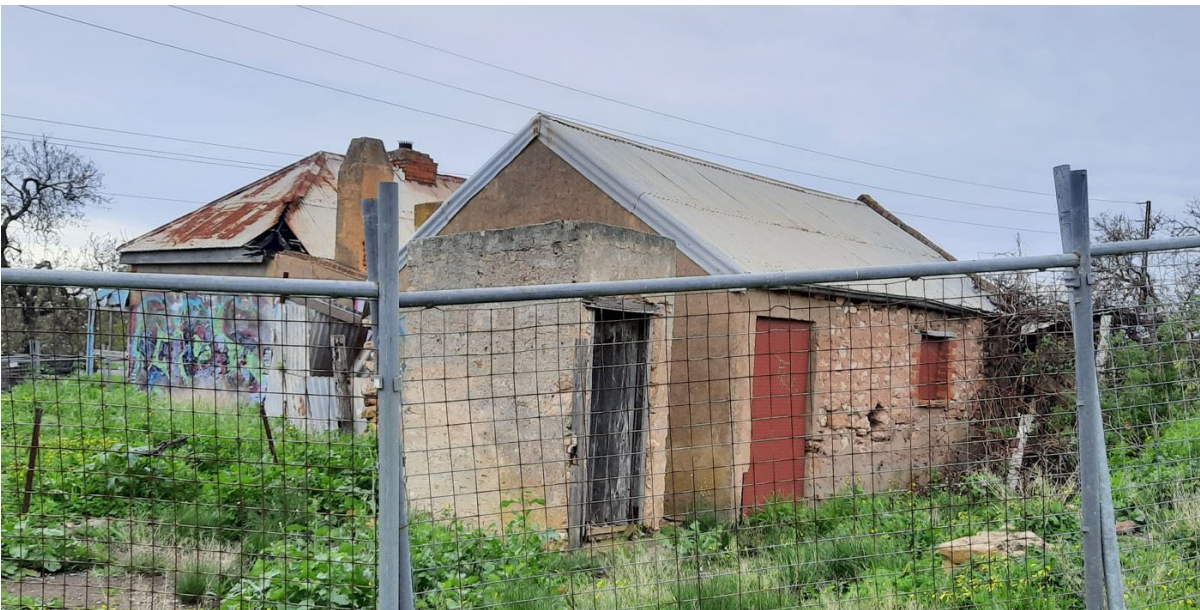
Early masonry outhouse with early timber lintel, door frame and door leaf with various areas of external concrete render.

Early outhouse and farming outbuilding, viewed from the south (GGA, 2021).

The form and materials of masonry elements to the early outhouse, including all walls and door openings. The form and use of early timber elements, including timber lintel, door frame and door

leaf is of significance and is included in the listing though current materials are not included in the listing.
