**NAME: Slate Culvert, St Judes Street, WILLUNGA**

**CURRENT USE:** culvert  
**FORMER USE:** Culvert  
**DATE(S) OF CONSTRUCTION:** C. 1864 with later alterations and restorations work

**RECOMMENDATION:** Local Heritage Place

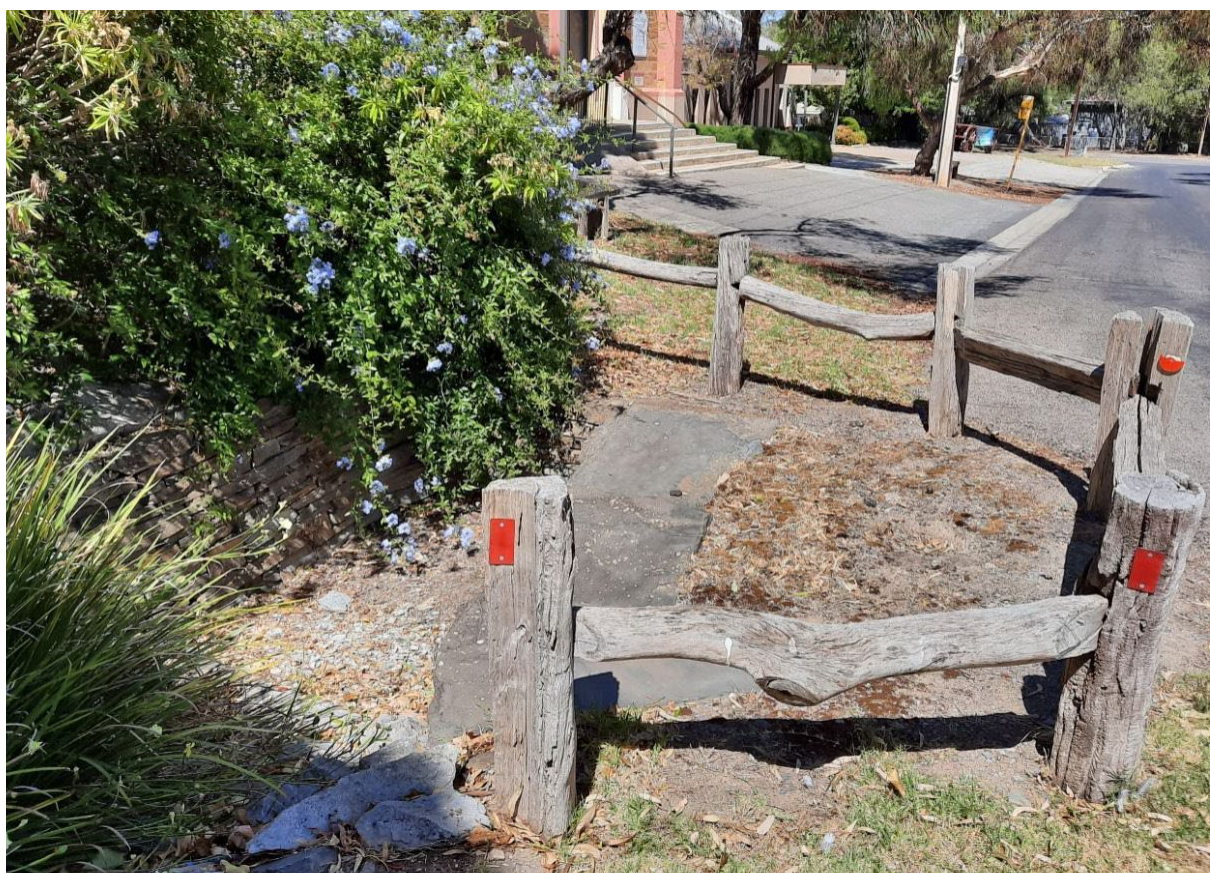
St Judes Street culvert, through which the 'unnamed Willunga creek' disposes into Lot 186 St Andrews Terrace, Willunga (GGA, 2022)

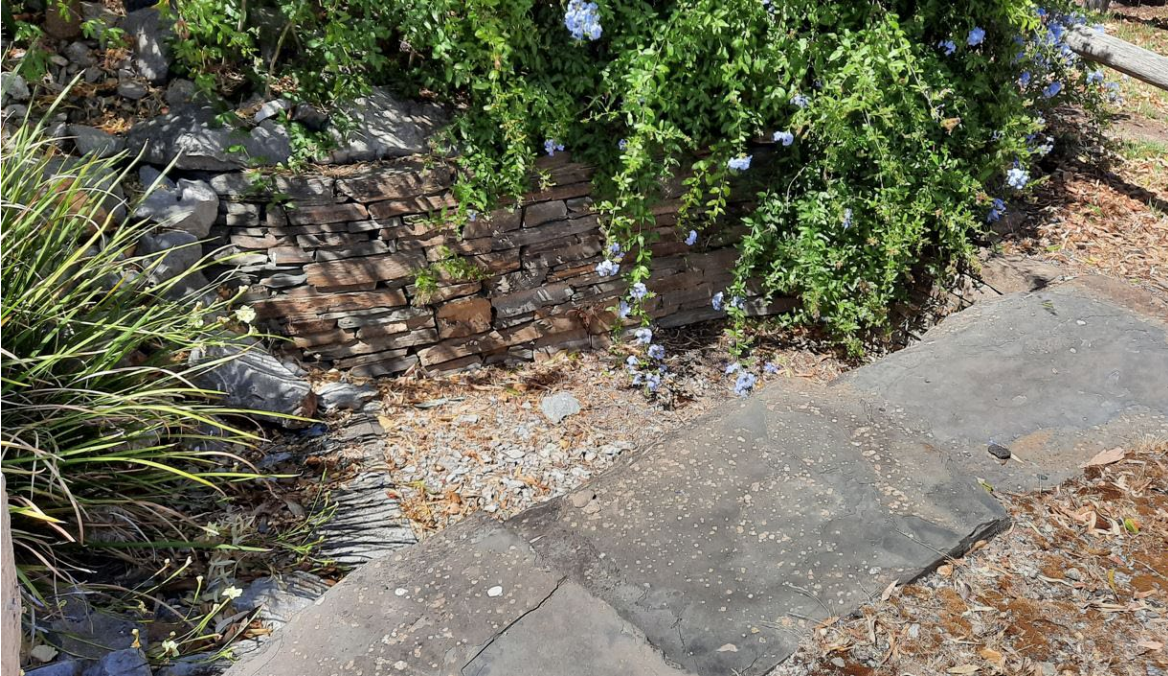
C.1864 dry stone walls and slate capping to culvert's southern end near 33 St Andrews Terrace; recent landscaping associated with 4 St Judes Street infringes the historic fabric (GGA, 2022).

Landscaping work associated with the construction of the c.2010s residence at 4 St Judes Street, Willunga does currently encroach on the heritage fabric of the c.1864 drain, though extensive original fabric remains evident.

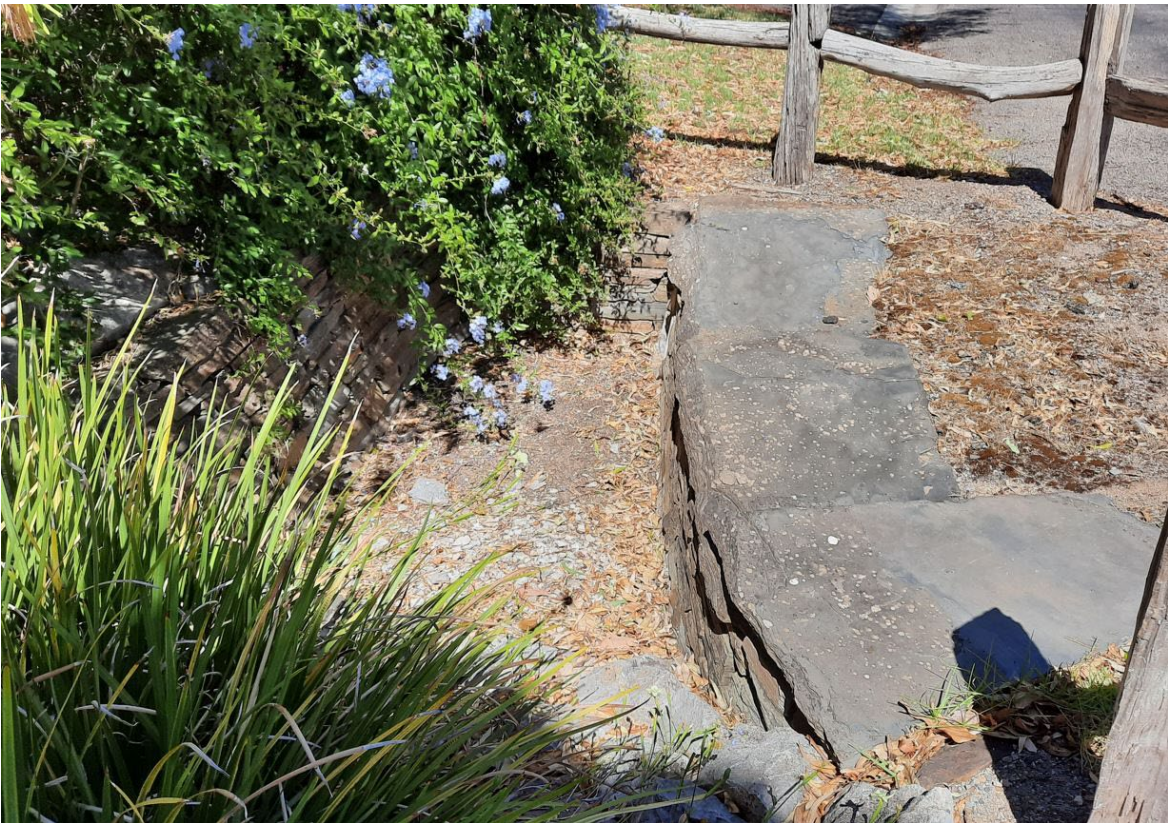
Masonry fabric to the southern end of the St Judes Street culvert (GGA, 2022)

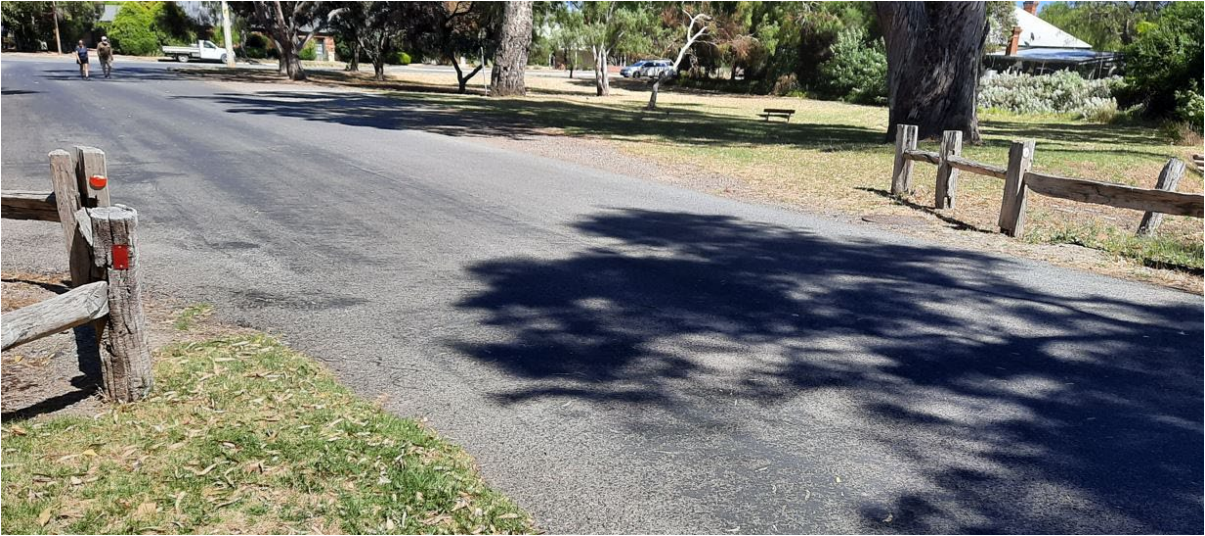
Culvert disposing across St Judes Street from 33 St Andrews Terrace to Lot 186 St Andrews Terrace. Early timber fence posts to both sides of culvert (GGA, 2022)

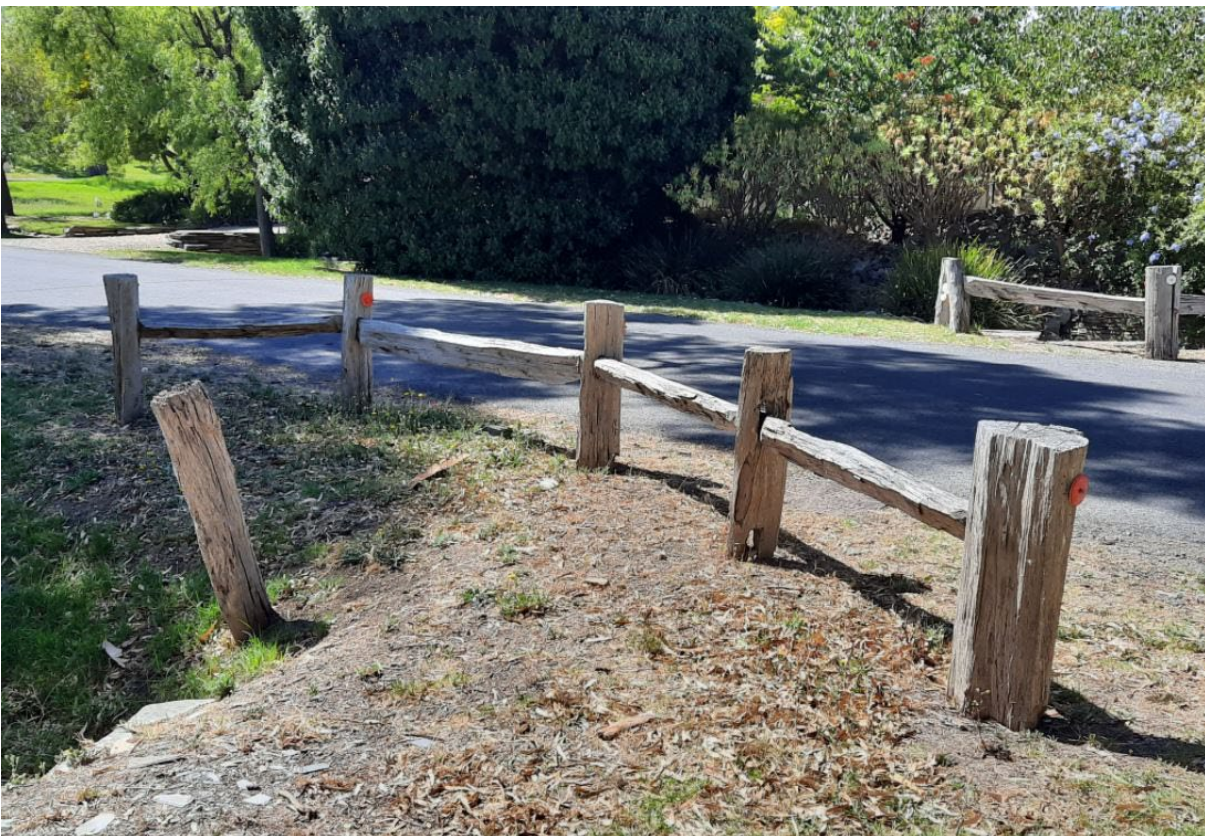
Northern end of culvert with early timber fencuing (GGA, 2022)
