**NAME:** Dwelling and Outbuildings, 100 Binney Road, WILLUNGA

**PLACE NO.:** Local, HID 5422

**DESCRIPTION:**

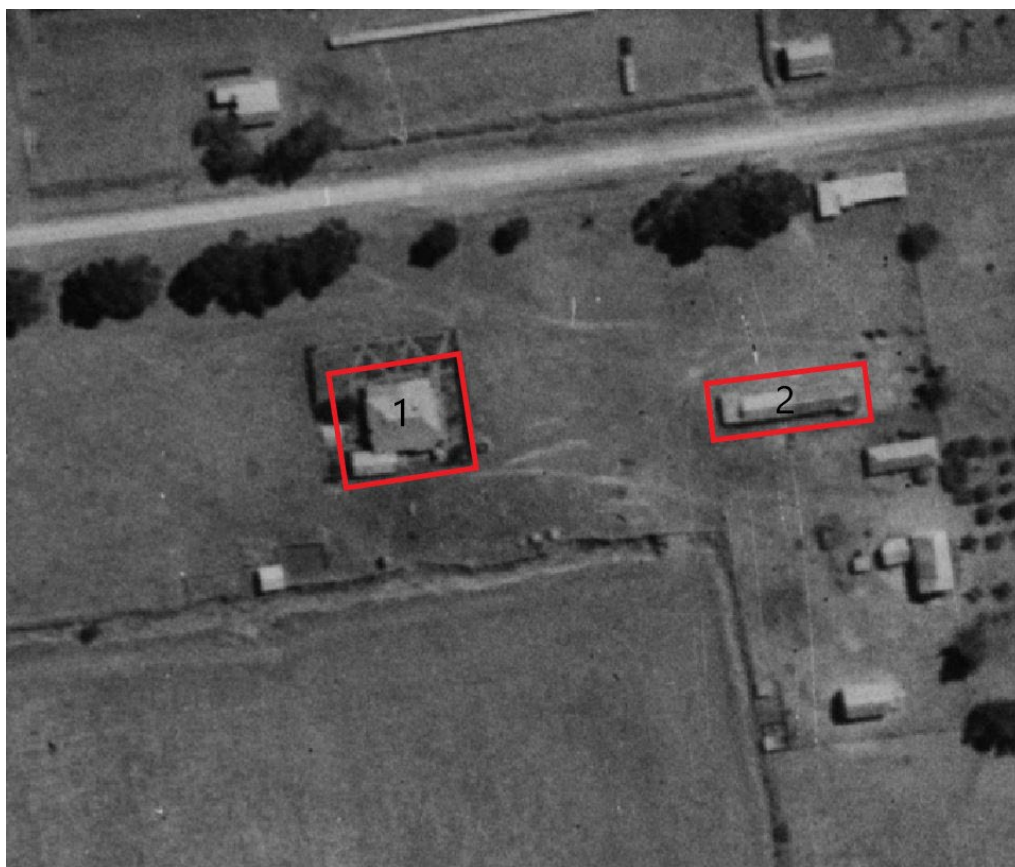
Site of Binney family farm, 100 Binney Road, Willunga in 1936; (1) former farmhouse and cellar highlighted in red box; (2) former outbuildings highlighted in red box. Note other extensive outbuildings to the south-east (lower right hand corner), now demolished (ICSM Historical Aerial Photography, Film Number MAP1942, Run 4S, Frame 6383, dated 7th July, 1936. <https://imagery.aerialphotography.fsdf.org.au/>, accessed 14/10/2021).

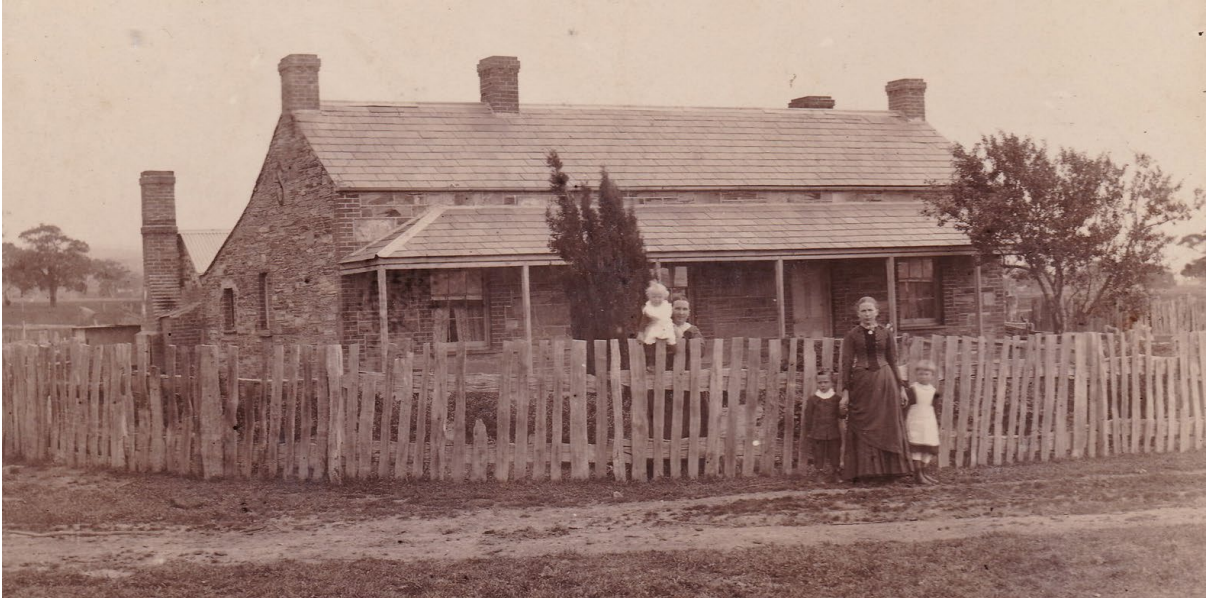
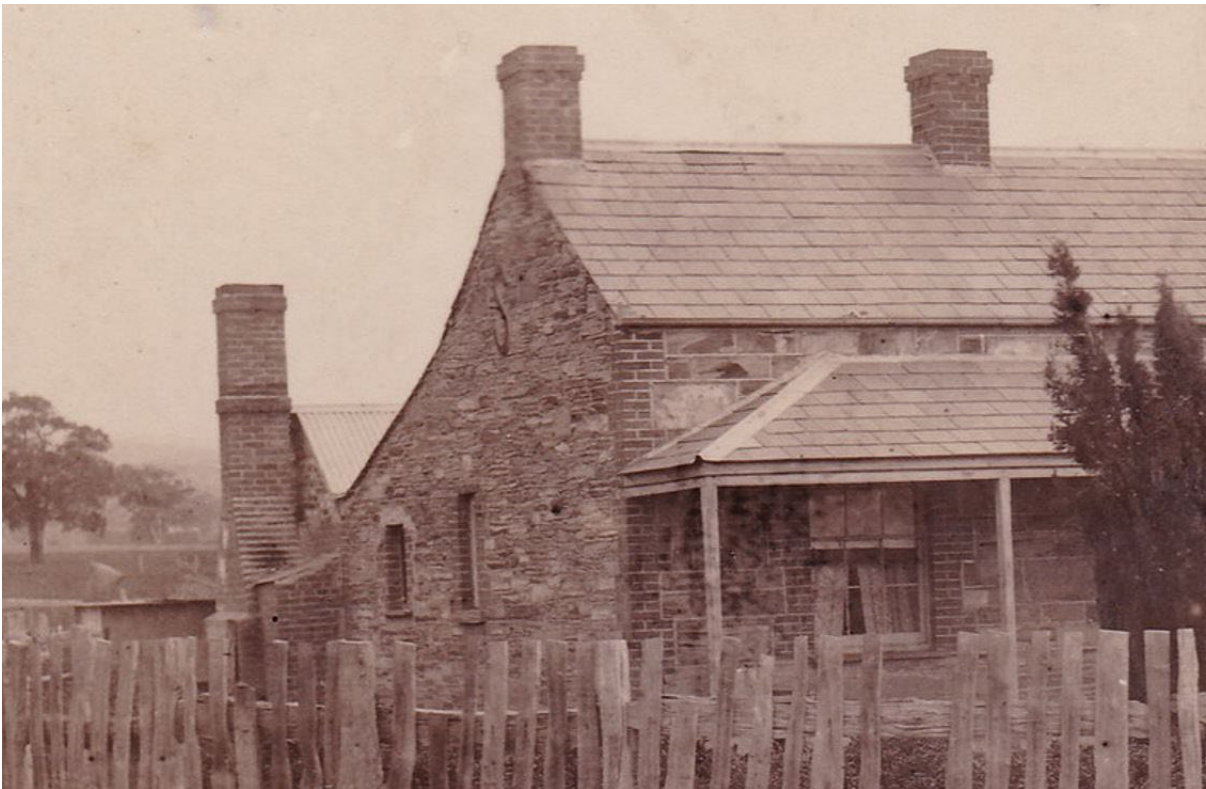
19<sup>th</sup> century photograph of 100 Binney Road, Willunga; (above) north elevation with Binney family members; (below) enhancement of east wall with distinctive chimney and window construction ([https://willunga.nowandthen.net.au/Binney\\_home,\\_100\\_Binney\\_Road](https://willunga.nowandthen.net.au/Binney_home,_100_Binney_Road), accessed 14/10/2021).

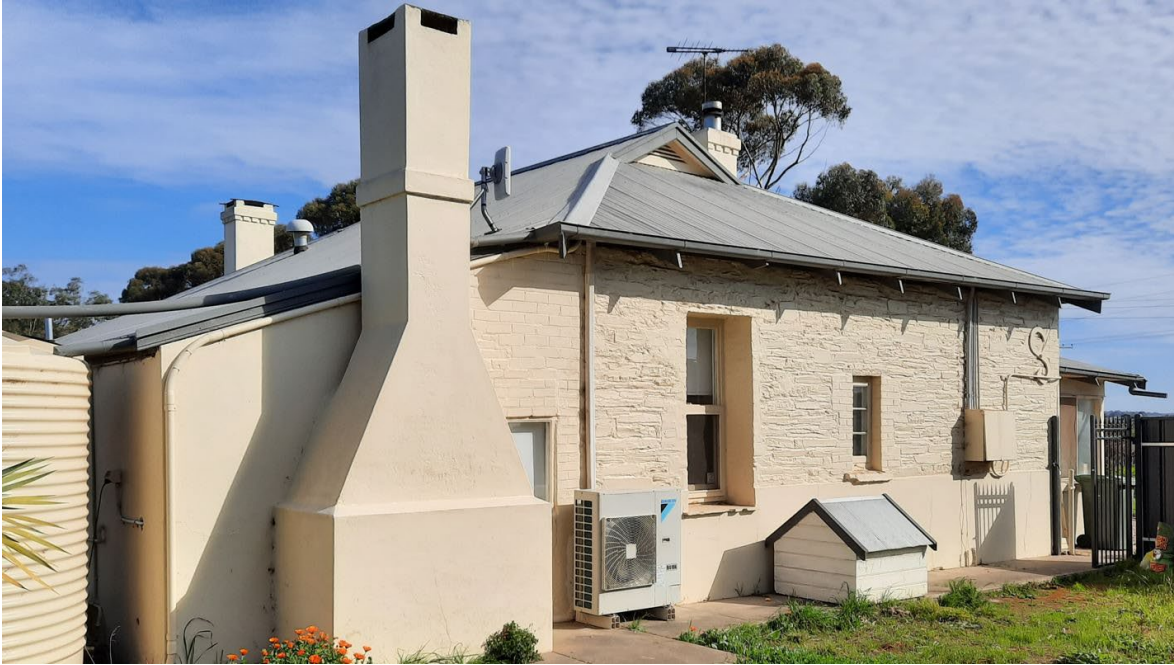
East elevation of former house; early kitchen chimney and an early small window have been retained despite extensive modifications and reconstruction works in c.1930s (GGA, 2021).

The form and materials of remaining early masonry elements to the c.1859 former farmhouse, including remnants of original walls, door and window openings and chimneys. Later alterations, including reconstructed masonry elements relating to the reconstructed roofline and non-original door and window openings, are not included in the listing. Original timber window fittings are also included in the listing. C.1930 modifications, included modified roof form and verandah gable to north elevation are not included in the listing. All later additions and modifications are not included in the listing.

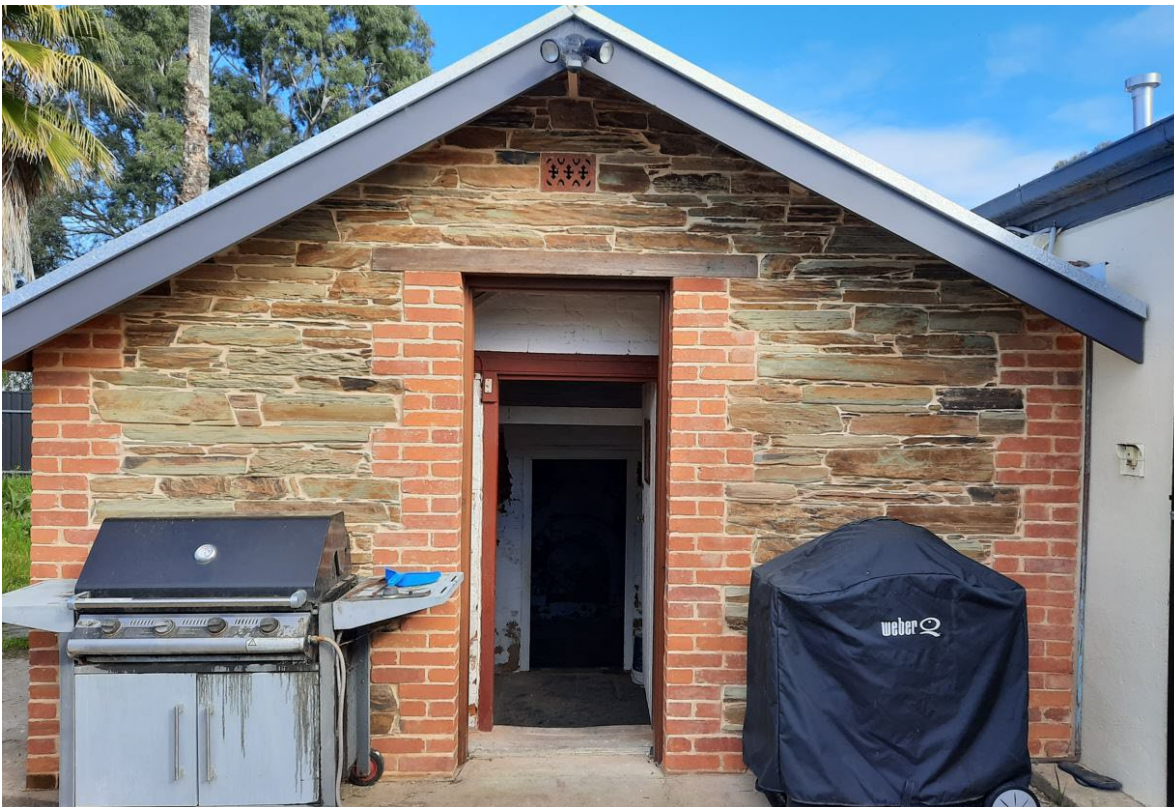
Early semi-excavated cellar with double walls and roofing dating to the mid-19<sup>th</sup> century, recent replacement of external corrugated steel roof cladding (GGA, 2021).

All forms and materials relating to the external semi-excavated cellar, including all original masonry and timber elements, including double masonry walls; brick fireplace, inner roof structure, slate floor and timber window and door fittings. Use of external corrugated steel replacement are considered of significance and included in the listing though current replacement materials are not included in the listing.

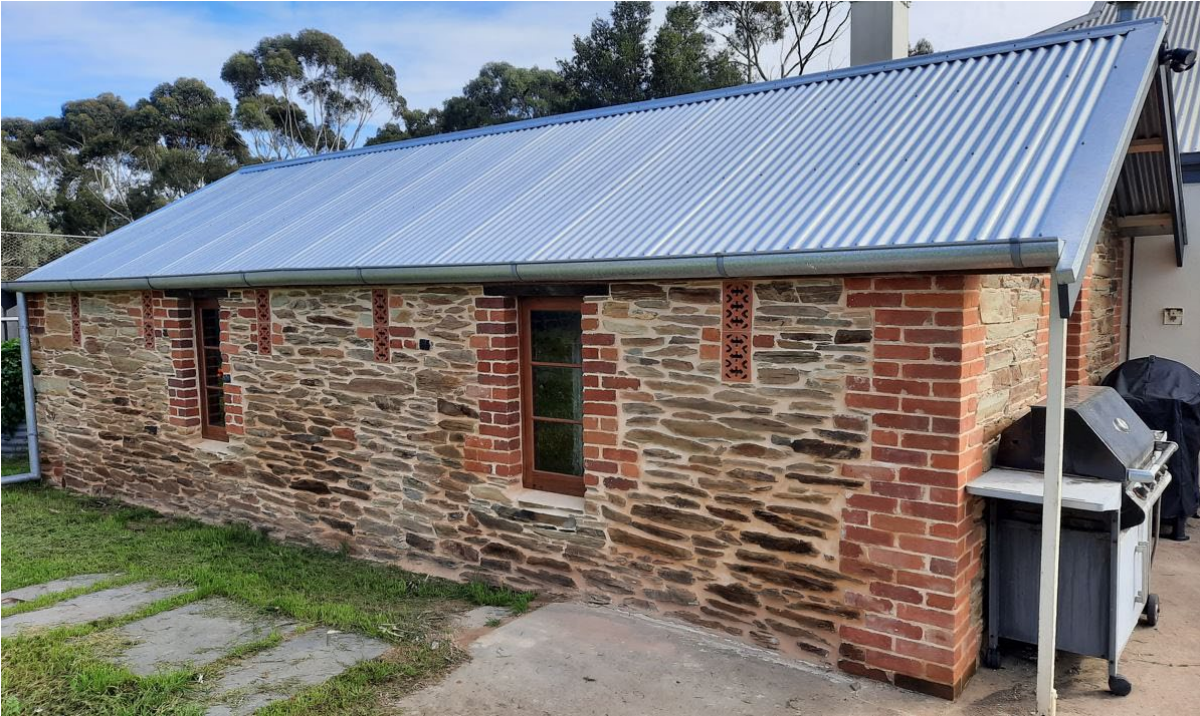
Early semi-excavated cellar with double walls and roofing dating to the mid-19<sup>th</sup> century, recent replacement of external corrugated steel roof cladding (GGA, 2021).

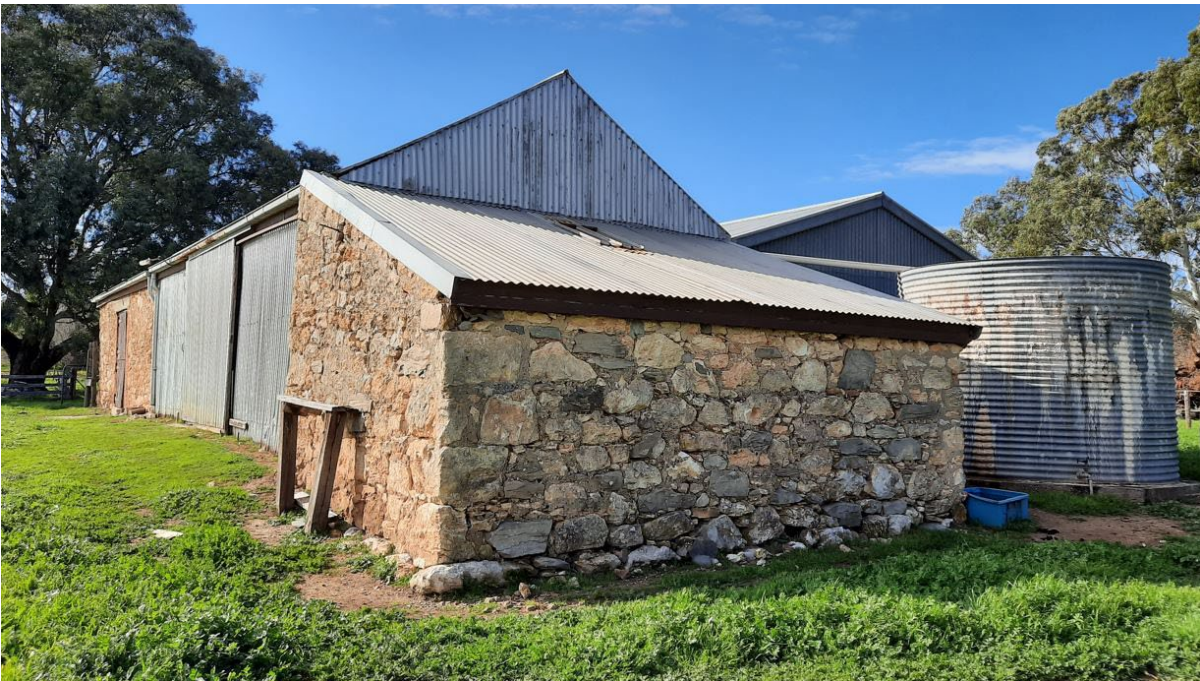
Early outbuildings with later corrugated steel additions to the east of the residence (GGA, 2021).

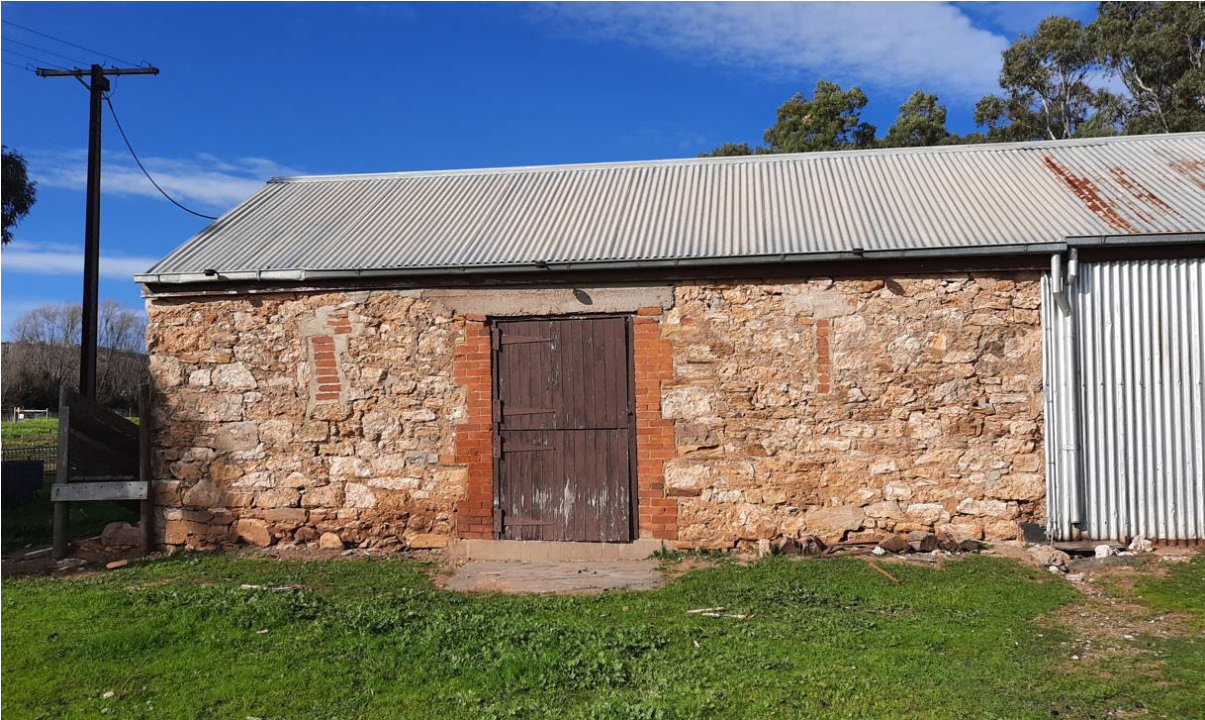
Mid-19<sup>th</sup> century masonry and timber-framed farm outbuilding with various areas of early and later replacement corrugated steel cladding; lean-to additions to west elevation retain internal pug walls (GGA, 2021).

All original masonry and timber elements relating to the former outbuilding, including freestone walls, brick quoins and surrounds, former 'keyhole' windows and lean-to additions. Early corrugated iron elements are of significance and are included in the listing. Use of external corrugated steel elements are considered of significance and included in the listing though current replacement materials are not included in the listing.
