**NAME: Slate channel and well, 6 Bayliss Road, WHITES VALLEY**

| <b>RECOMMENDATION:</b> | Local Heritage Place (amended) |

**NAME: Slate Channel, 6 Bayliss Road, WHITES VALLEY**

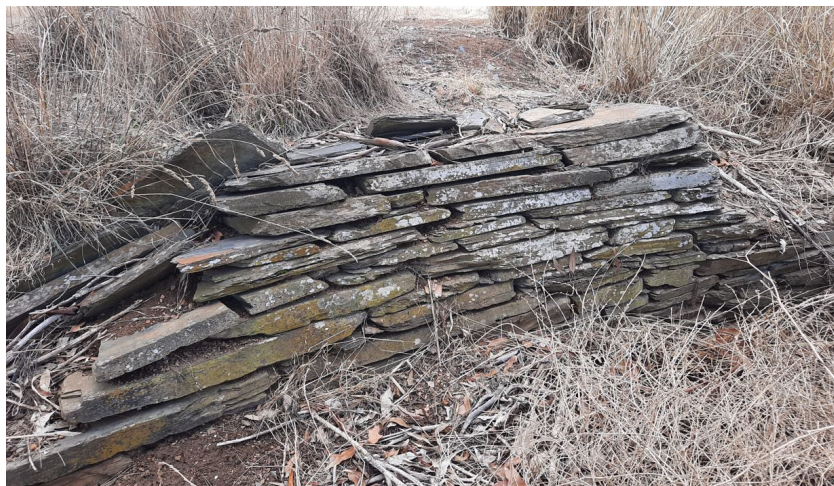
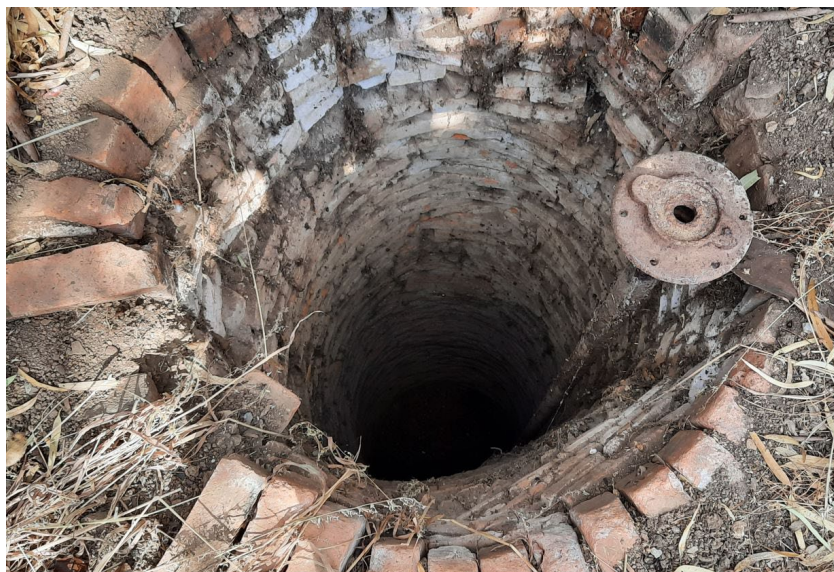
Slate channel (above) and well (below) at 6 Bayliss Road, Whites Valley (GGA, 2022)

C. mid-19<sup>th</sup> century slate channel, constructed in the 'book-leaf' manner from locally-sourced slate following the creekbed that runs to the south-west through the site. Approximately five metres of the channel have been currently excavated, further possible fabric may lie buried beneath foliage to the south-west.

C. mid-19<sup>th</sup> century (possibly late-19<sup>th</sup> century) well constructed of brick, currently partially excavated to an approximate depth of four metres.

It is recommended that further excavation works should occur to the slate channel to identify the full scope of material relating to the channel.

It is recommended that further excavation works should occur to the well to identify the full scope of material relating to the well. It is also recommended that a suitable permanent cover to the well should be implemented to avoid possible injury while allowing for an interpretation and understanding of the fabric and its relationship to the site's history.

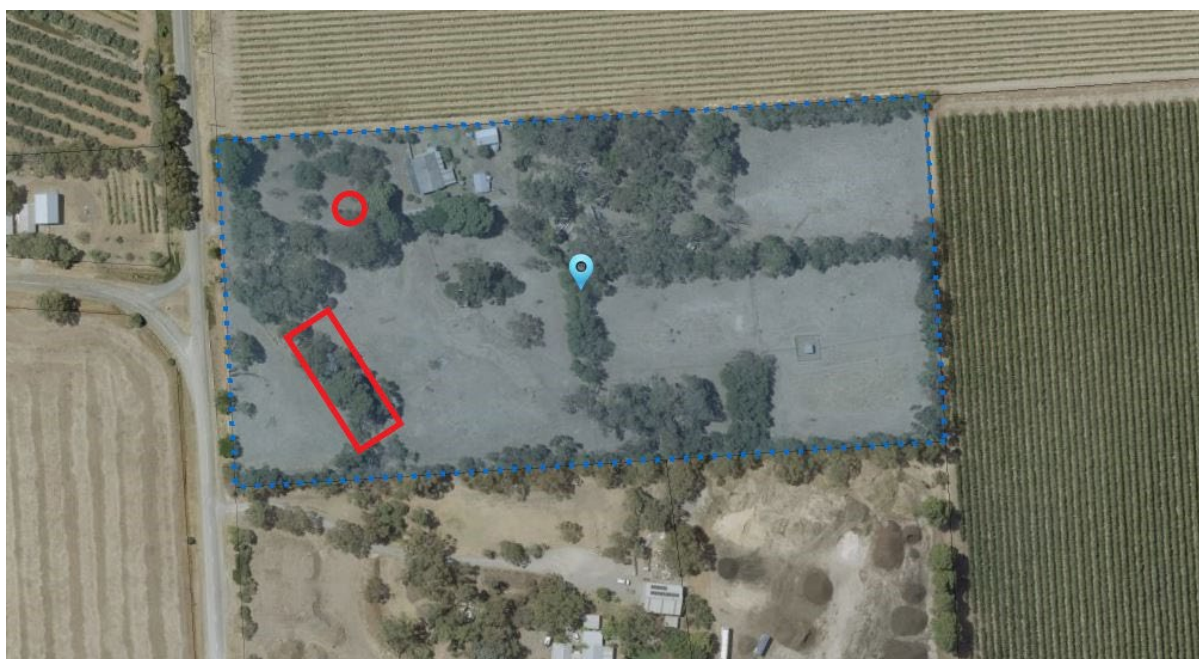
Site of 6 Bayliss Road, Whites Valley; slate channel located within red rectangle, well within red circle (SAPPA, Planning SA).

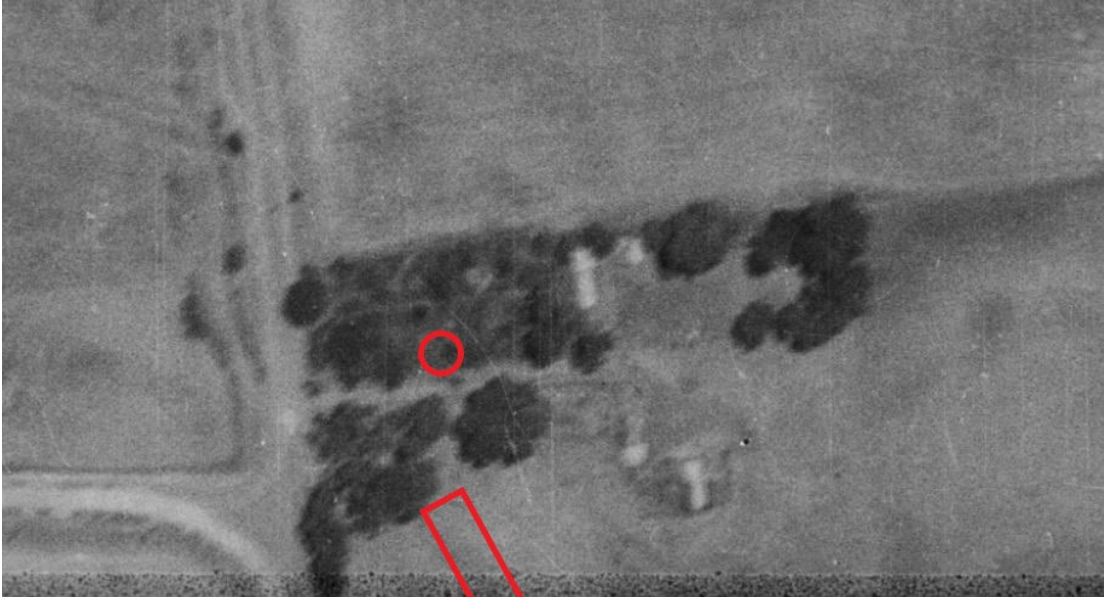
1936 aerial photograph of 6 Bayliss Road, Whites Valley; approximate locations of slate channel (red rectangle) and well (red circle) illustrated (ICSM Historical Aerial Photography, Film Number MAP1941, Run 2, Frame 6266, dated 3<sup>rd</sup> April, 1936. <https://imagery.aerialphotography.fsdf.org.au/>, accessed 19/04/2022).

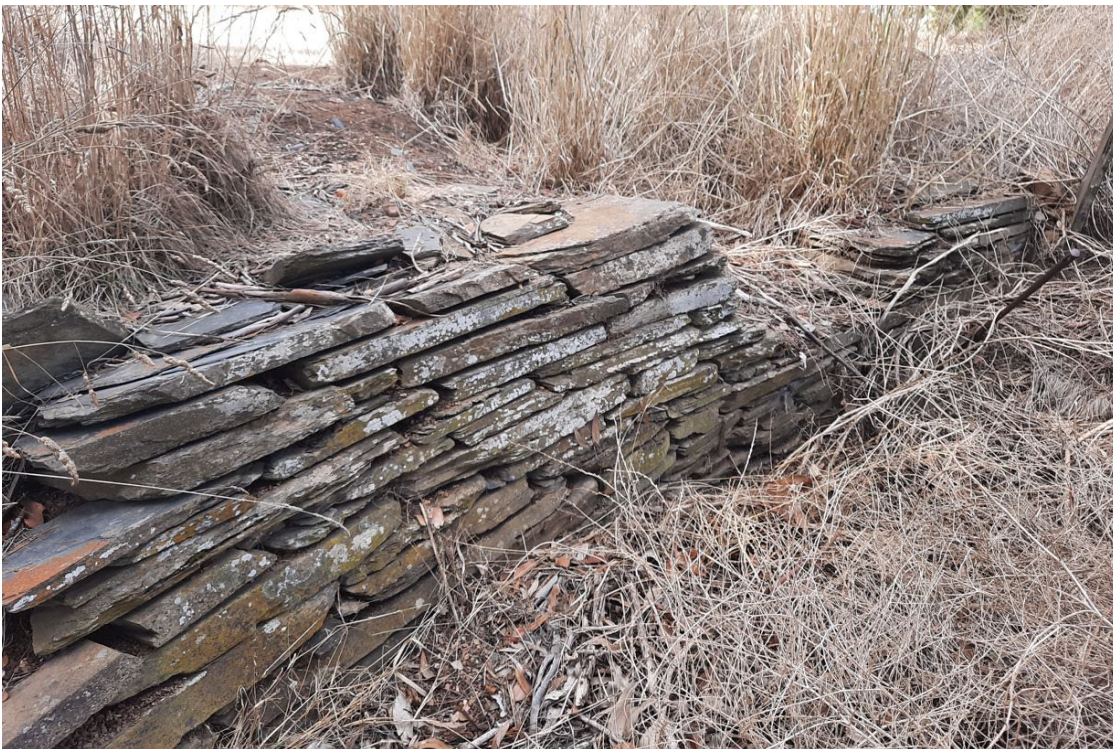
Primary identified fabric of slate channel, looking east. Note recess to central portion, suggesting perpendicular drainage channel from nearby paddock to main creekbed (GGA, 2022).

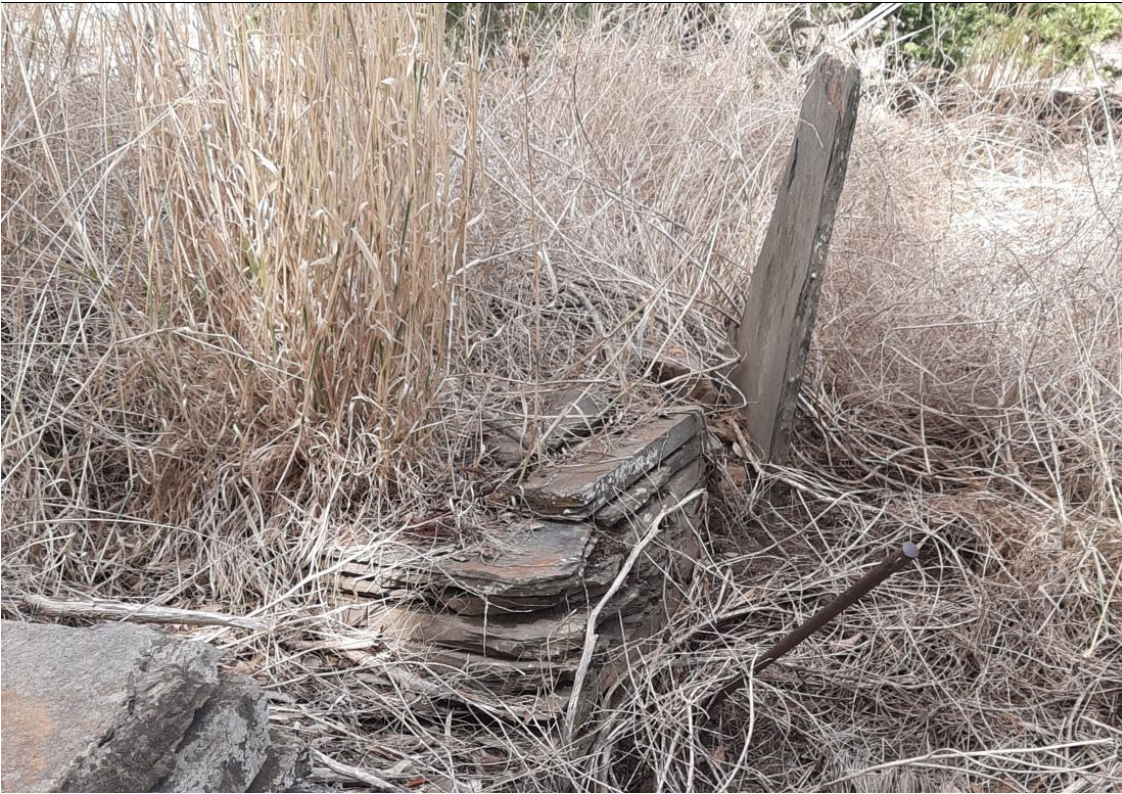
Slate fabric associated with slate channel, looking south. Purpose of larger vertical slate element unknown, more slate fabric likely remains buried beneath foliage to the south-west (GGA, 2022).

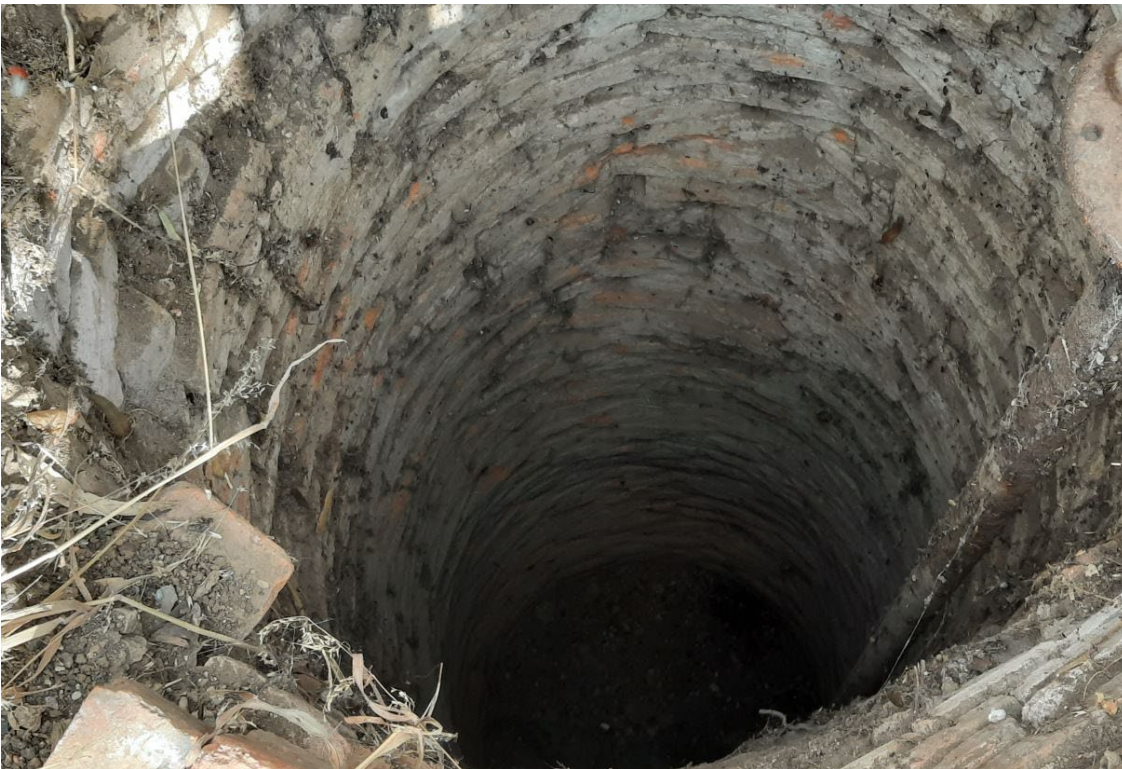
Excavated well fabric constructed of brick, extending to approximately 4 metres in depth (GGA, 2022).

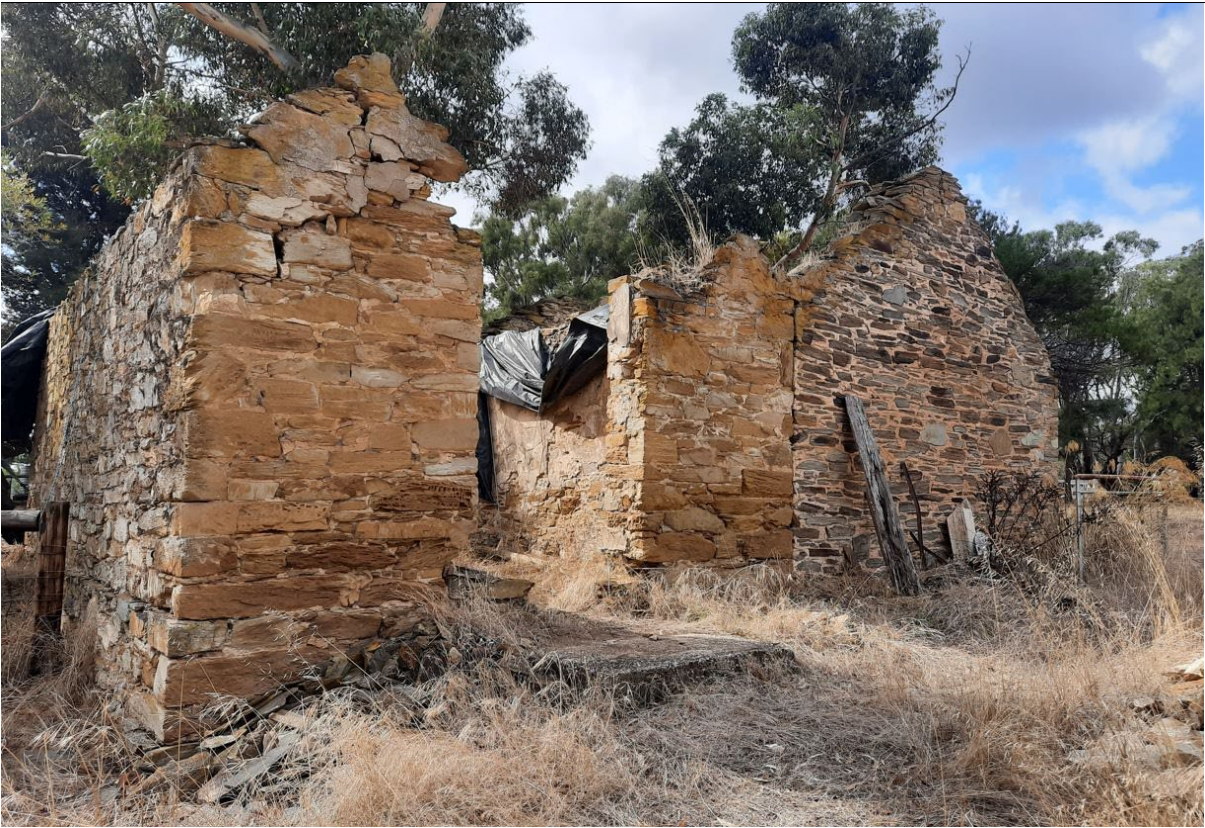
Mid-19<sup>th</sup> century ruins of 'Stewarton Farm', looking north (GGA, 2022).

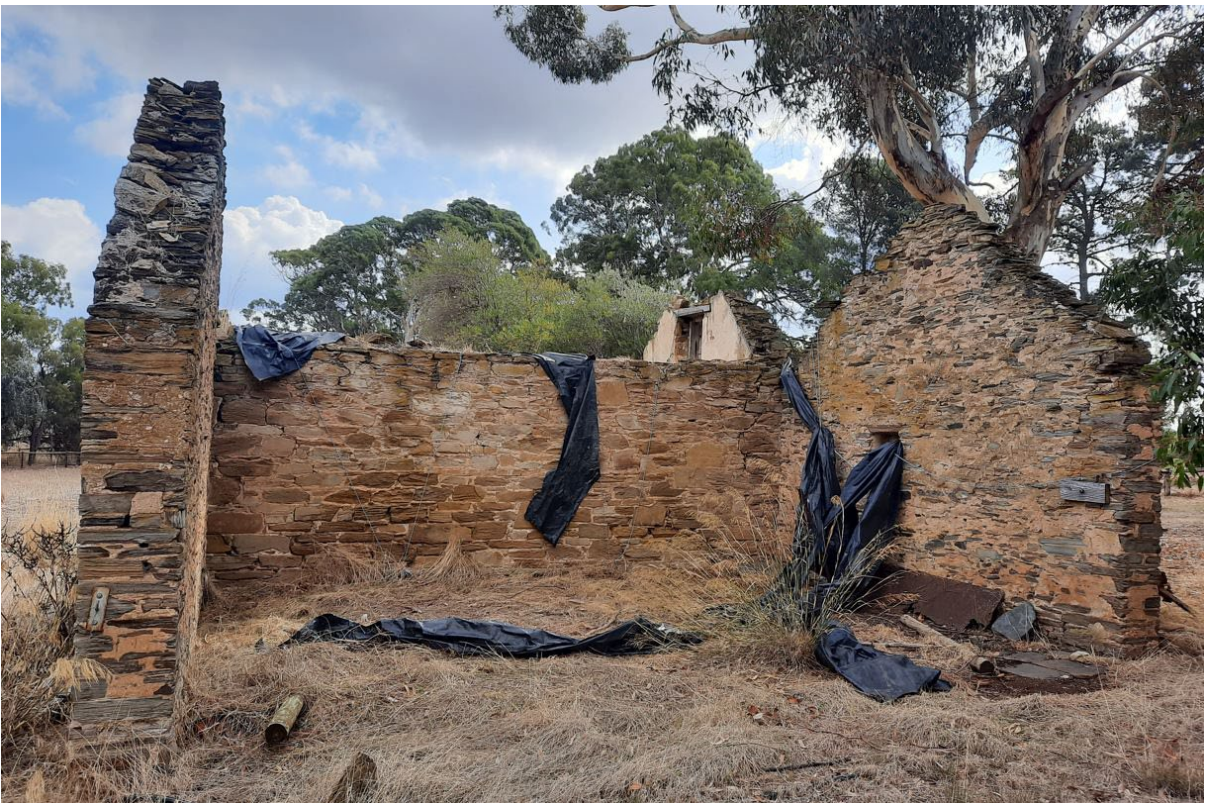
Mid-19<sup>th</sup> century ruins of 'Stewarton Farm', looking west (GGA, 2022).
