**NAME: Dwelling, 191 Port Road, ALDINGA**

| <b>RECOMMENDATION:</b> | Local Heritage Place |

**DESCRIPTION:**

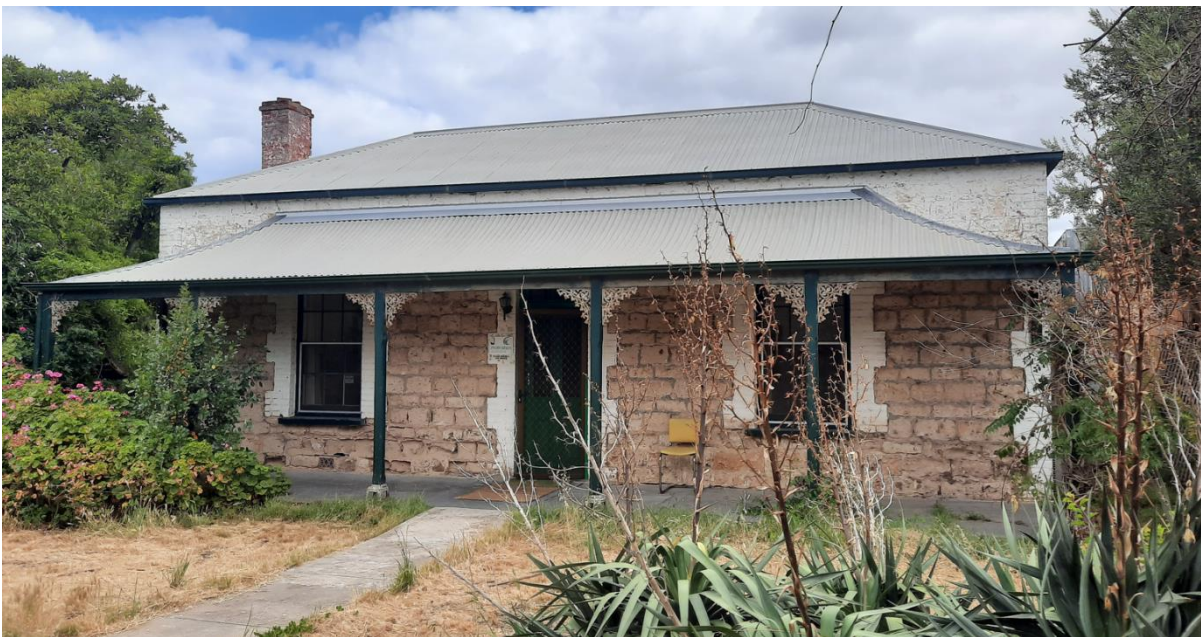
Cottage at 191 Port Road, Aldinga (GGA, 2021)

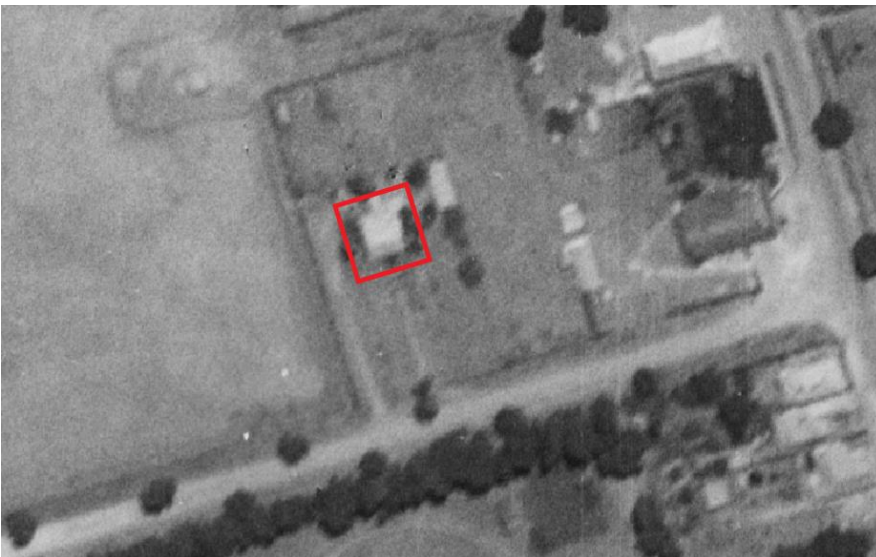
1936 aerial photograph of 191 Port Road, Aldinga, highlighting the intact nature of the residence and its important contribution as one of relatively few early surviving residences within the historic Aldinga township centre (ICSM Historical Aerial Photography, Film Number MAP1942, Run 6, Frame 6419, dated 3rd July, 1936.

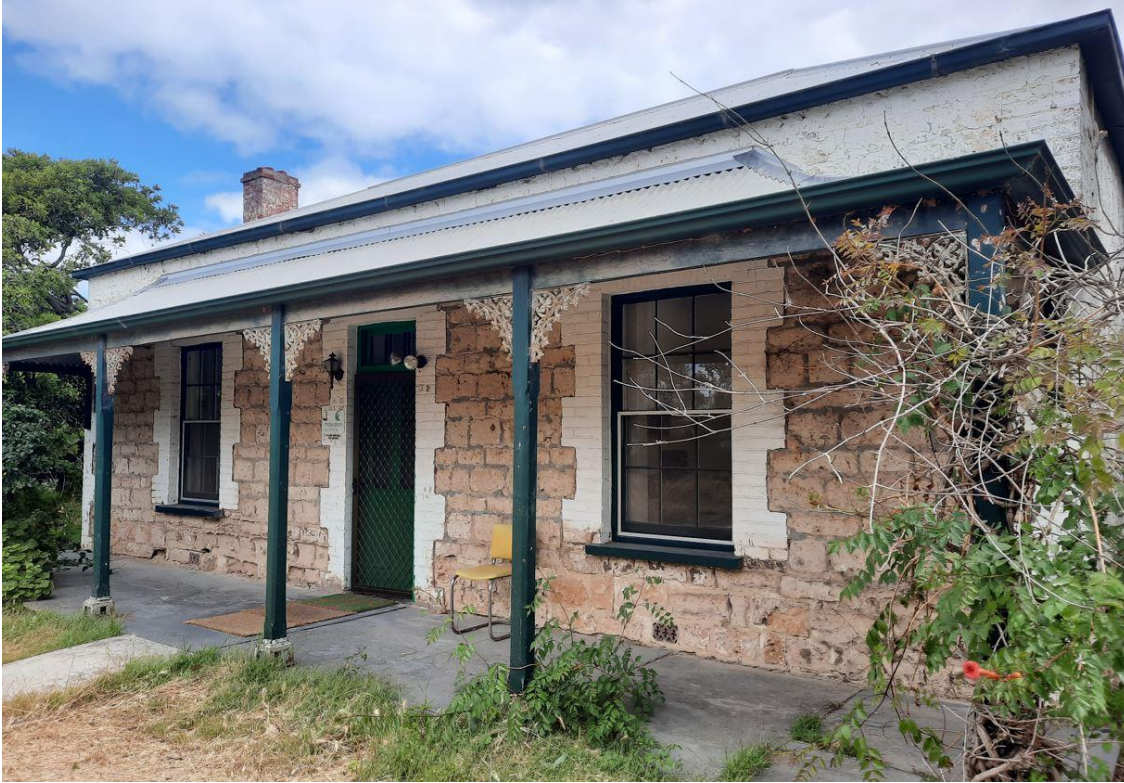
Primary south elevation of former cottage at 191 Port Road, Aldinga (GGA, 2021)

The south elevation verandah form is considered of significance, as is the use of timber framing and corrugated steel cladding, though replacement materials are not included in the listing.

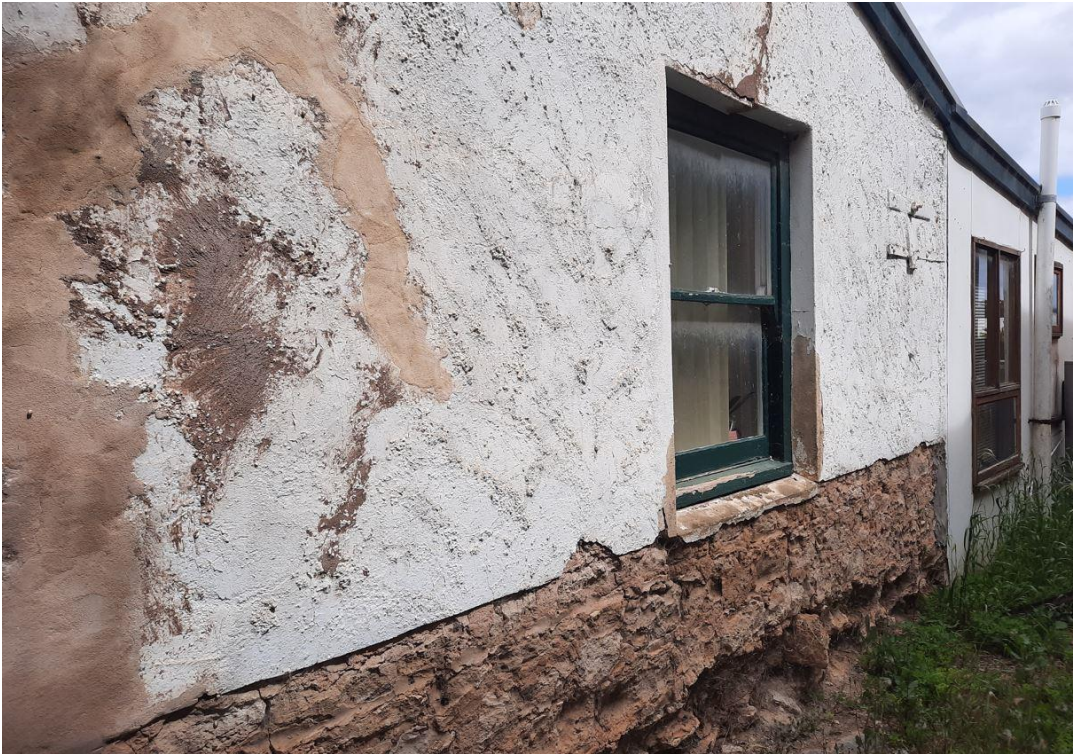
East elevation of former cottage, early masonry in poor condition at lower level with cement rendering from mid-level. Original iron wall plating at upper level. Late 20<sup>th</sup> century additions about early lean-to additions to the immediate north (GGA, 2021).

The form and materials of all surviving masonry elements to the former cottage, including all walls, window and door openings, brick chimney and slate paving. External cement rendering is considered unsympathetic in nature and is not included in the listing and should be removed.

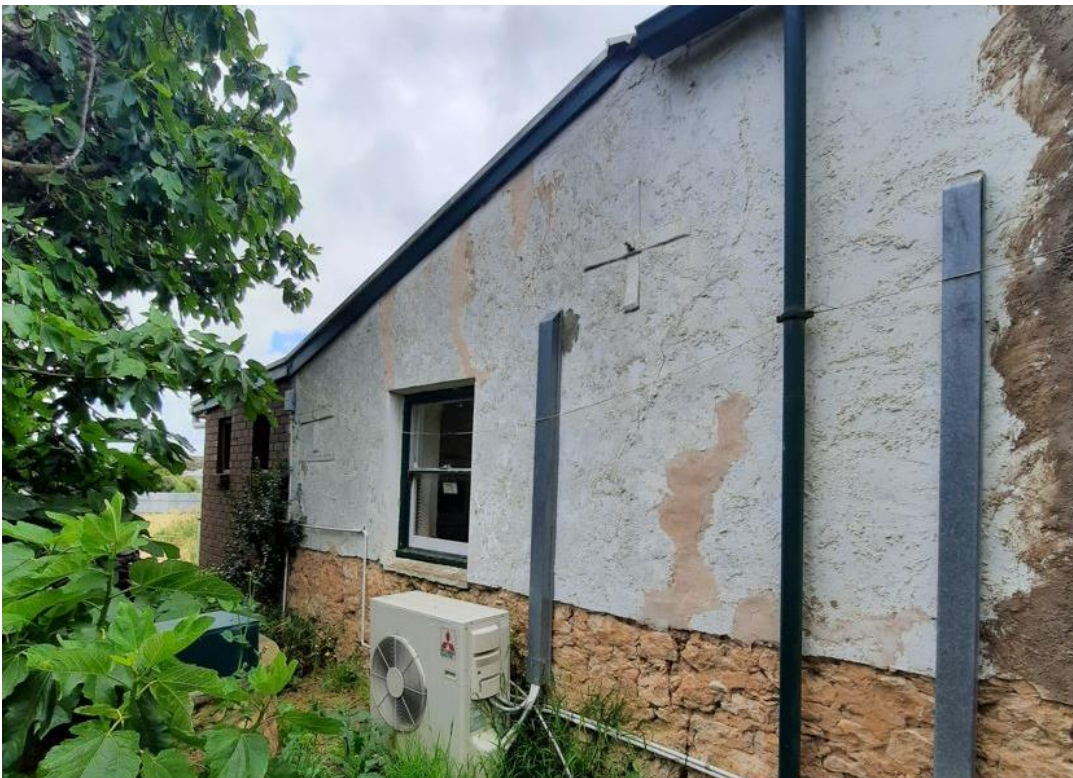
West elevation of former cottage, early masonry in poor condition at lower level with cement rendering from mid-level. Original iron wall plating at upper level. Mid-20<sup>th</sup> century additions about early lean-to additions to the immediate north (GGA, 2021).

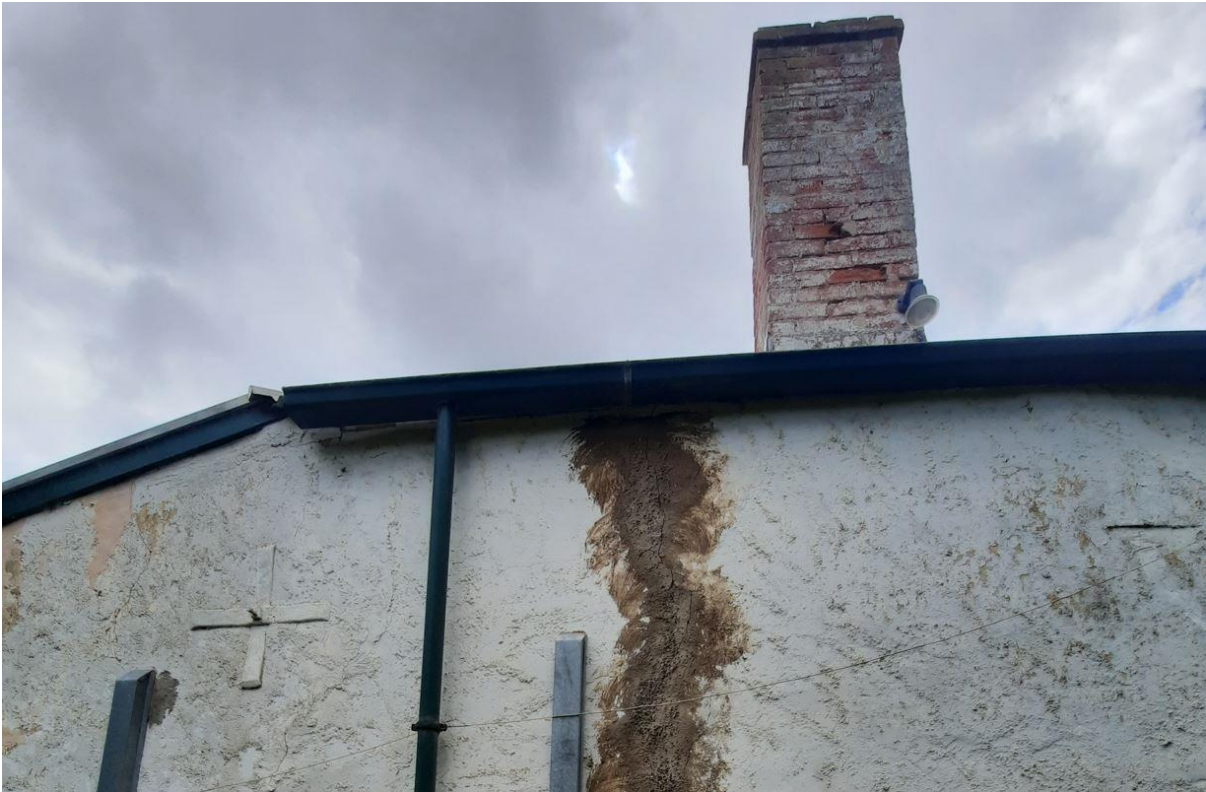
Upper portion of west elevation, with external rendering and early brick chimney (GGA, 2021).

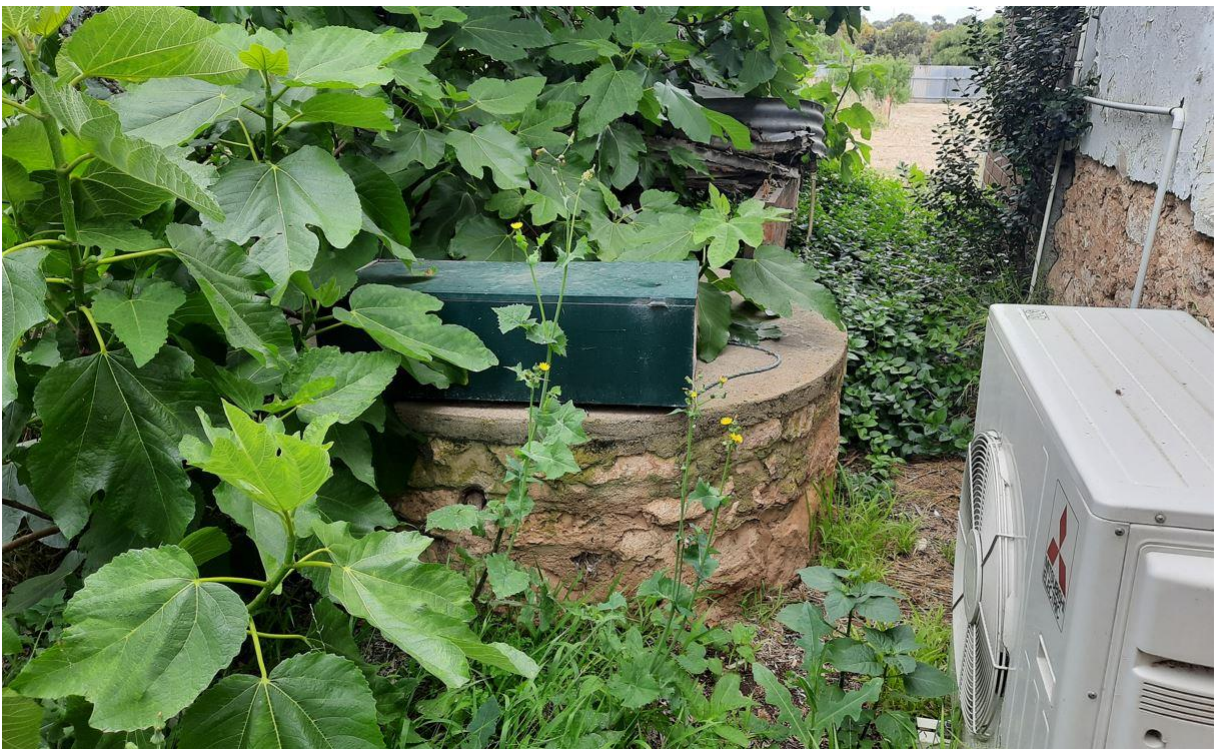
Masonry well with later concrete capping to immediate west of former cottage (GGA, 2021).

The form and materials of the early masonry well (excluding concrete capping) are of significance and are included in the listing. The early fig tree is considered of significance to the history of the site and is included in the listing.

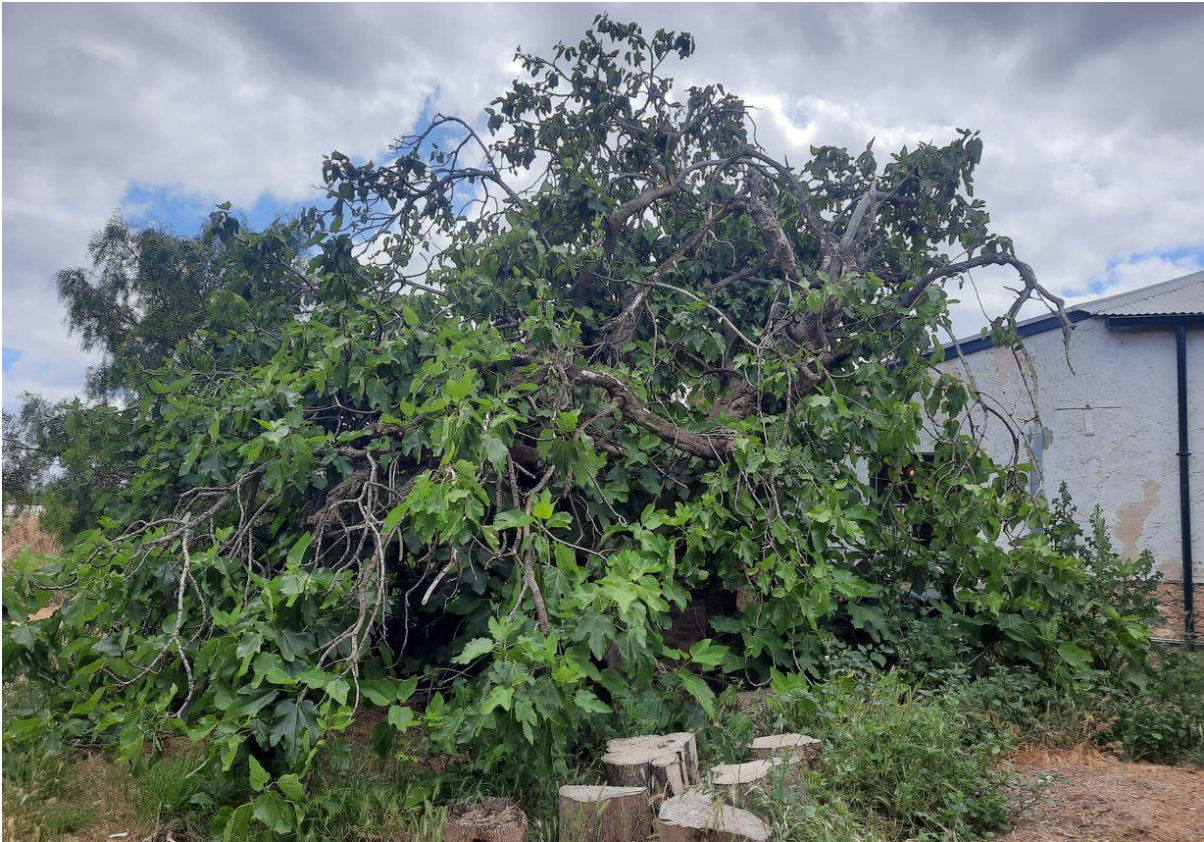
Fig tree dating from site's early history to immediate west of former cottage (GGA, 2021).

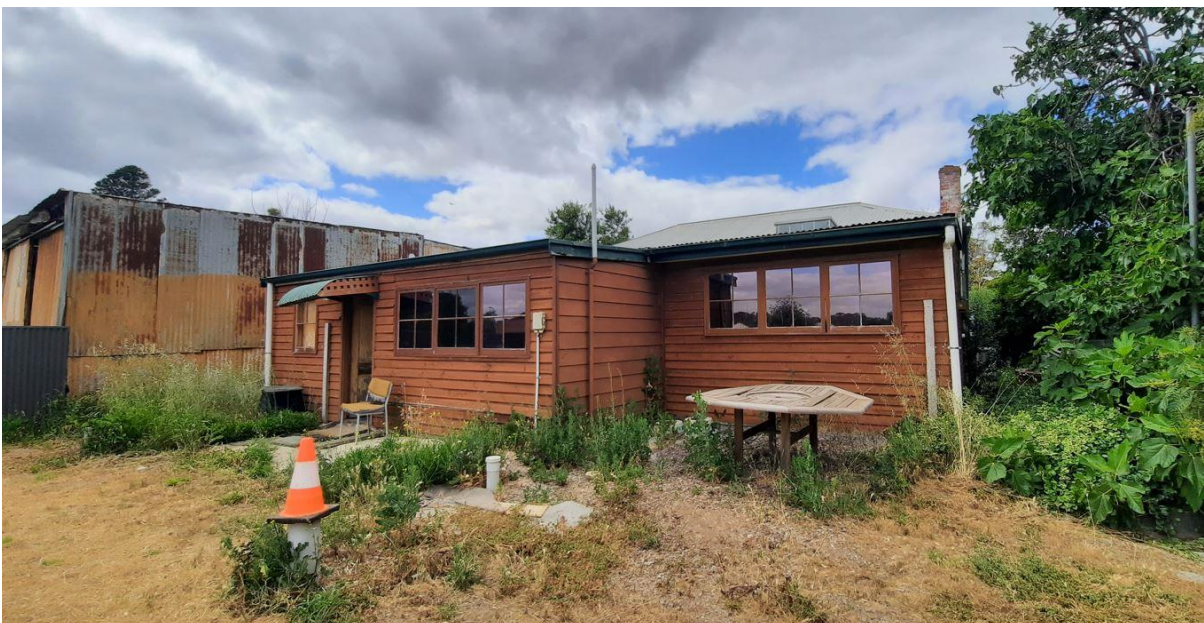
Timber framed and timber clad late 20<sup>th</sup> century additions, abutting early lean-to additions to immediate north, viewed looking south. Adjoining sheds appear to date from the mid 20<sup>th</sup> century. (GGA, 2021).

Mid to late 20<sup>th</sup> century brick and timber-framed additions to the immediate north of early lean-to additions are not of significance and are not included in the listing.
