**NAME:** Dwelling, 26 St Andrews Terrace, WILLUNGA

**PLACE NO.:** Local, HID 5503

**DESCRIPTION:**

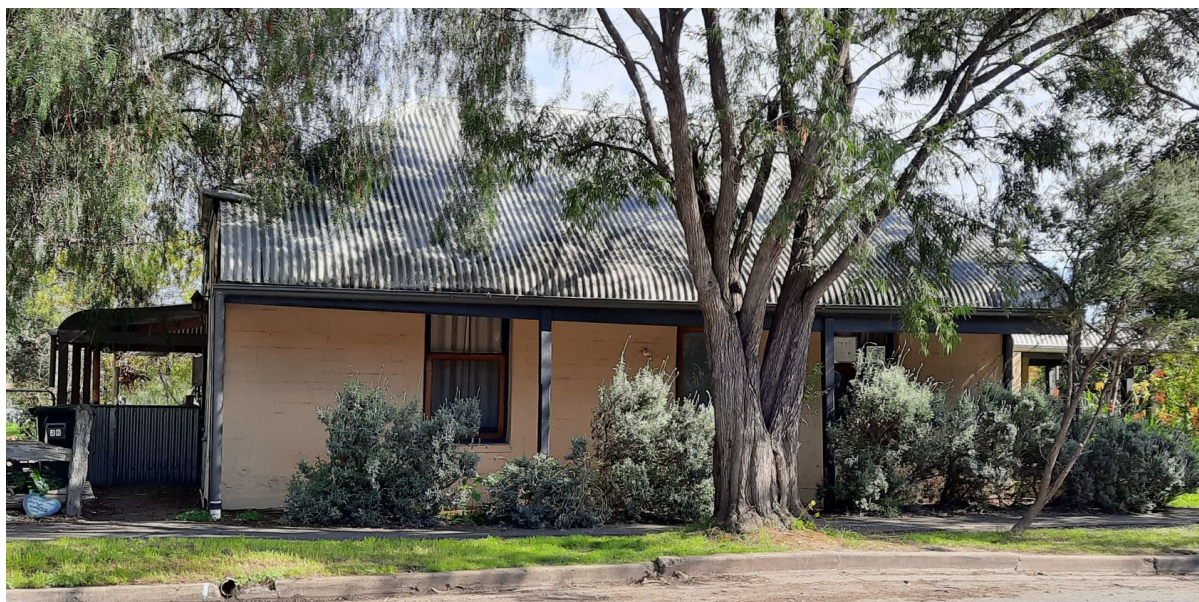
26 St Andrews Terrace, Willunga (GGA, 2021)

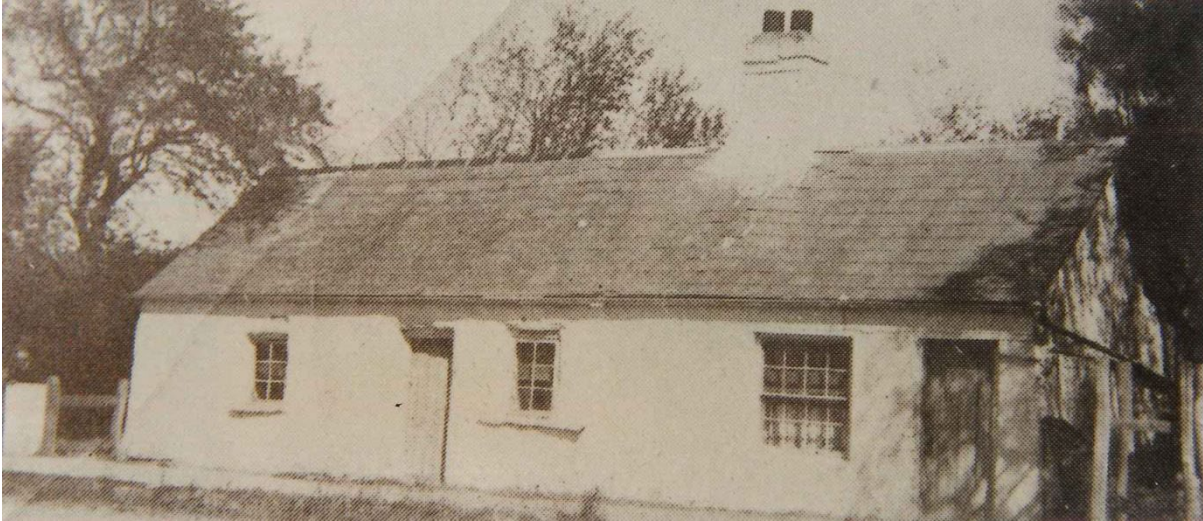
It would appear that very little early physical fabric, clearly illustrated in an early photograph before alterations (see Historical Images), remains to the current building. The window and door opening arrangement is one of few clues to the original appearance, though both window and door openings have been subsequently altered. An original shopfront/adjoining cottage has been demolished, with the installation of an additional verandah.

Original appearance of 26 St Andrews Terrace, Willunga before extensive modifications (McDougall, 1999, *Willunga Historical Conservation Zone*, p.71).

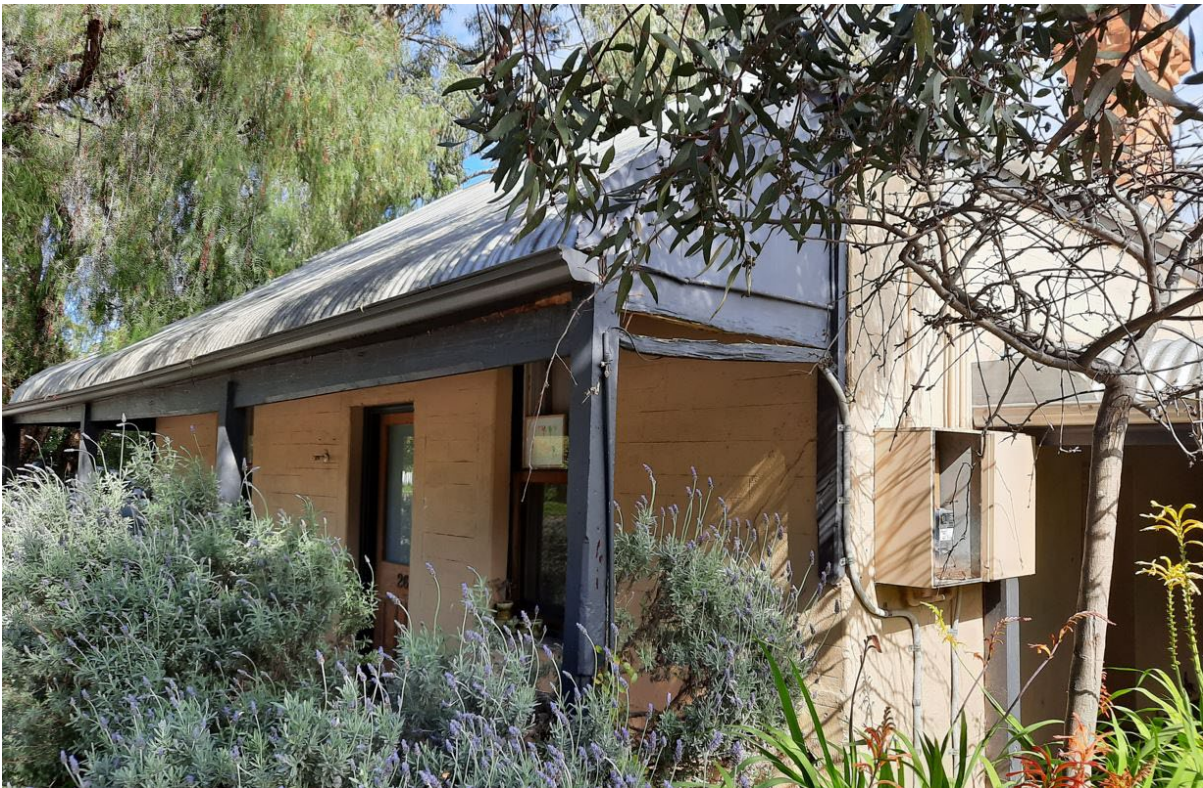
Mid-19<sup>th</sup> century cottage of pise construction with 20<sup>th</sup> century alterations and reconstruction works. External walls rendered and lined to resemble stonework. Window openings enlarged with later timber fittings. Reconstructed hipped roof clad in corrugated steel extended over later timber-framed verandah structure. Brick chimney to north elevation. Extensive additions to rear of property.

External pise walls to 26 St Andrews Terrace, Willunga now rendered and lined to resemble stonework (GGA, 2021)

It is recommended that the cottage at 26 St Andrews Terrace, Willunga be removed from the SA Heritage Register as a Local Heritage place.

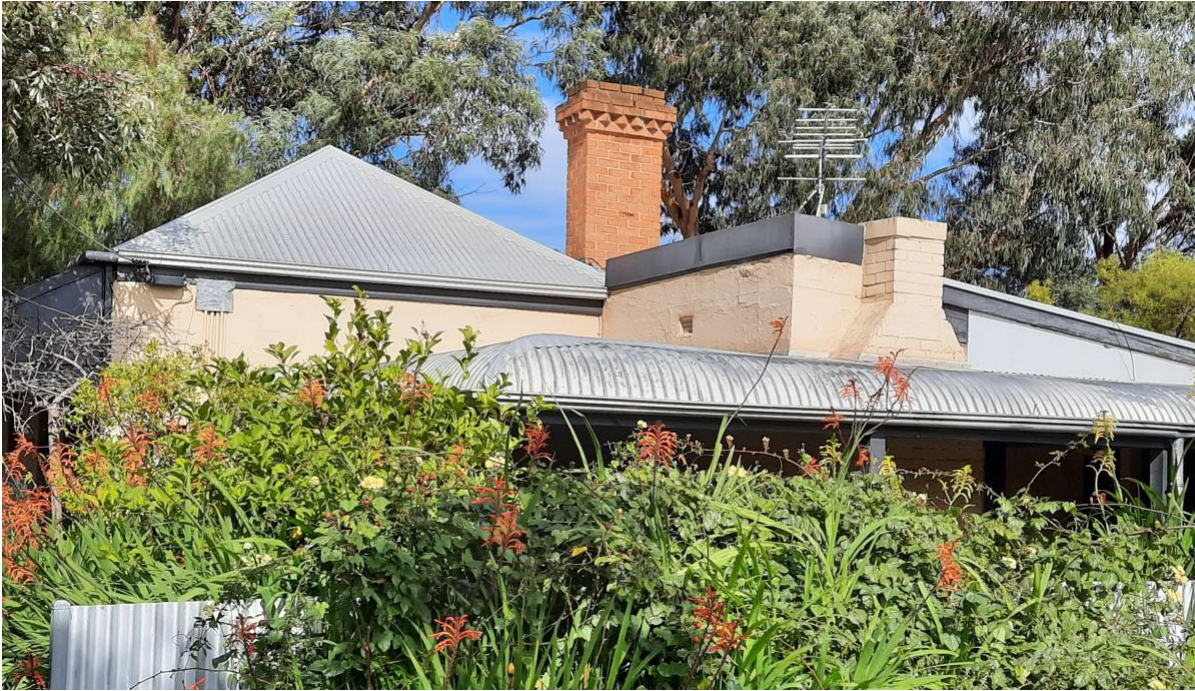
While original fabric does remain, this fabric has been so extensively altered as to render the external façade to be practically unrecognisable from early photography. As such, all remaining original fabric is not deemed to meet Local Heritage criteria.

Extensive alterations and additions to 26 St Andrews Terrace, Willunga (GGA, 2021)
