**NAME:** Cottage and Moreton Bay Fig Trees, 128 Main Road, WILLUNGA

**PLACE NO.:** Local, HID 5430

**DESCRIPTION:**

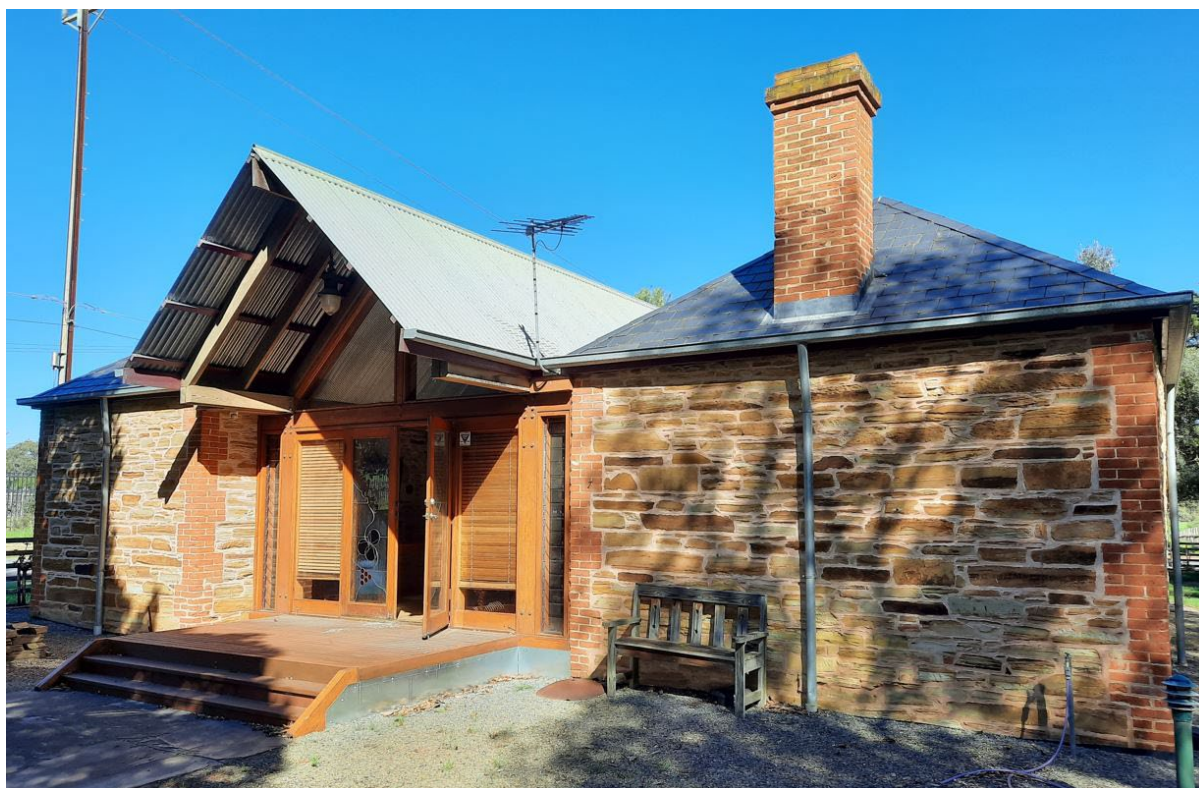
Former cottage ruin (now reconstructed) at 128 Main Road, Willunga (GGA, 2021)

Mid-19<sup>th</sup> century former farmhouse constructed of masonry with brick quoins and surrounds. C.2000 reconstruction works including reconstructed masonry elements and timber-framed, corrugated steel-clad additions. Slate window sills and lintels with timber lintel to north elevation. Replacement single-casement window to early window form to north elevation.

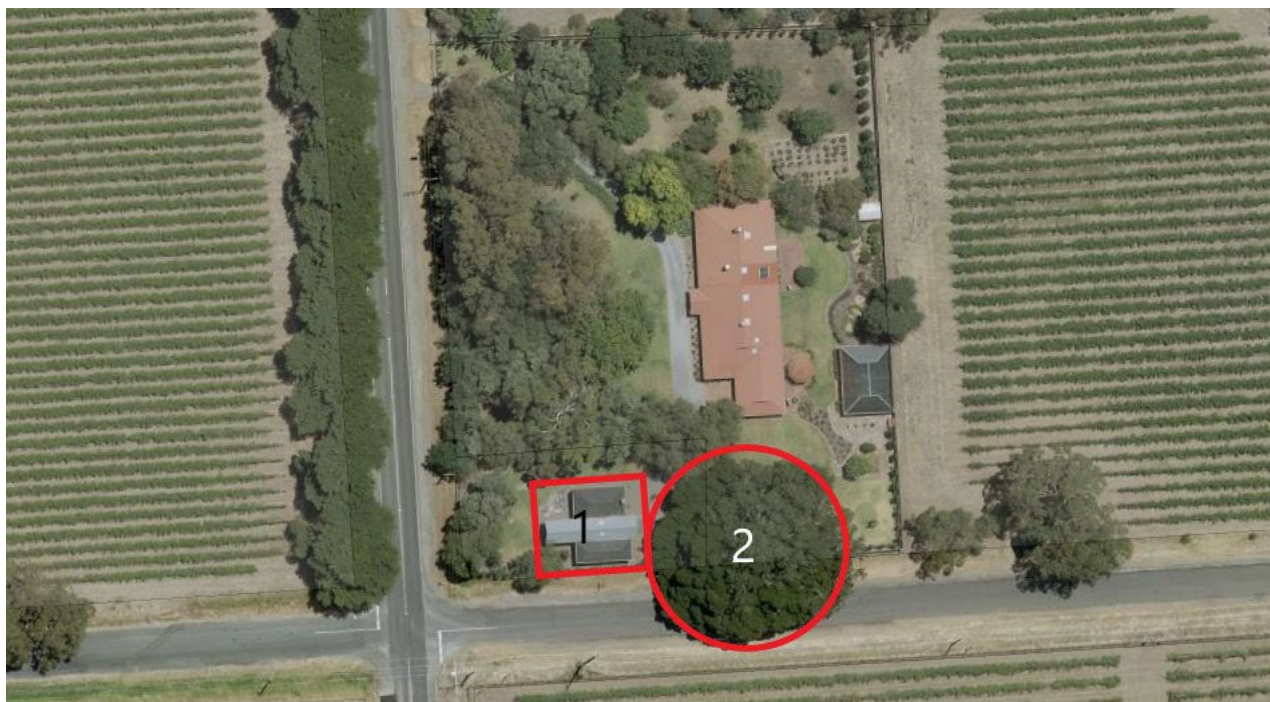
Site of 128 Main Road, Willunga; (1) former cottage; (2) site of two Moreton Bay figs (Planning SA SAPPa)

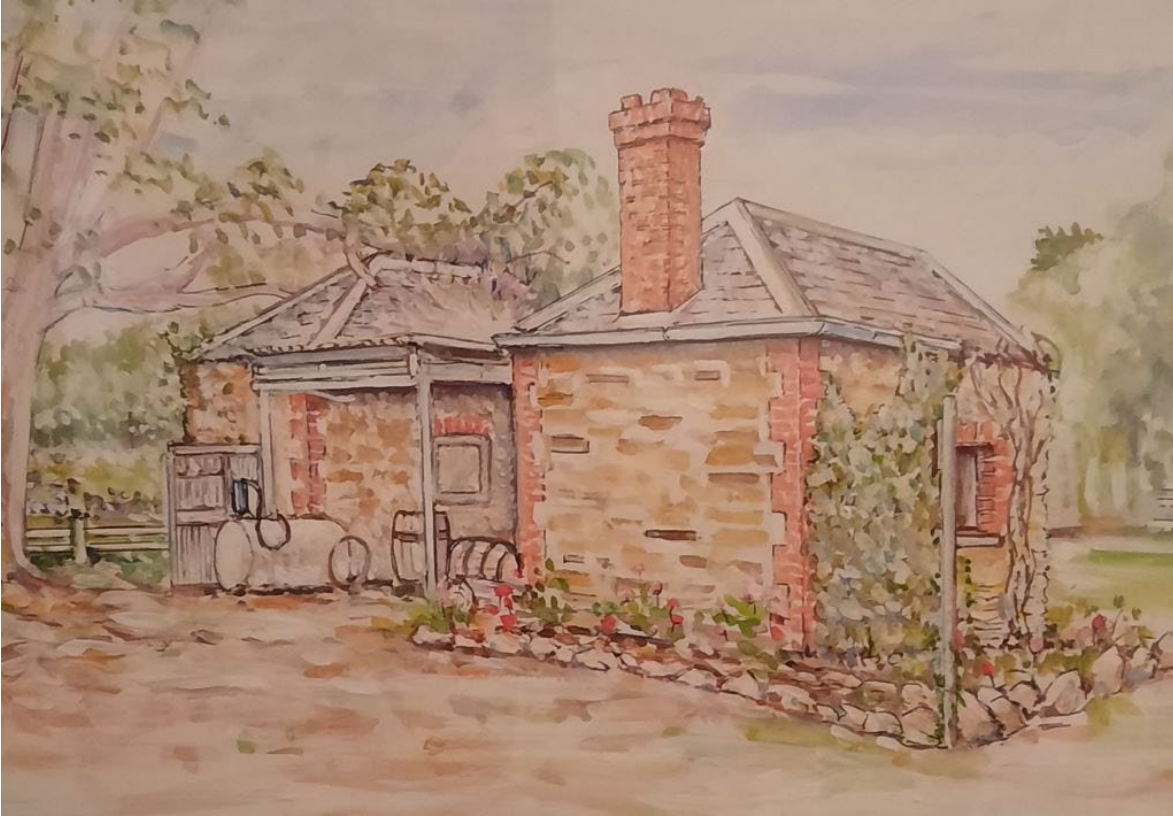
1994 watercolour of former cottage ruins at 128 Main Road, Willunga, retained by current owners (GGA, 2021)

The form of the early building can be easily seen in a watercolour illustration dating to 1994 (see Historical Images). Following an inspection, no early pise or rendered masonry elements discussed by the 1997 Survey were identified.

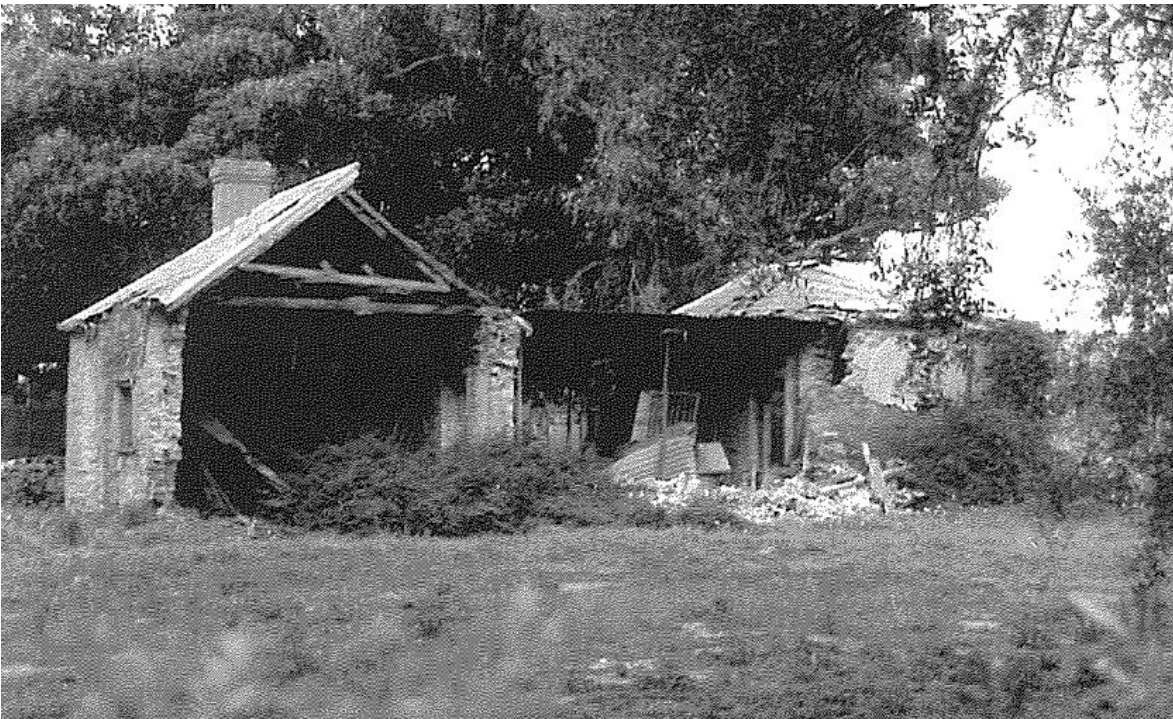
1997 photograph of former cottage ruins at 128 Main Road, Willunga (1997 Willunga District Heritage Survey)

The 1997 survey noted the current owners at that time expressed an interest in 'salvaging' the ruin; extensive and high-quality architecturally-designed reconstruction works were undertaken in approximately c.2000. It is understood that extensive portions of existing masonry, then in ruinous form, were reconstructed around this time to form the current building. These c2000 reconstruction works are highly-sympathetic in nature and can be difficult to identify. Surviving early portions with minimal areas of reconstructed stonework are identified as including the brick chimney, masonry walls to the east elevation and the eastern 'half' of all masonry walls orientated on an 'east-west' axis.

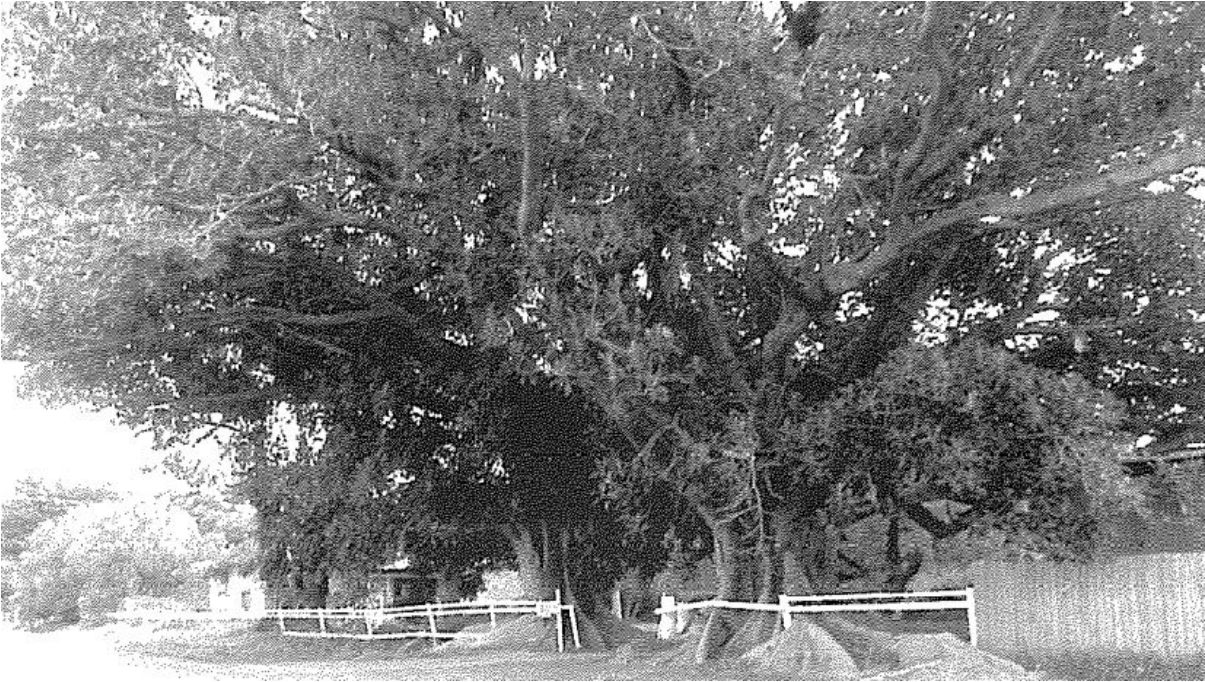
1997 photograph of Moreton Bay Fig trees at Gaffney Road at entrance to former farmhouse ruins (1997 Willunga District Heritage Survey)

As noted in the 1997 Survey, the two substantial Moreton Bay fig trees located on the property's southern entrance date to the site's early history during the ownership of Thomas Culley, suggestive of planting in the mid-19<sup>th</sup> century.

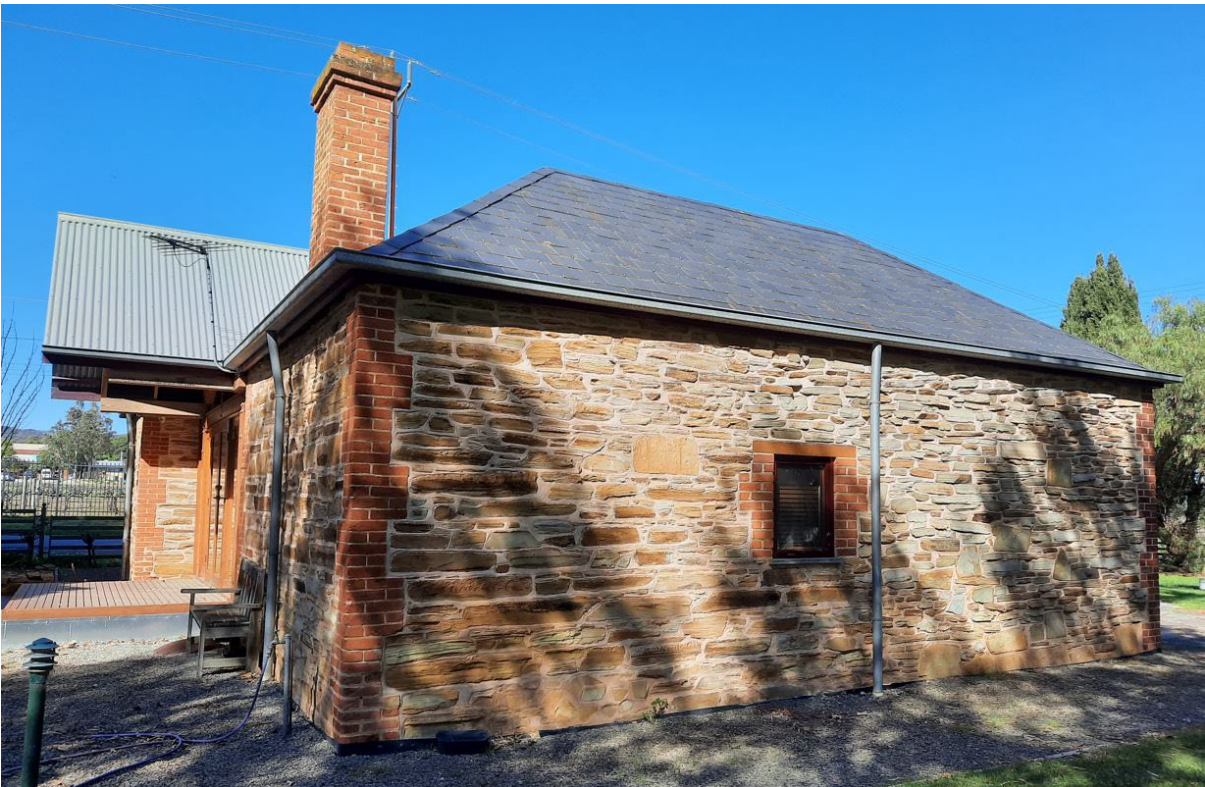
North elevation of former farmhouse, having been extensively reconstructed with additions in c.2000 (GGA, 2021)

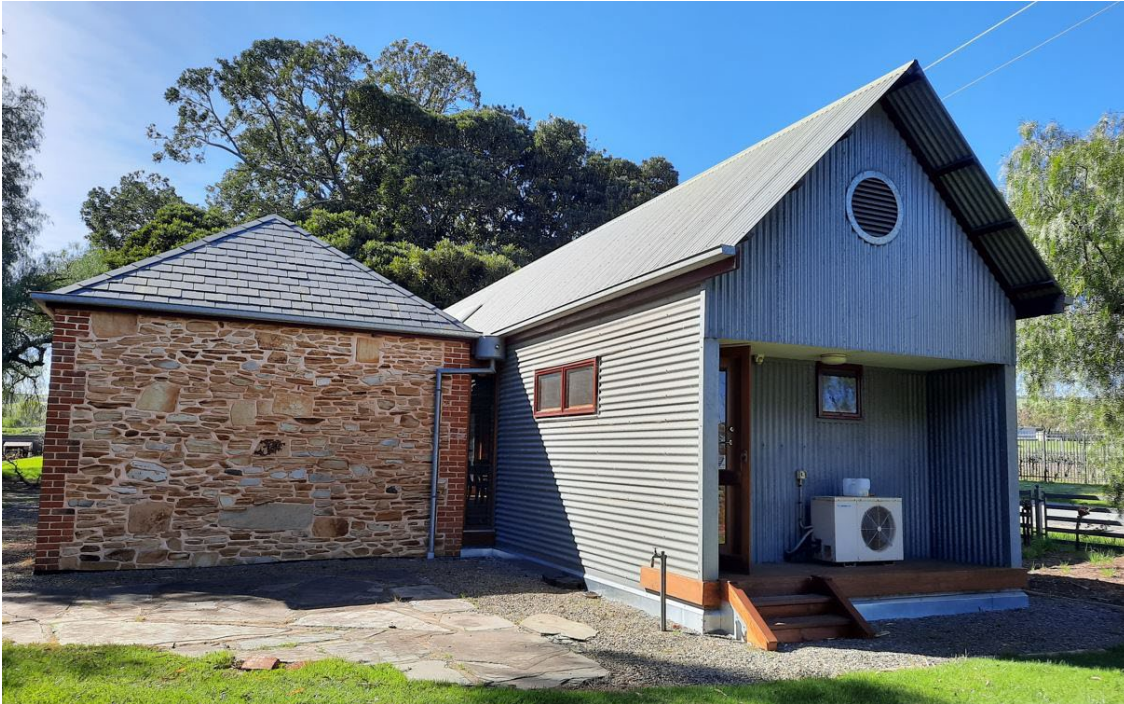
Reconstructed masonry fabric to west elevation with c.2000 additions (GGA, 2021)

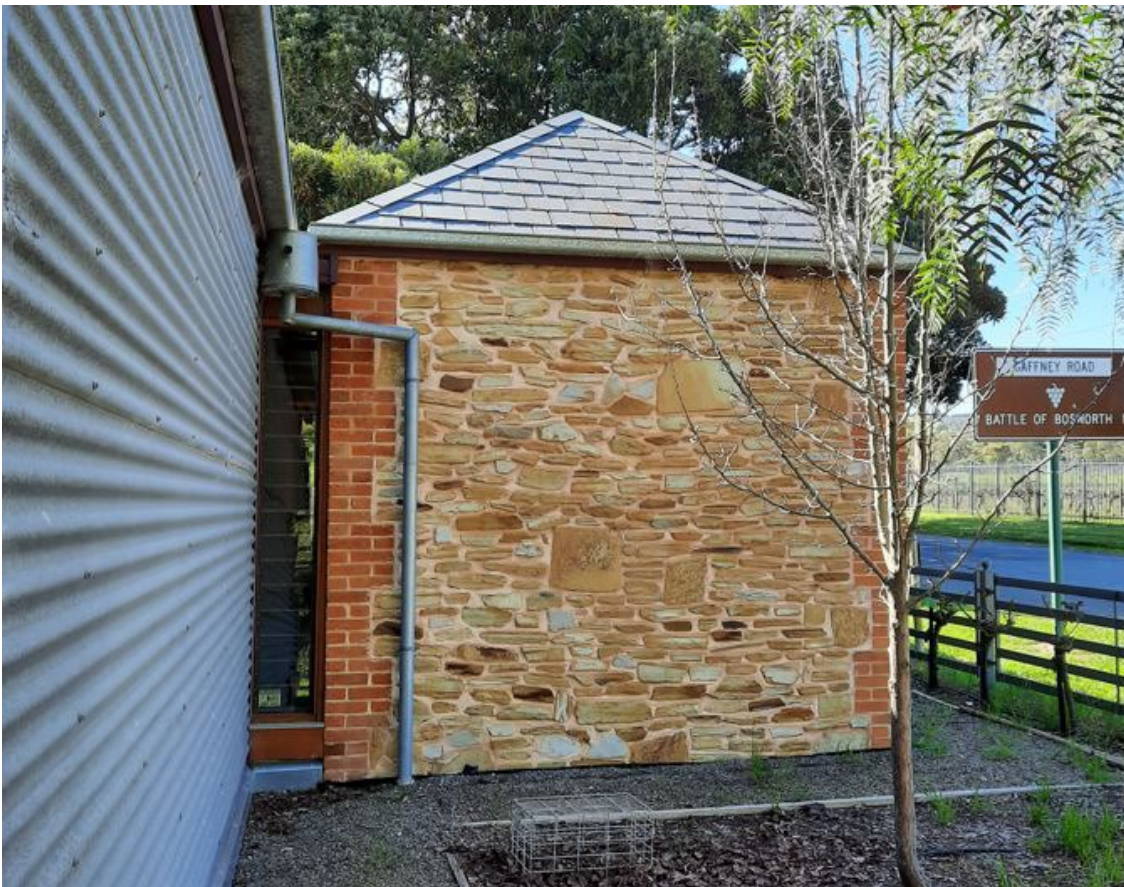
Reconstructed masonry fabric to west elevation with c.2000 additions (GGA, 2021)

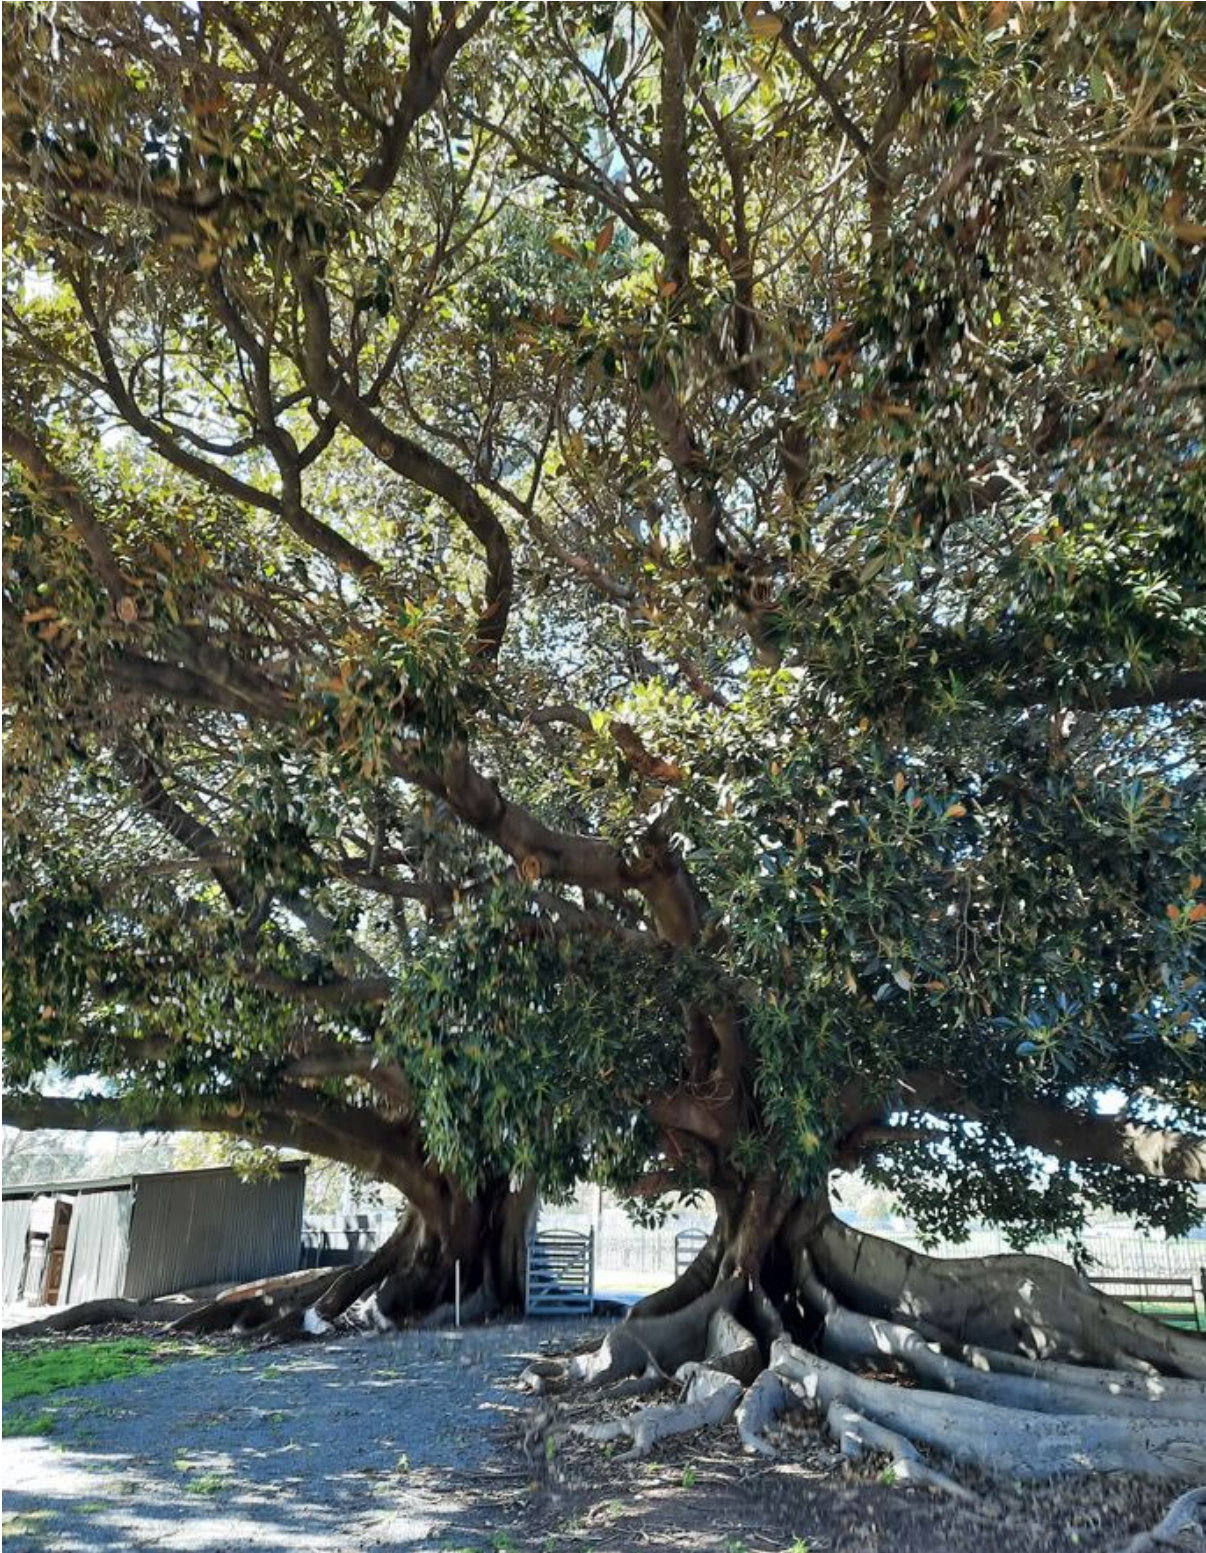
Two notable Moreton Bay fig trees to southern entrance to 128 Main Road, Willunga (GGA, 2021)

The current listing also identifies 'seven' Moreton Bay fig trees; following a site inspection and information from the current owners, it is understood that only the two examples located on the property's southern entrance are in existence.
