**NAME:** Old Sellicks Hill Road, SELLICKS HILL

**RECOMMENDATION:** Local Heritage Place

**NAME: Old Sellicks Hill Road, SELICKS HILL**

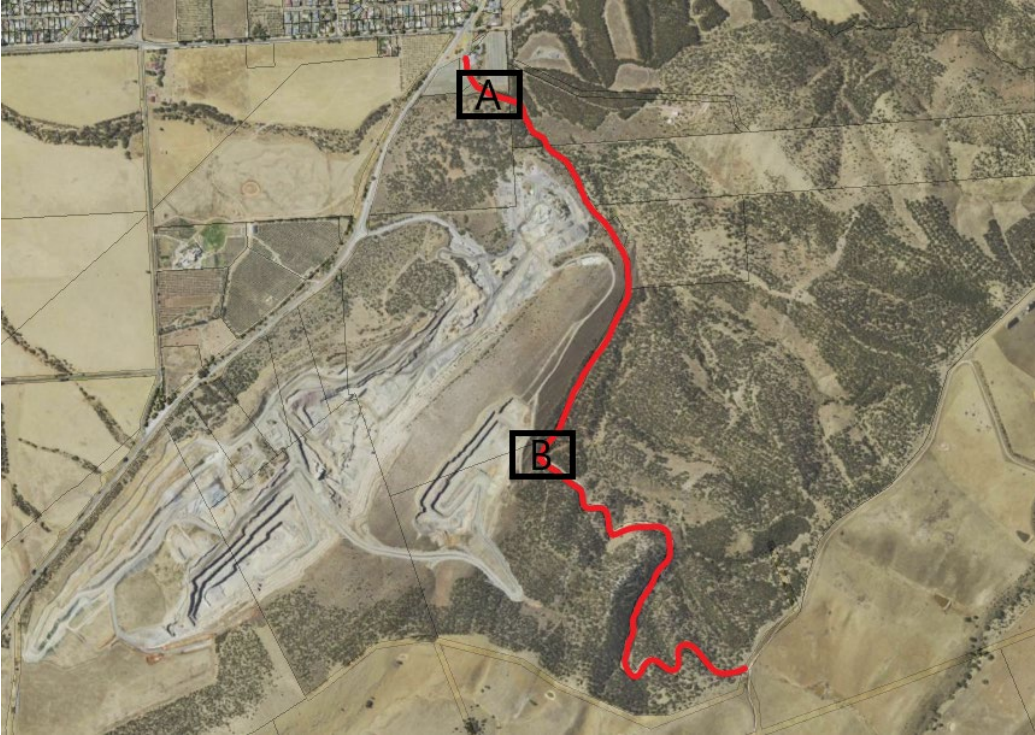
Site of Old Sellicks Hill Road, SELICKS HILL, red line illustrates path of closed road commencing near the Victory Hotel to the north to the termination of the closed portion of the road to the south-east, a distance of approximately three kilometres. Sites A & B (indicated by black boxes above) show locations of significant built heritage elements relating to the Road's history, shown in site mapping diagrams below (Planning SA SAPPa)

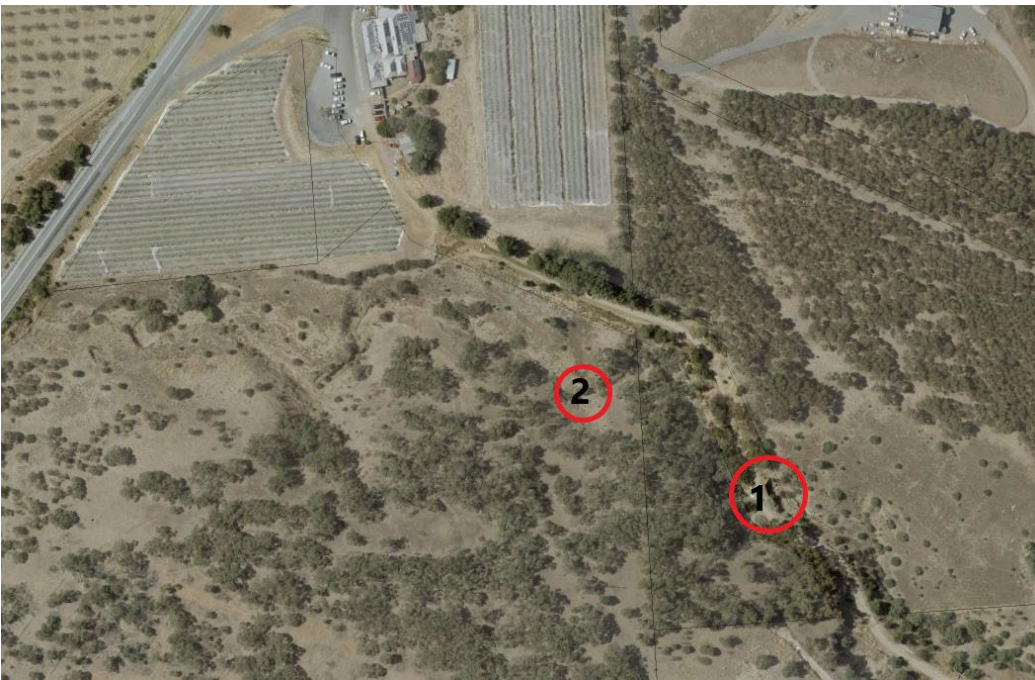
Enhancement of Site A showing significant heritage fabric; (1) Pedler's Creek Bridge; (2) approximate site of Pedler's Creek slate weir (Planning SA SAPPa)

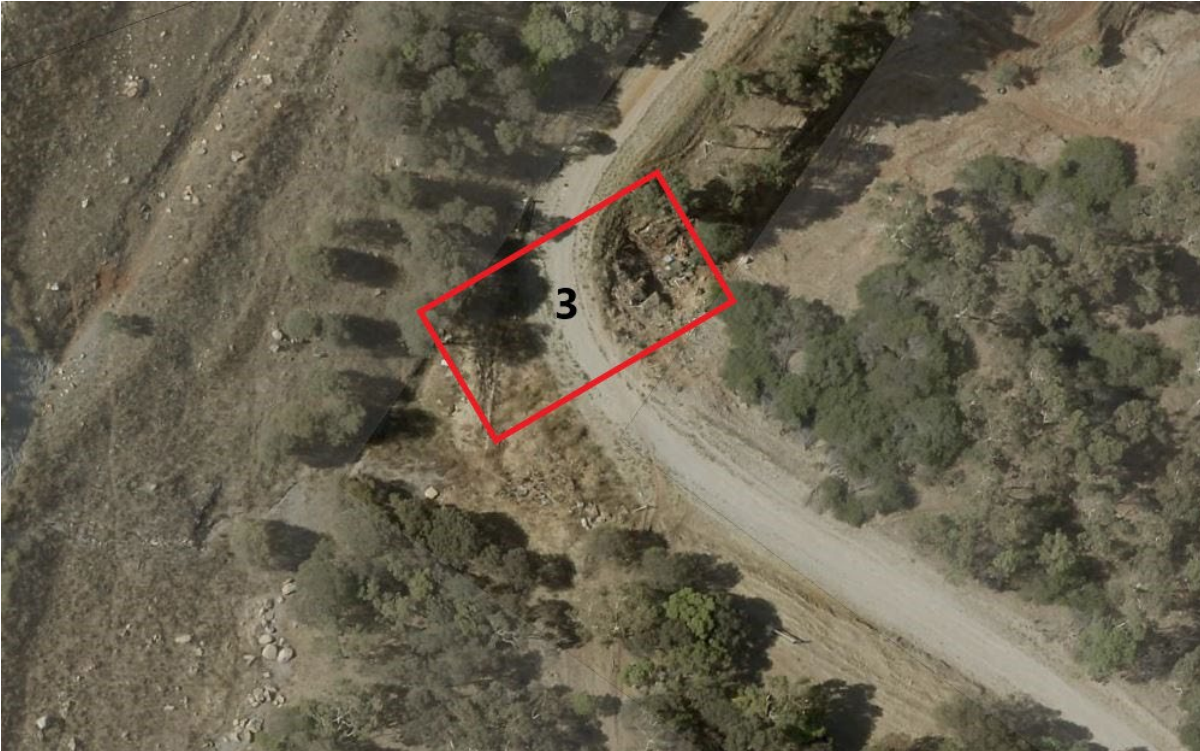
Enhancement of Site B showing significant heritage fabric; (3) Slate culvert underneath Old Sellicks Hill Road, approximately 1.5 kilometres south of the Victory Hotel (Planning SA SAPPa)

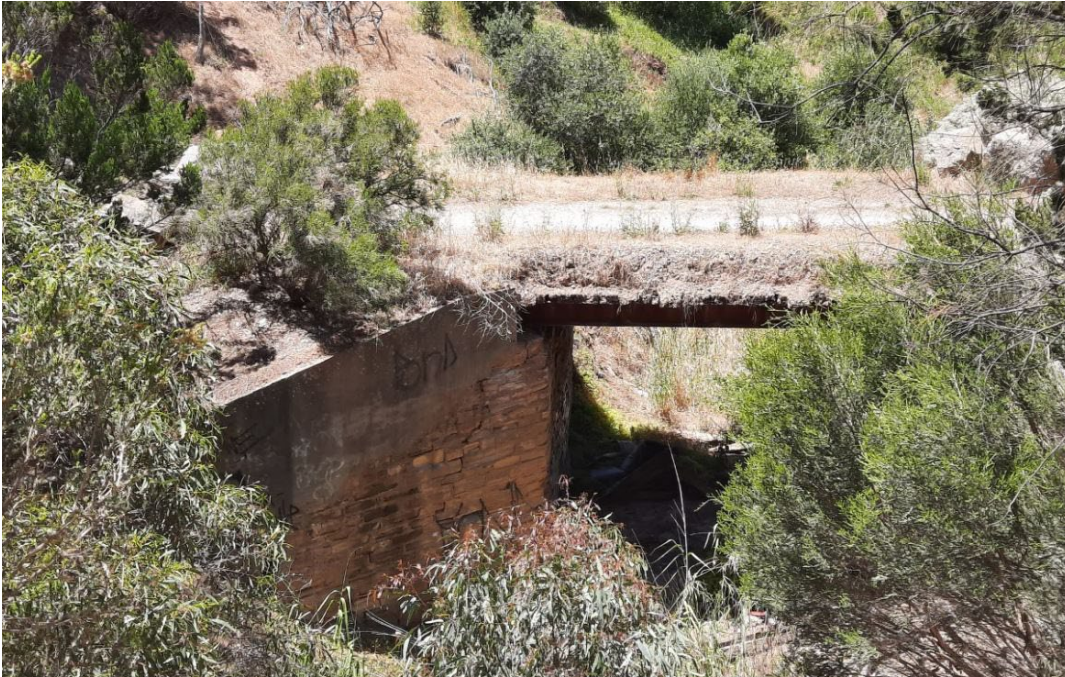
Masonry fabric and steel girders of Pedler's Creek Bridge, Old Sellicks Hill Road, looking east (GGA, 2022)

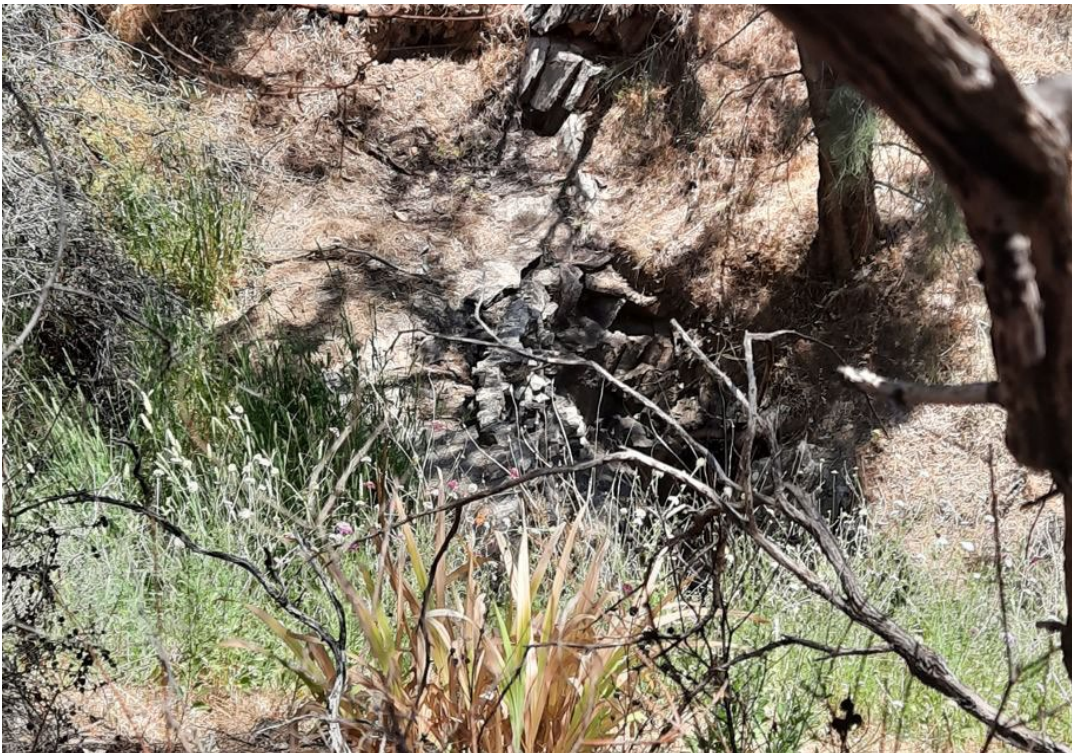
Masonry fabric of old slate weir immediately north-west of Pedler's Creek Bridge, looking south (GGA, 2022)

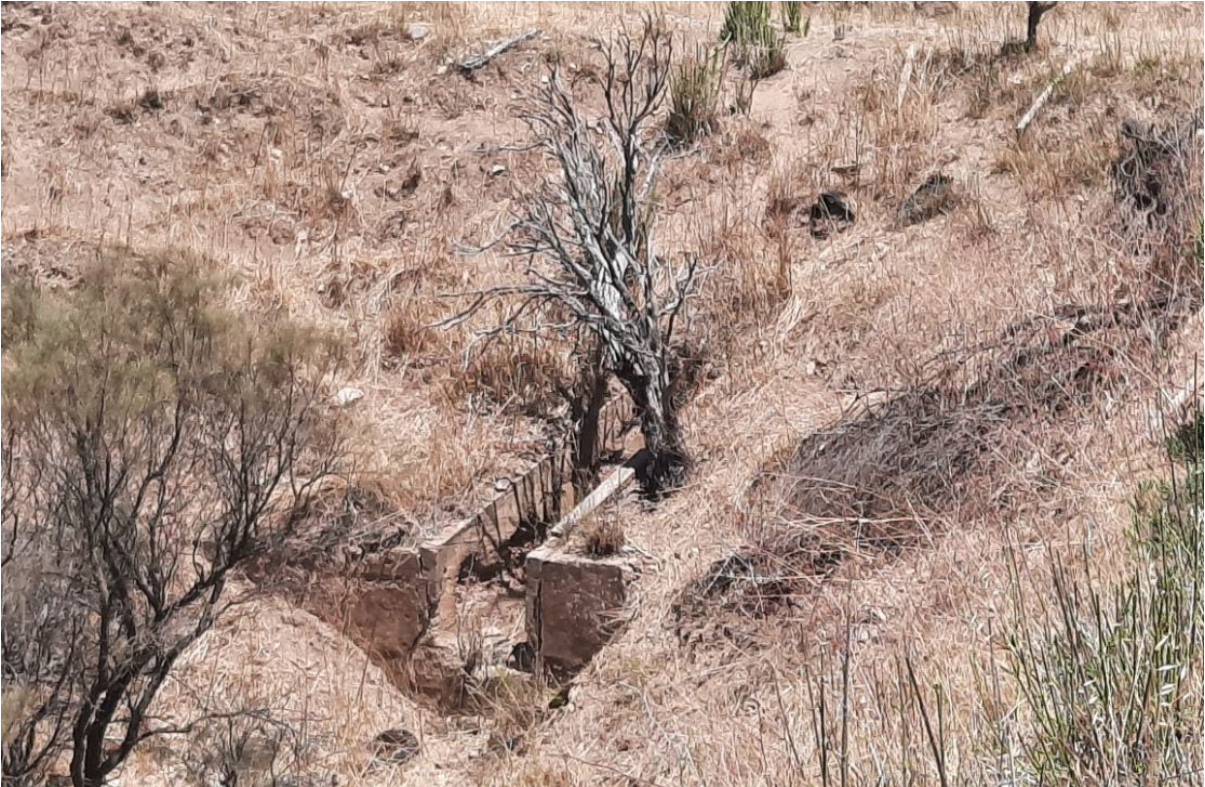
Masonry fabric associated with early culvert under corner of Old Sellicks Hill Road, some later concrete fabric (GGA, 2022)

While a number of previously unidentified slate culverts have been documented along the road and could also be of significance, further investigation is required to understand the extent of these elements which do not currently present as significant heritage elements in comparison with the above identified examples.

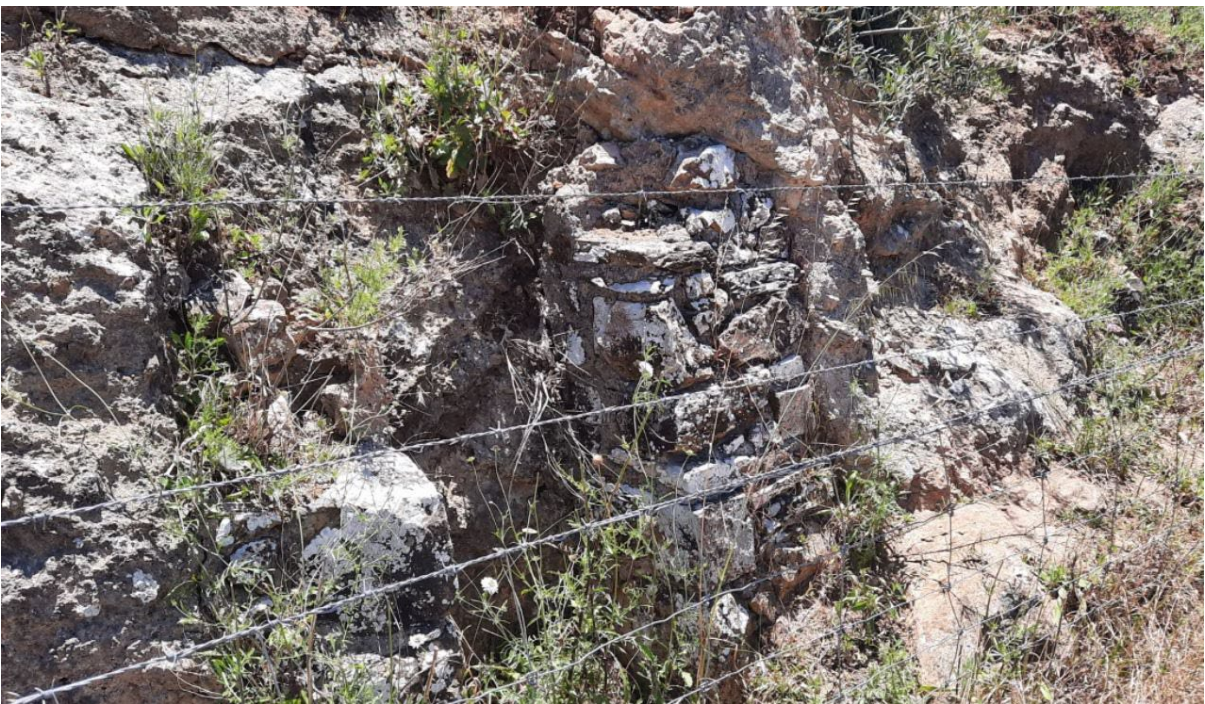
Constructed retaining wall element to Old Sellicks Hill Road, possibly dating to the initial 1850s construction period (GGA, 2022)

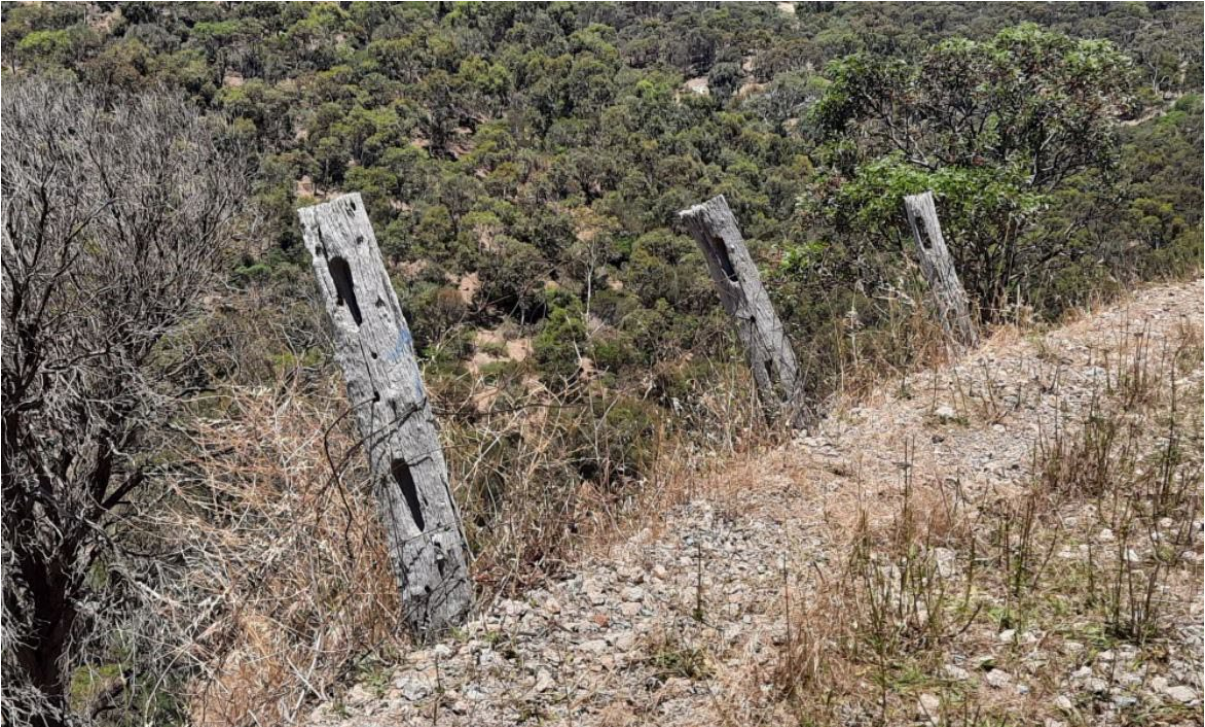
Examples of typical early timber fencing to Old Sellicks Hill Road, now in various states of decay (GGA, 2022).

All surviving mid-19<sup>th</sup> century timber fabric is included in the listing, though it is acknowledged that a majority of this timberwork is currently in deteriorated condition. It is recommended that all early timberwork should be retained and conserved where possible.

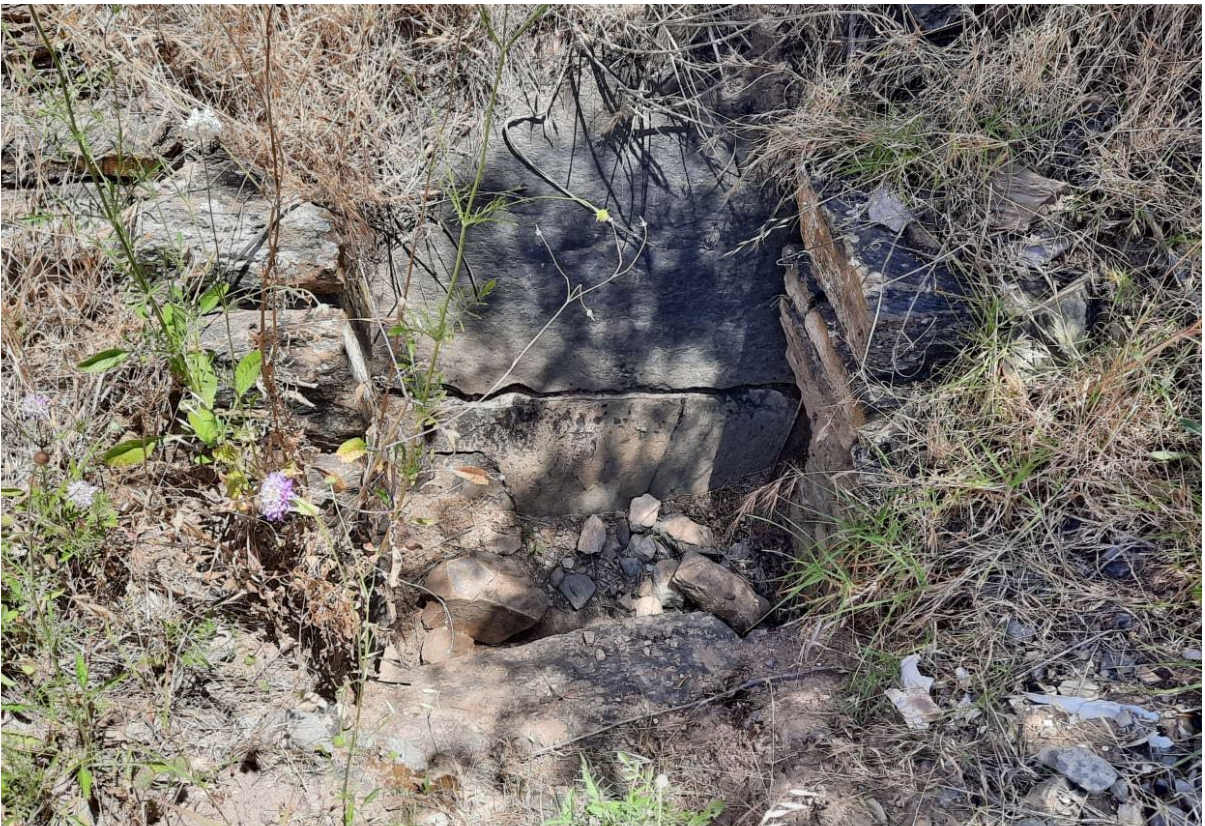
Slate culvert running beneath Old Sellicks Hill Road (GGA, 2022).

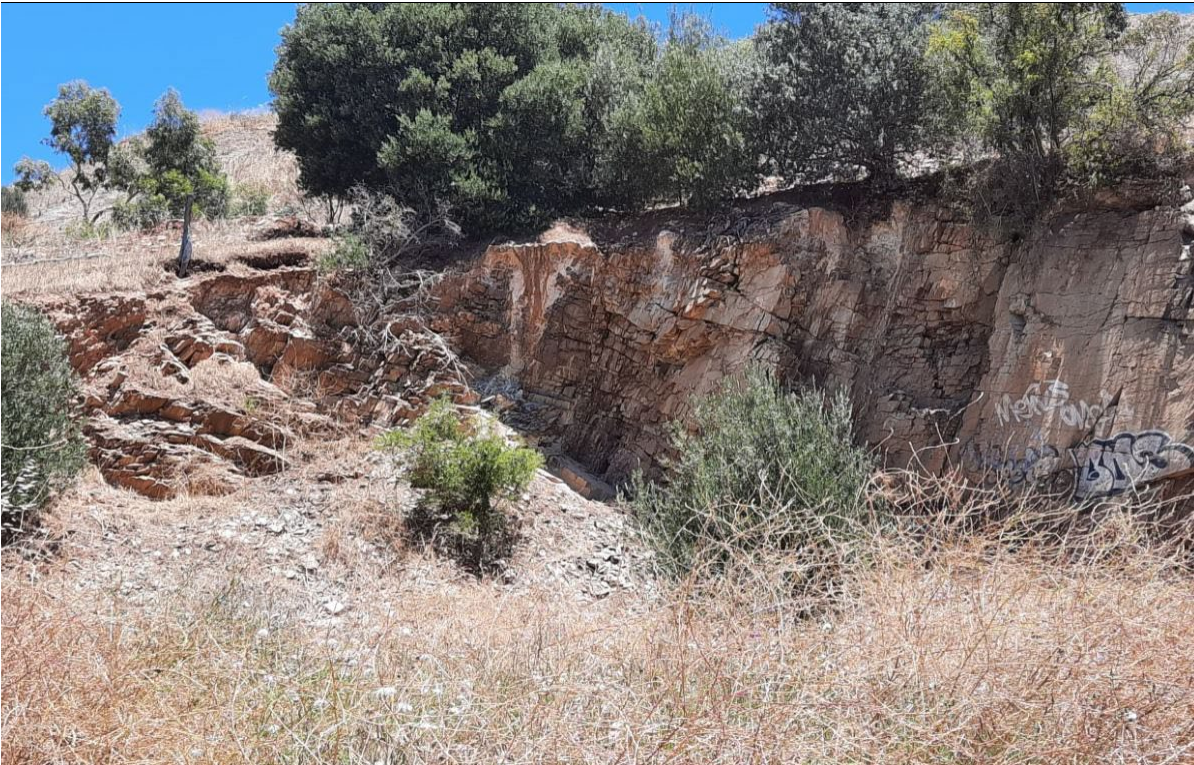
Mid-19<sup>th</sup> century quarry site located immediately west of Old Sellicks Hill Road, near Pedler's Creek Bridge (GGA, 2022).

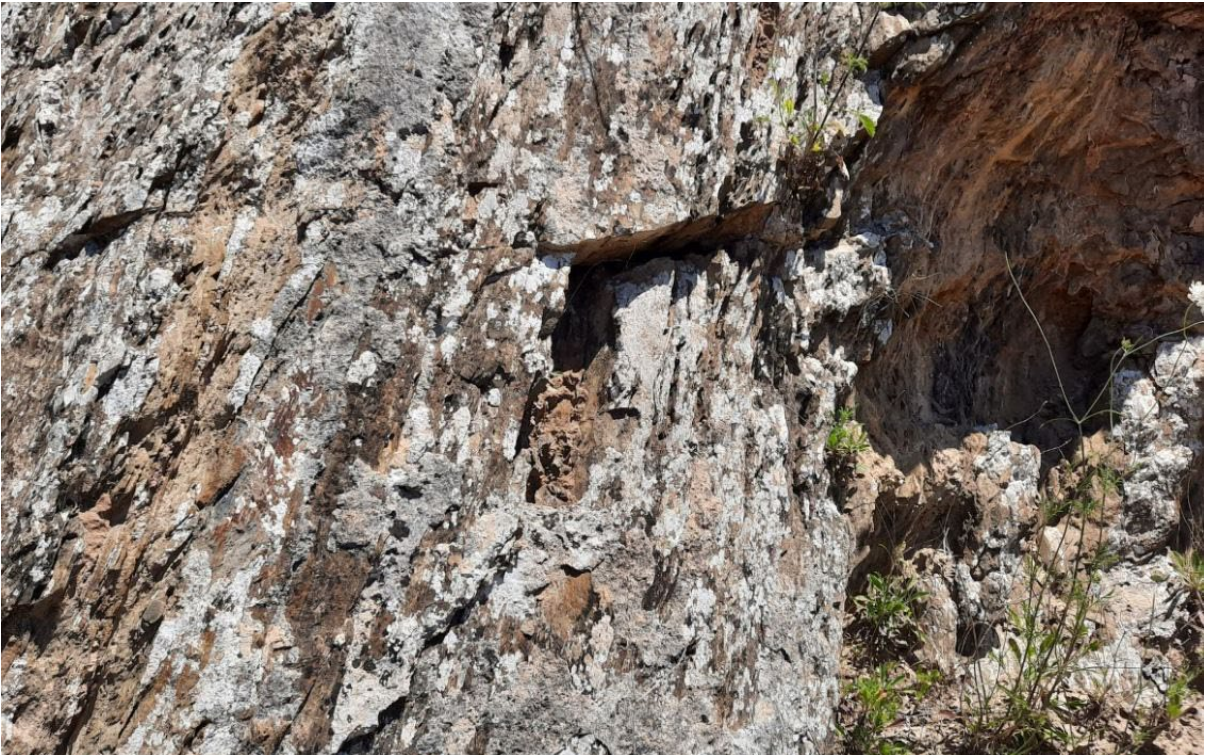
Excavations to Old Sellicks Hill Road, gouged hole in stone possibly relates to dynamite insertion (GGA, 2022).

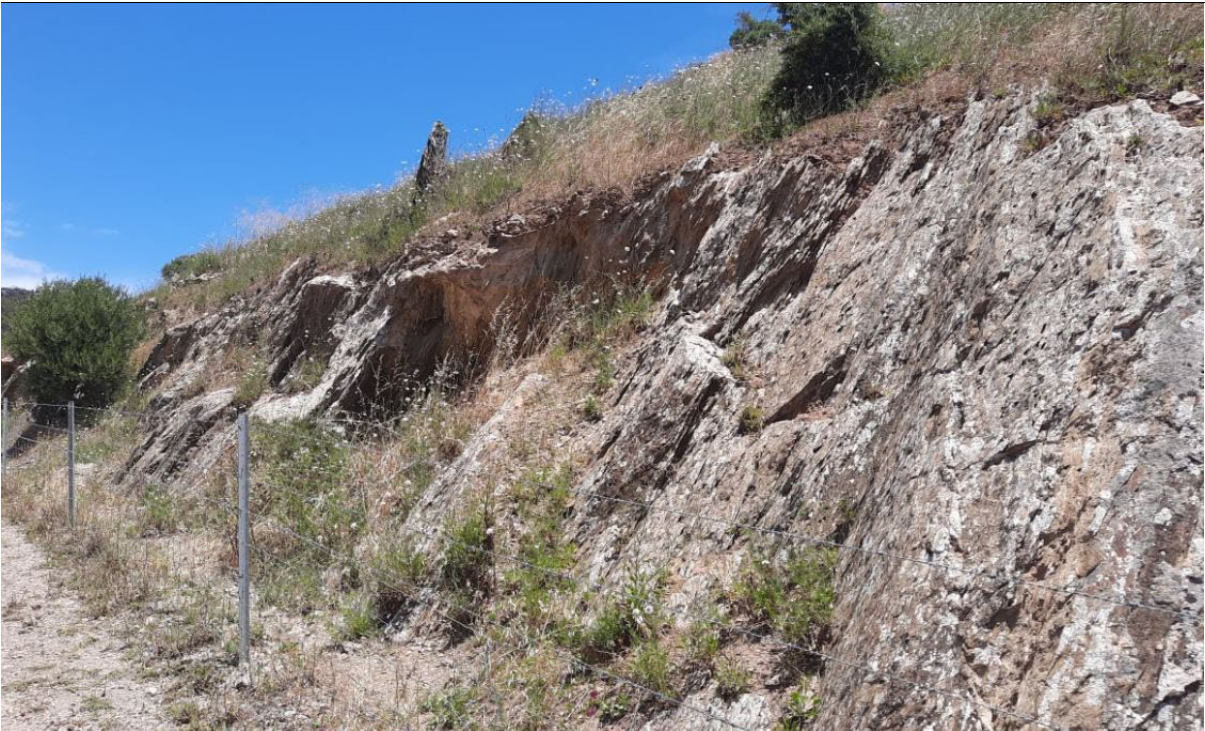
Typical excavated stone to Old Sellicks Hill Road, one of many such examples lining the original c.1859 roadway (GGA, 2022).
