**NAME: Slate Culvert at five-way intersection, High Street, WILLUNGA**

| <b>CURRENT USE:</b> | Drainage culvert |
| <b>RECOMMENDATION:</b> | Local Heritage Place |

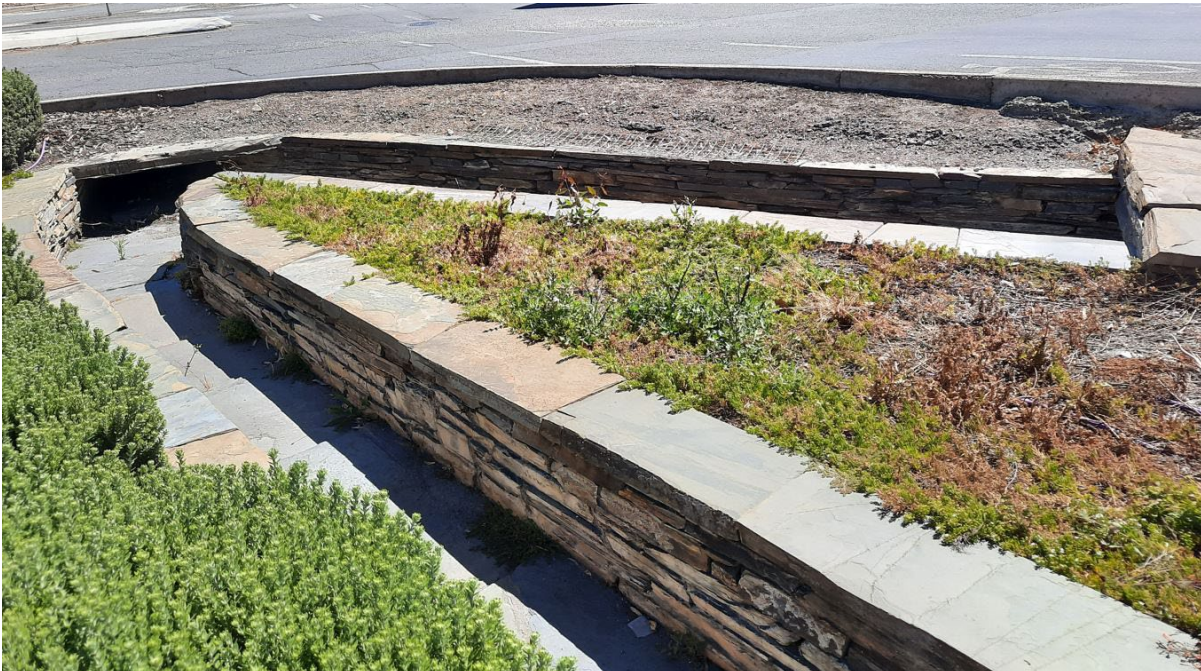
Slate culvert at the five-way intersection of High Street, Willunga; GGA, 2022)

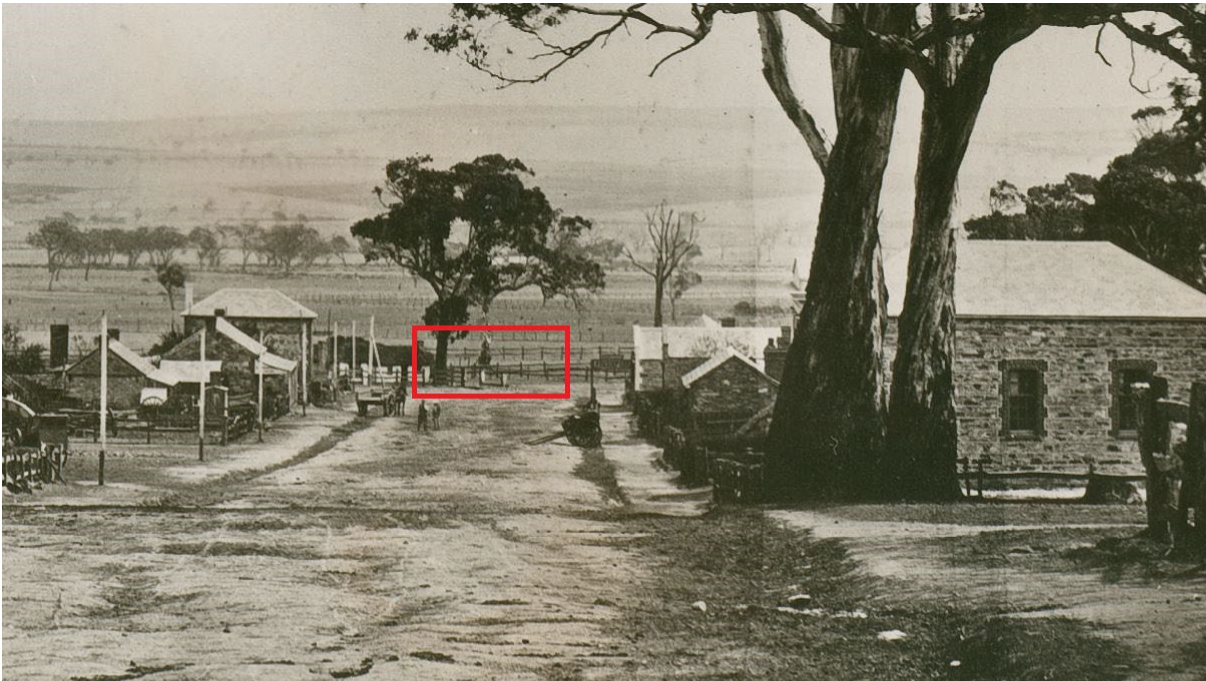
C.1870 photograph of site of five-way intersection slate culvert at the bottom of High Street, Willunga (site shown within red rectangle). Note excavated lines of earth on either side of High Street, indicating completion of recent subterranean drainage culverts at that time. There appears to be a small footbridge over the site of the slate culvert, possibly the 'infant bridge' referred to in the 1865 article. (SLSA B 7192)

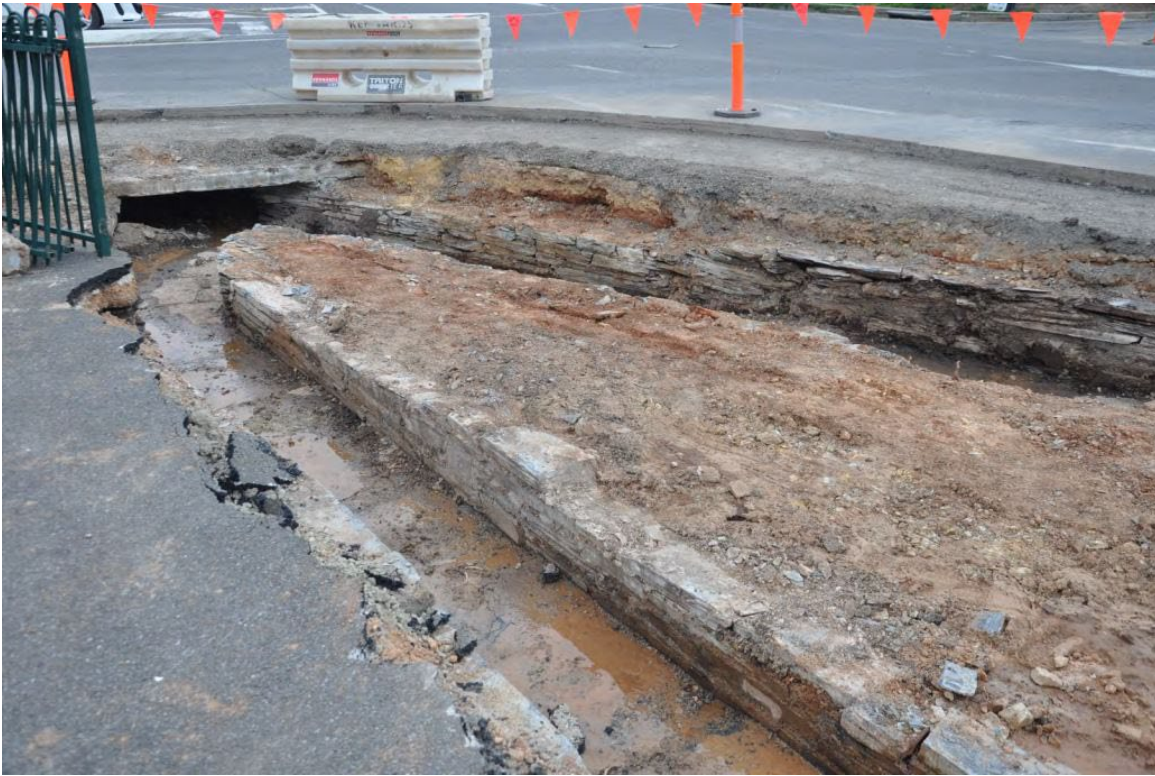
2017 photograph of then recently-excavated slate culverts at High Street five-way intersection, uncovered during the Willunga streetscape project (National Trust of SA, Willunga Branch)

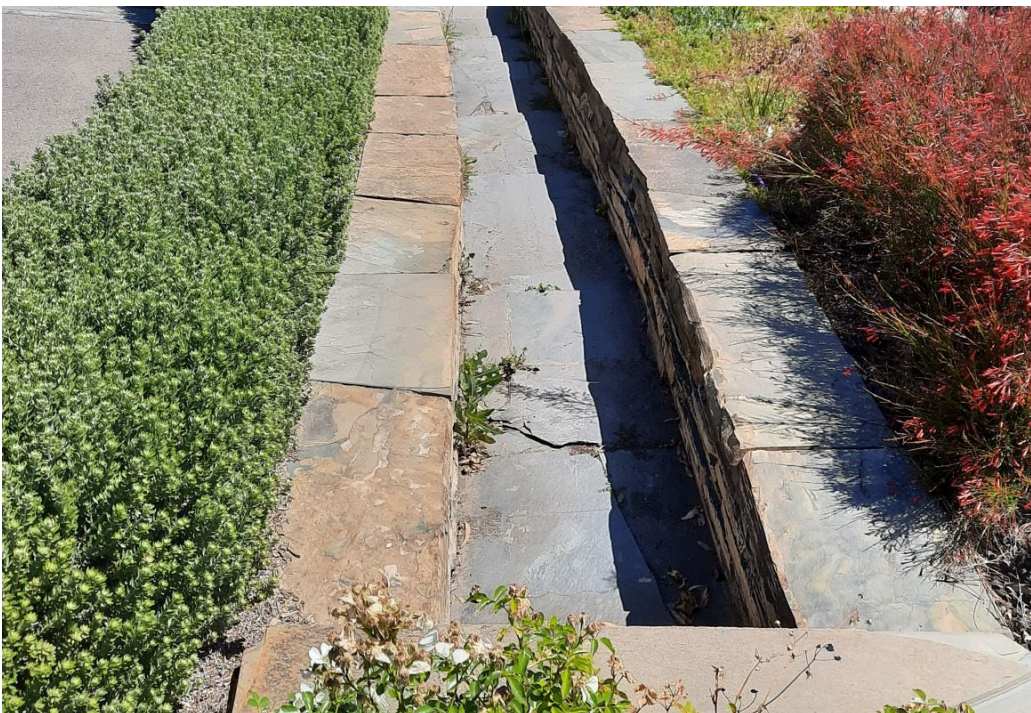
Slate fabric of the culvert dispensing from St Andrews Terrace towards Aldinga Road, looking north (GGA, 2022).
